Document title	Appendix 5.2: The Tree Inspector Comrie Flood Protection Scheme Arboricultural Report Parts 1 and 2	
Originator	The Tree Inspector	
Checker	Ellie Davies	
Approver	Gail Currie	
Authoriser	Rebecca McLean	
Status	For Information

# Arboricultural Report: Part 1 Comrie Flood Protection Scheme

18<sup>th</sup> July 2018

Prepared for **SWECO UK**

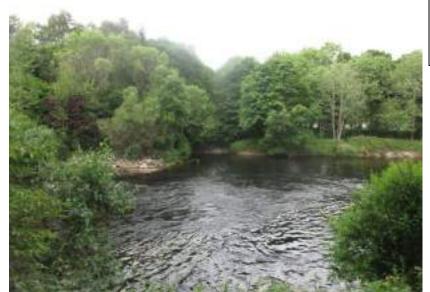
Dalginross: View from south Earn bank near tree 53 north towards burn

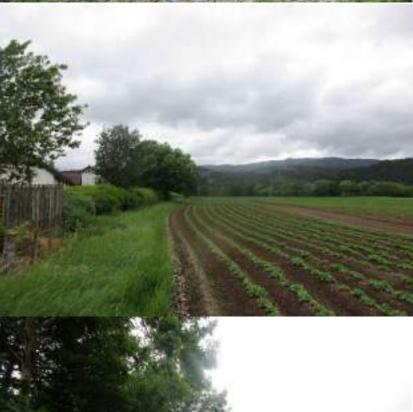
Dalginross: trees and hedges on village eastern extent

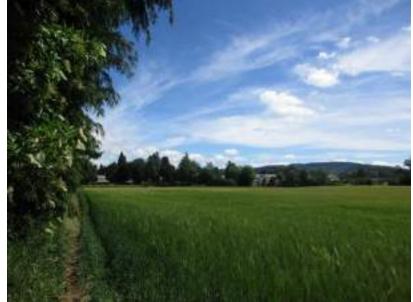
Dalginross South West view from garden of house on camp road towards Dalginross

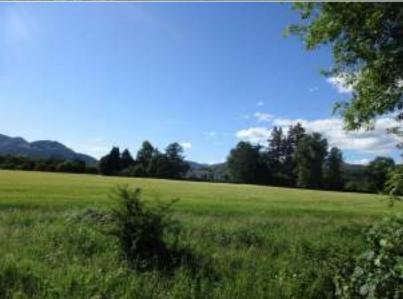
Dalginross South West: View from Dalginross to garden of house on camp road

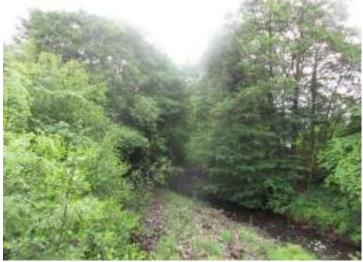
Comrie north: view from northern extent south along burn adjacent to churchyards

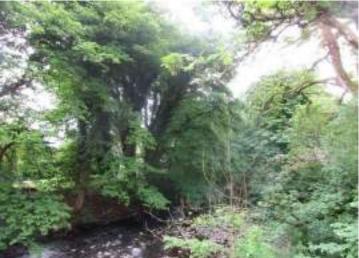
Comrie north view from near A85 Bridge north along burn adjacent churchyards

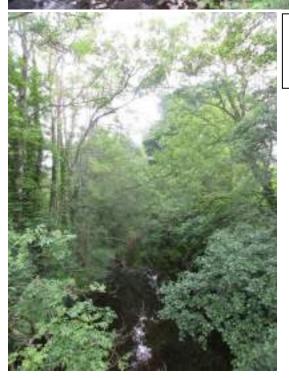
Comrie north view from near A85 Bridge north along burn adjacent churchyards

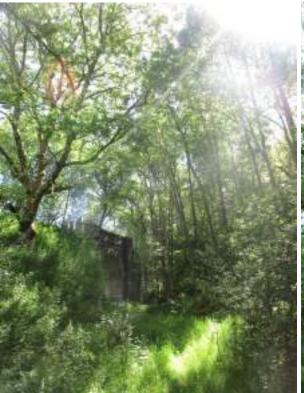
Rail\_Embankment\_South\_view\_east\_along\_mill\_lade\_adjacent\_tree\_1347

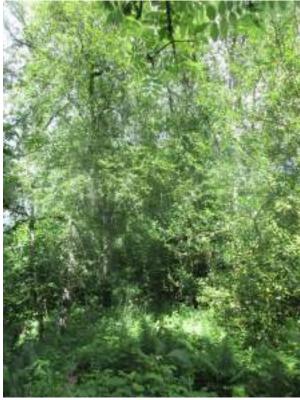
Rail\_Embankment\_South\_view\_atop\_embankment\_adjacent\_tree\_1350
