# Comrie and Dalginross 2013 Flood Study

## **Flood Defence Inspection Report**

03 November 2014 – Issue 2

*Produced for*  
Perth and Kinross Council

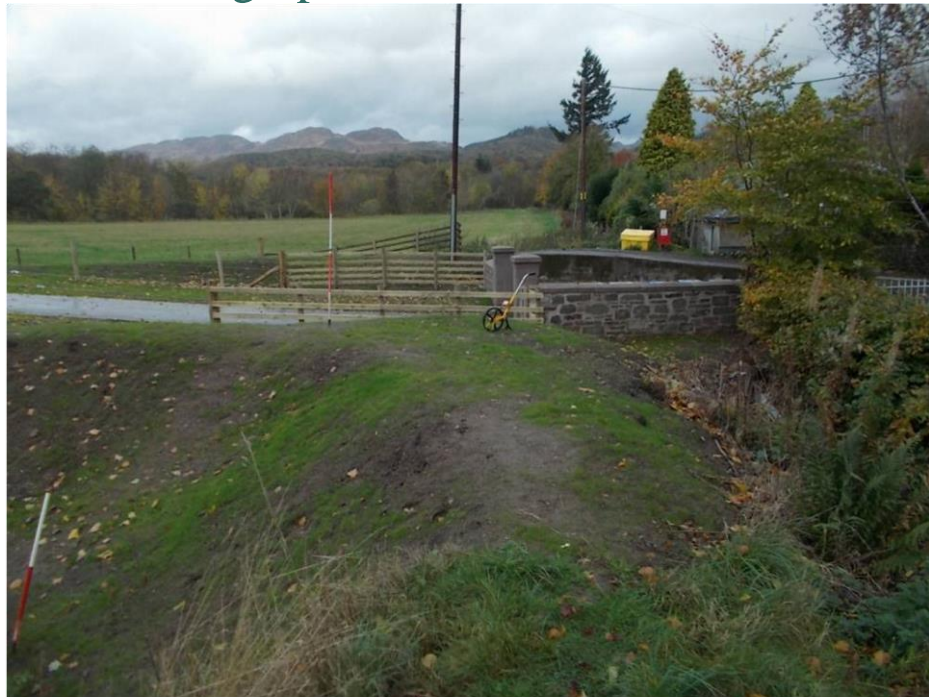
Approximately 167 metres of the earth embankment runs parallel to the Fey Burn and approximately 20.4 metres of embankment runs on the south side along the Camp Road toward Tomnagaske House (photograph 2) The earth embankment is approximately 1.5 metres in height above the adjacent land

Photograph 1 – Earth bund looking north

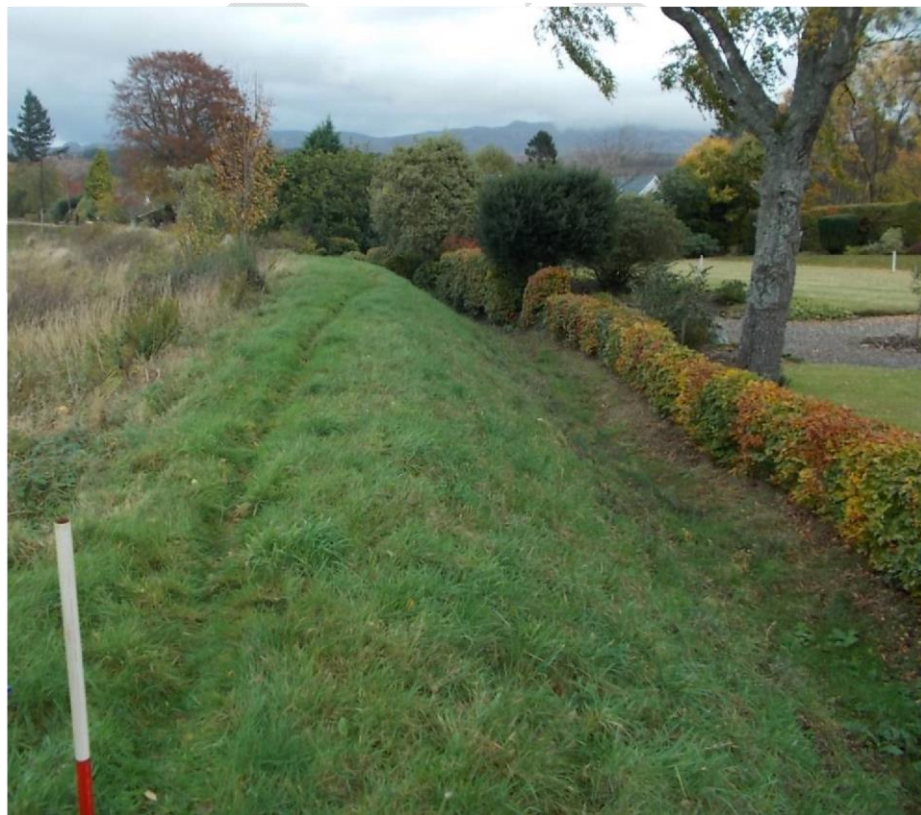
Photograph 2 – Localised bank erosion where bund changes direction

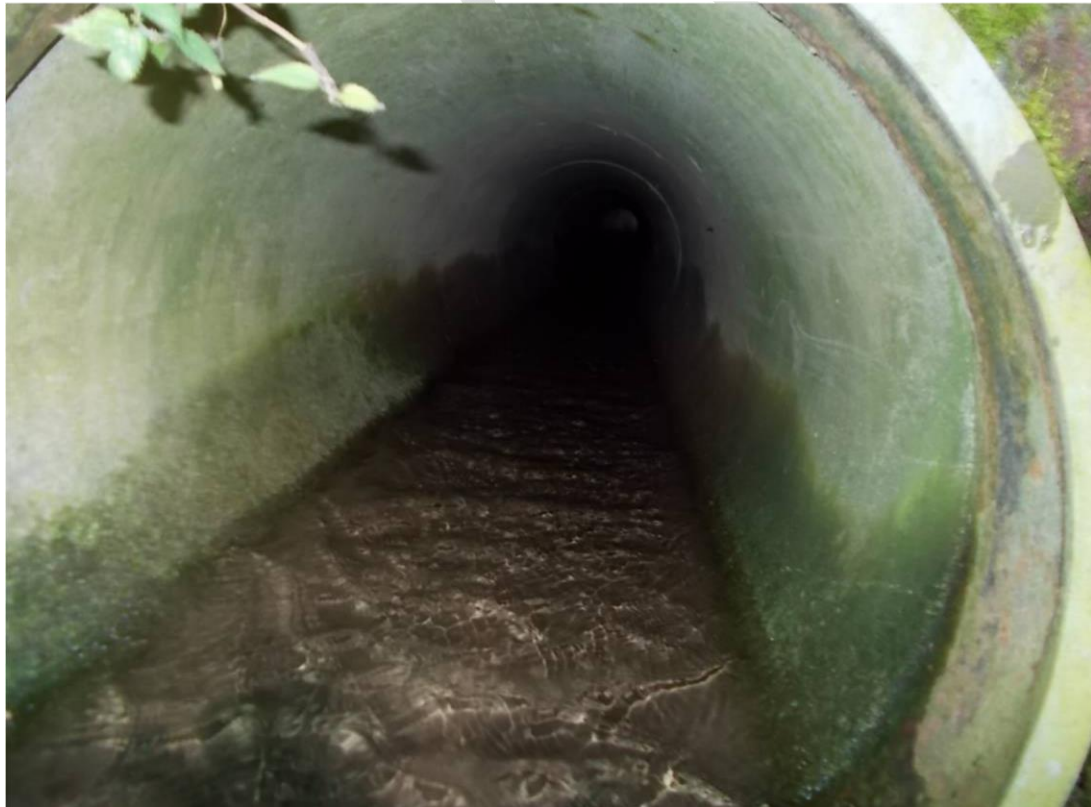
A reinforced concrete pipe conveys the Fey Burn under Camp Road. A CCTV survey was not undertaken and only the culvert Inlet & Outlet were inspected. It was noted that the flap valve referred to in record drawings is no longer present (Photograph 4). The culvert appears to be in good condition (Photograph 5).

Photograph 4 – North end of the pipe (no flap valve)

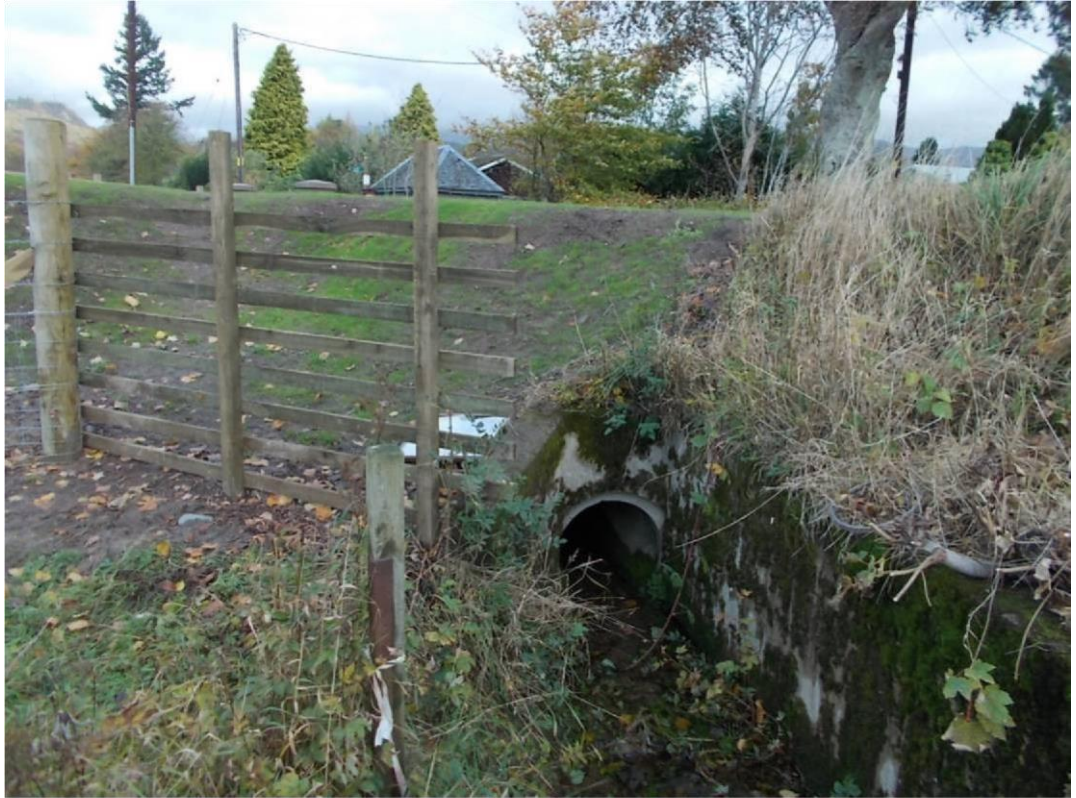
Photograph 5 – South end of the pipe

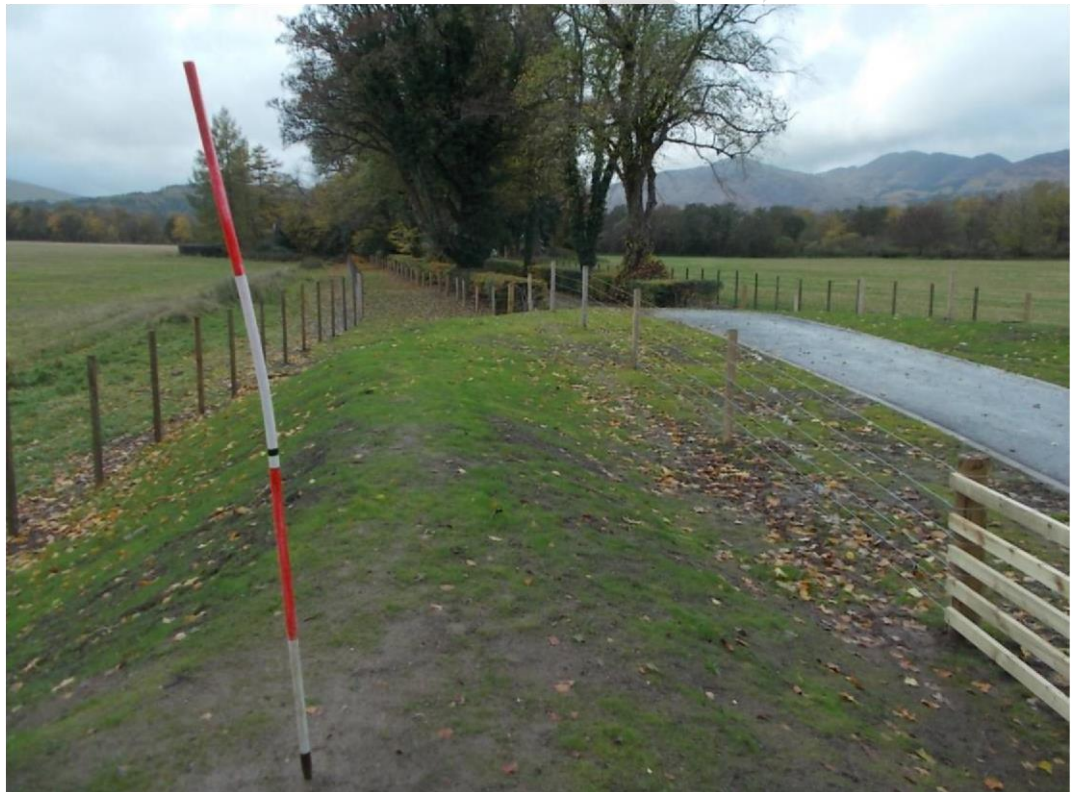
The earth embankment is generally in good condition with no signs of slip or scour. The embankment is generally well vegetated. The crest of the embankment is not level as it is being used as a footpath from approximate chainage 39 metres onwards to the north. Manmade steps were seen at chainage 39 metres on the east side, leading to minor erosion where the embankment changes direction (photo 2). There was no evidence of burrowing animals inhabiting the embankment. Other photographs; photo 6 looking west and photo 7 looking east along the embankment.

Photograph 6 – looking west towards Tomnagaske House

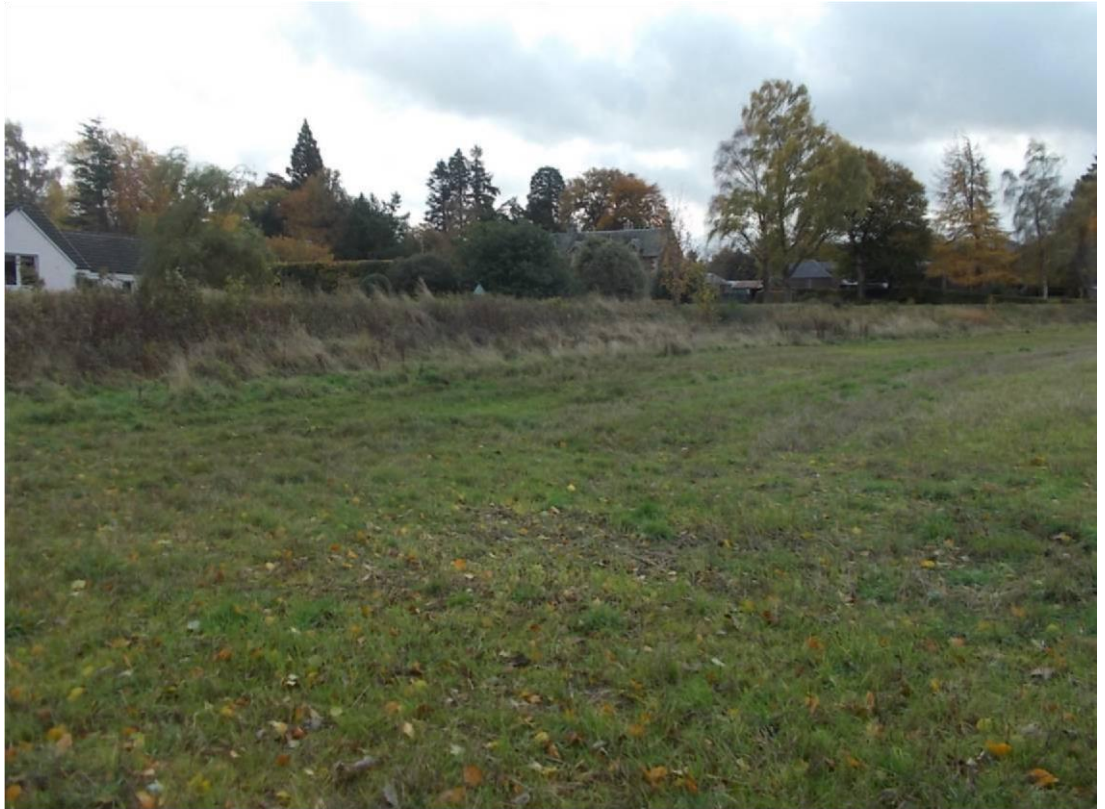
Photograph 7 – Looking East on Earth bund

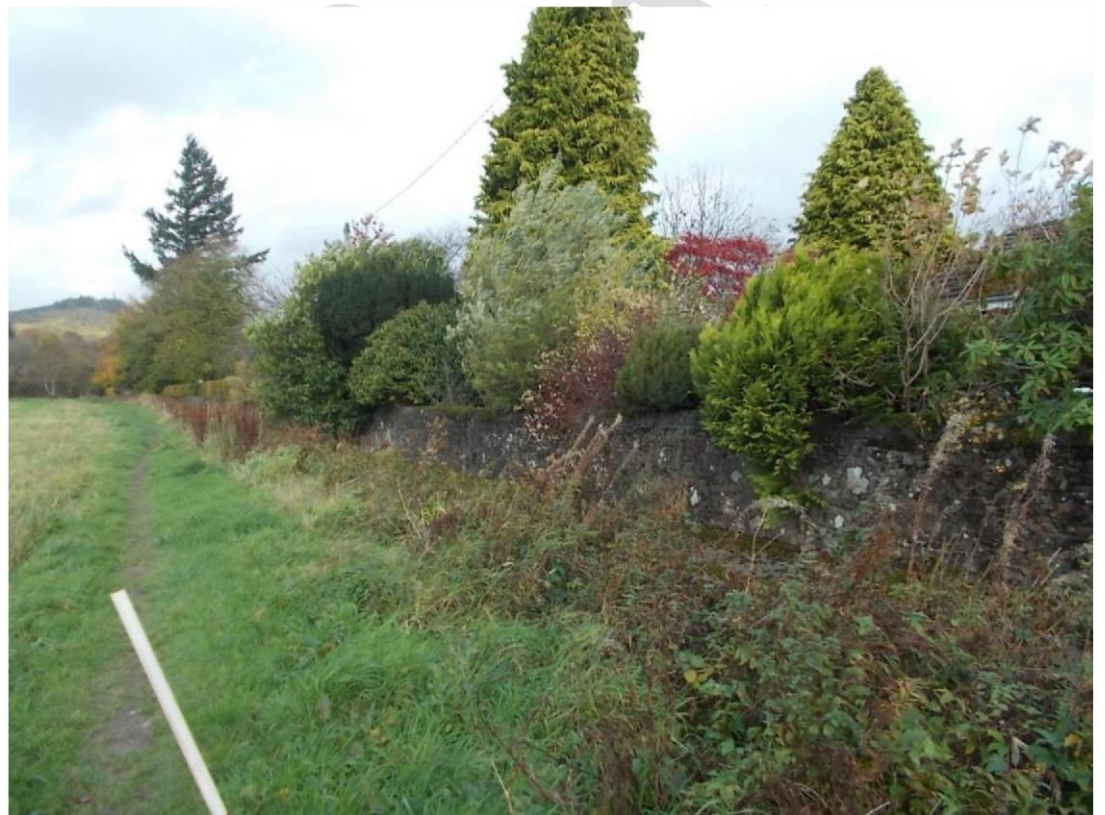
Referring to record drawing C1, (refer to Appendix C) this section of wall appears not to have been raised or strengthened by the works undertaken circa 1960 (Photograph 8), but is very similar in construction and is probably contemporaneous. The following notes were taken during the inspection.

Photograph 8 – Concrete base with concrete/masonry stem

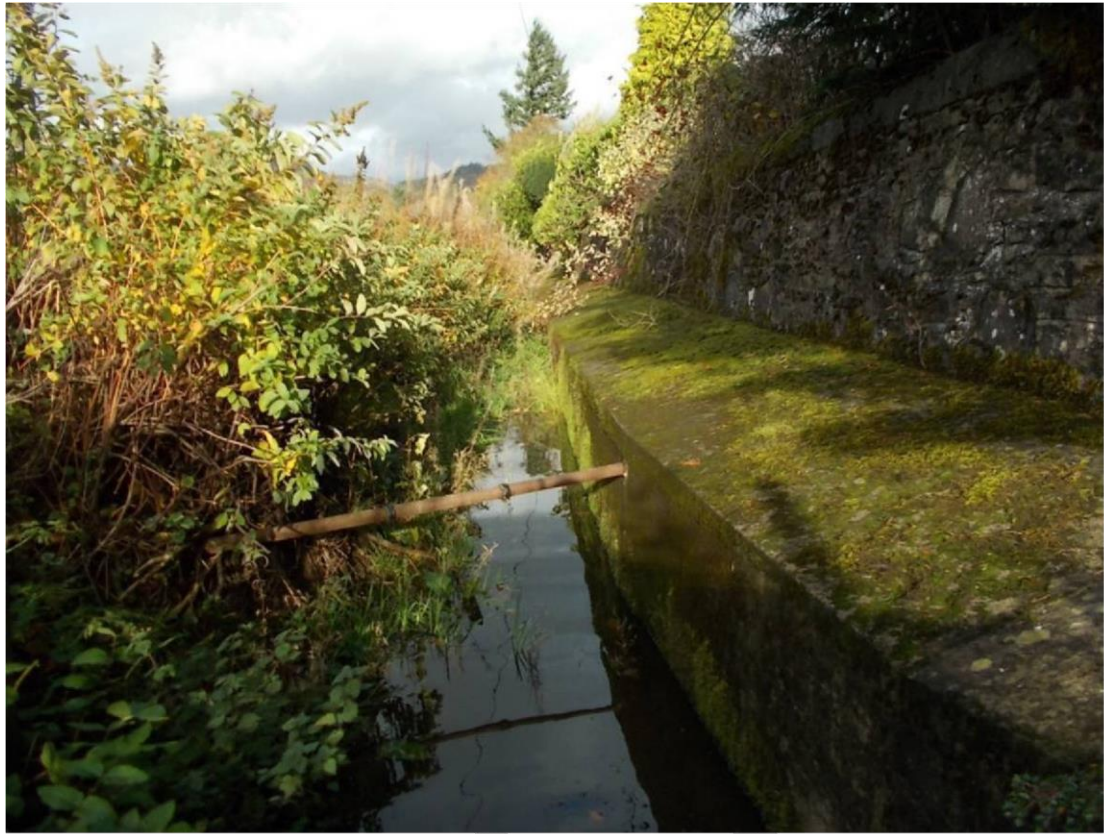
Photograph 9

- A steel pipe (Photograph 9) runs through the mass concrete base at approximate Chainage 9.8 metres measured from the start of the wall. The pipe runs across the Fey Burn. The pipe is buried to the west side and is cast in concrete on the east side;
- Mortar loss was noted at Chainage 19.6 metres which should be repointed (Photograph 10);

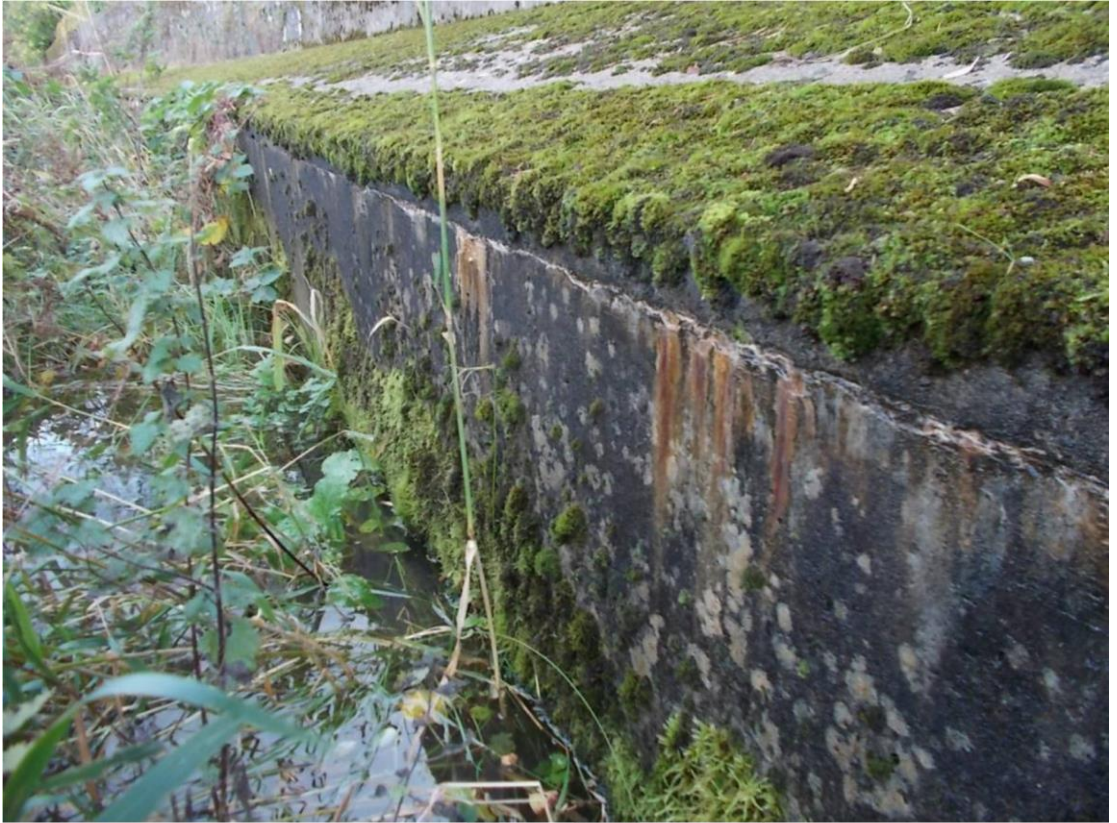
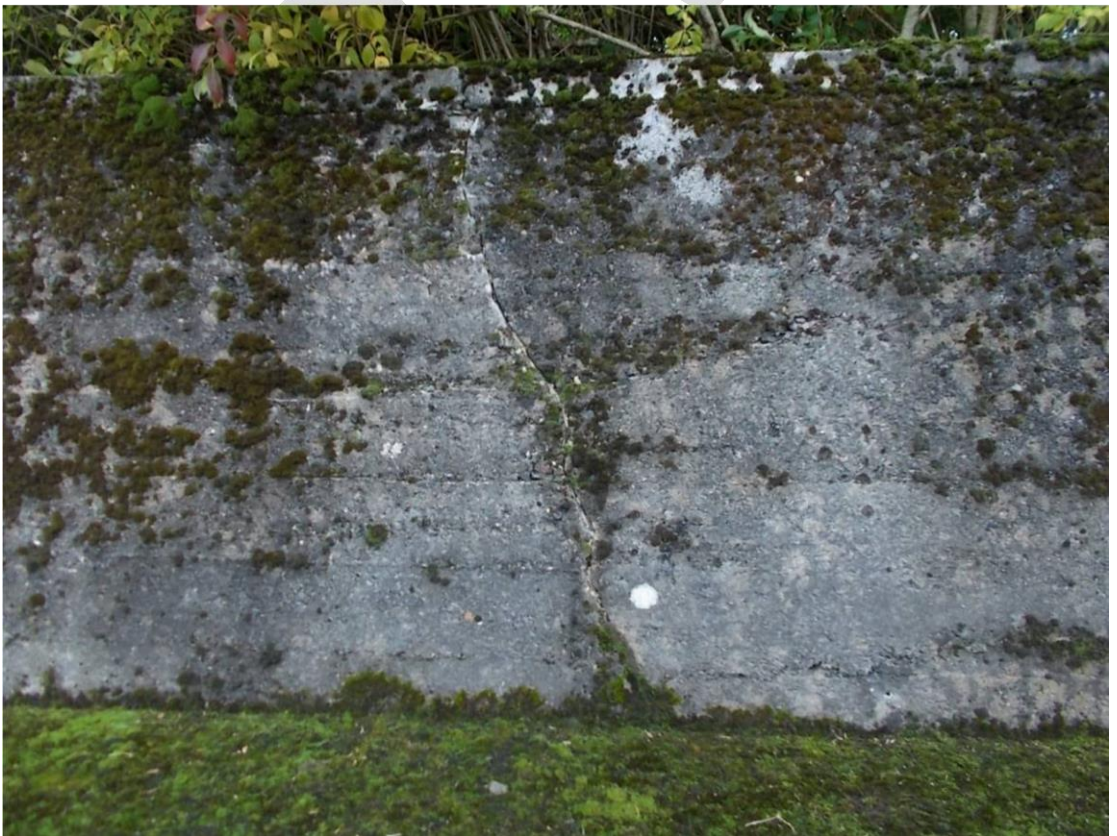
- Photographs 11 and 12 show localised rust stains and a crack in the wall at chainage 81.3 metres. Photograph 13 shows an area at the top of wall with 3 legged cracks. This section of wall was noted to have a hollow sound around a previously repaired concrete section. This is not considered to be of immediate concern but should be monitored during future inspections.
- Photograph 14 shows localised bulging in the wall and loose masonry. This does not however, look to be of immediate concern. Repointing and monitoring this section of wall is highly recommended. A crack in the wall that continues down to the mass concrete was seen at chainage 111 metres, refer photograph 15. A tree was noted directly

Photograph 11 – rust stains.

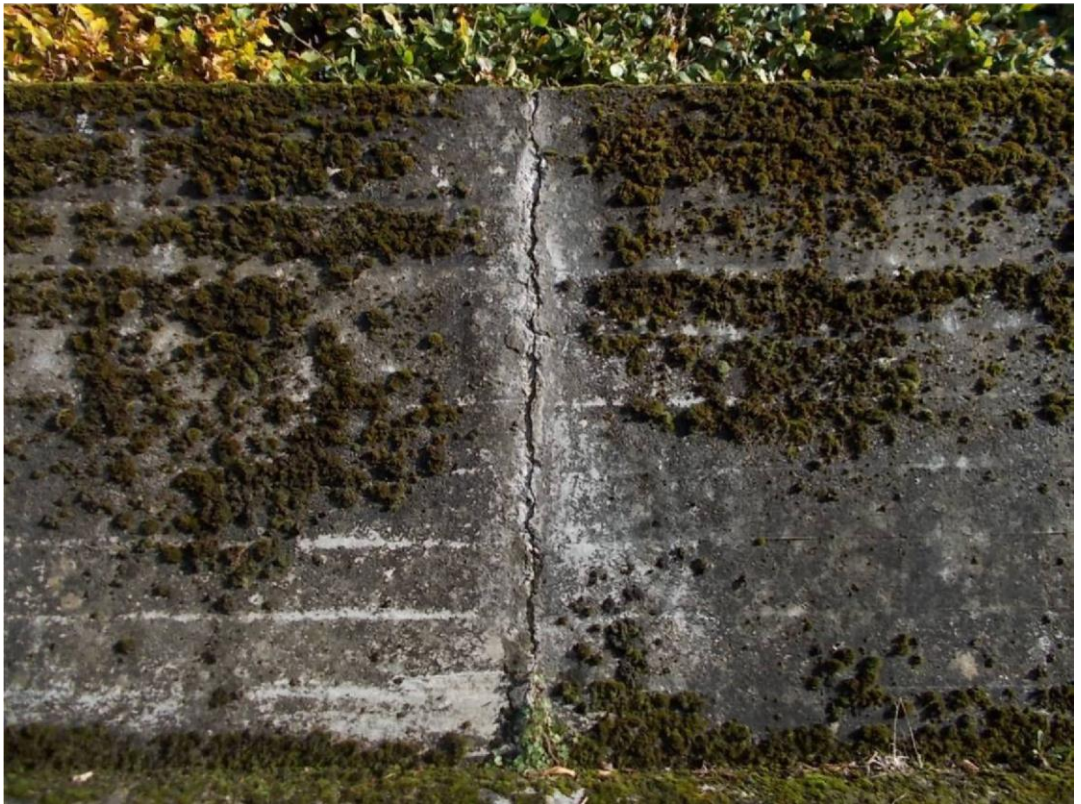
Photograph 15

- There is cracking at the vertical construction joints. There is no flexible filler detailed at the joints and the cracking is likely to have occurred soon after construction as a result of early thermal shrinkage of the concrete (photograph 15). However, the cracking is generally superficial and is not of concern;

- There is vertical cracking on the wall and localised spalling around the cracking (photograph 15). Again early thermal movement is the likely cause. It is recommended that this is repaired using a crack repaired prior to the next inspection;

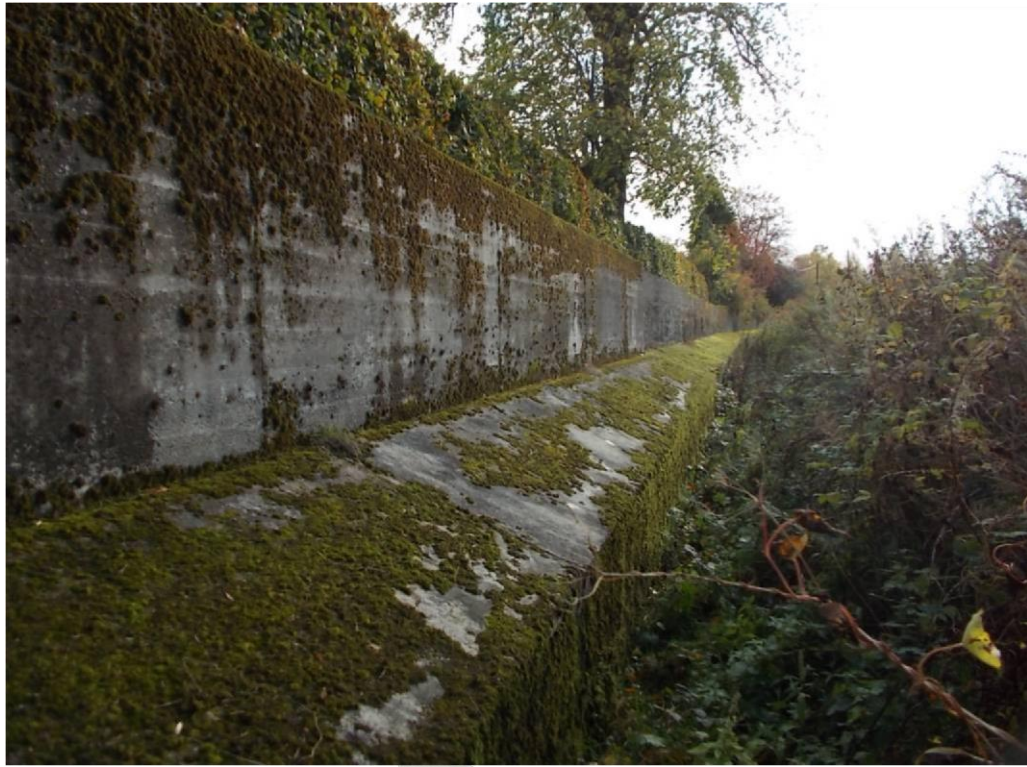
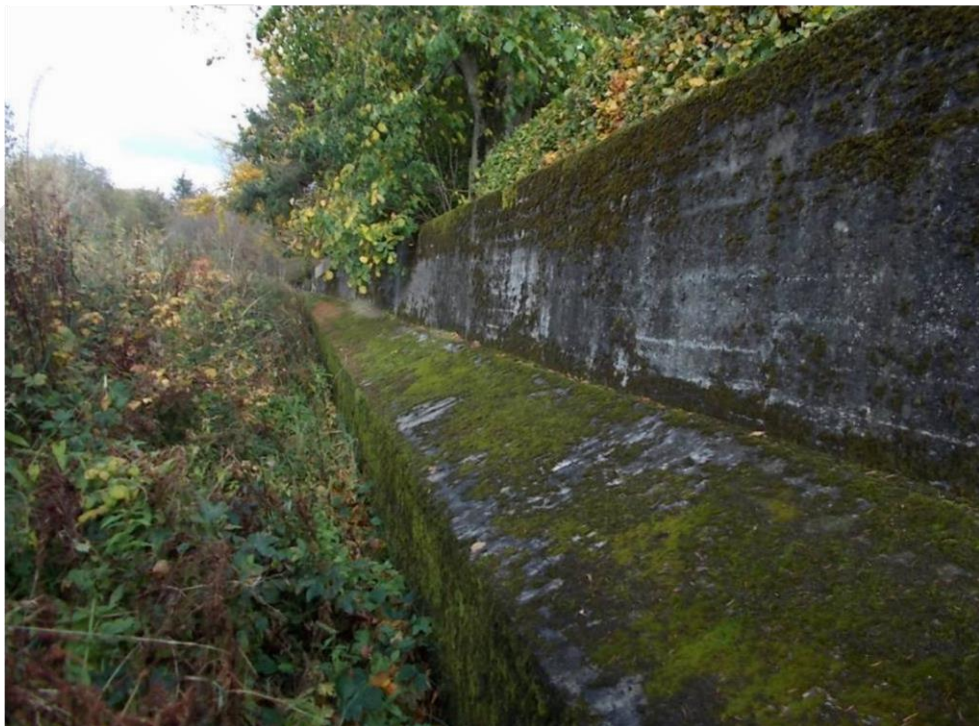
- The concrete surface on the sloping face and the lower section of the wall is extensively covered with moss. This section of the wall could therefore not be inspected (photograph 16 looking south on wall and photo 17 looking north on wall). Removal of vegetation is recommended prior to future inspections;

Photograph 16 looking South

Photograph 17 looking North

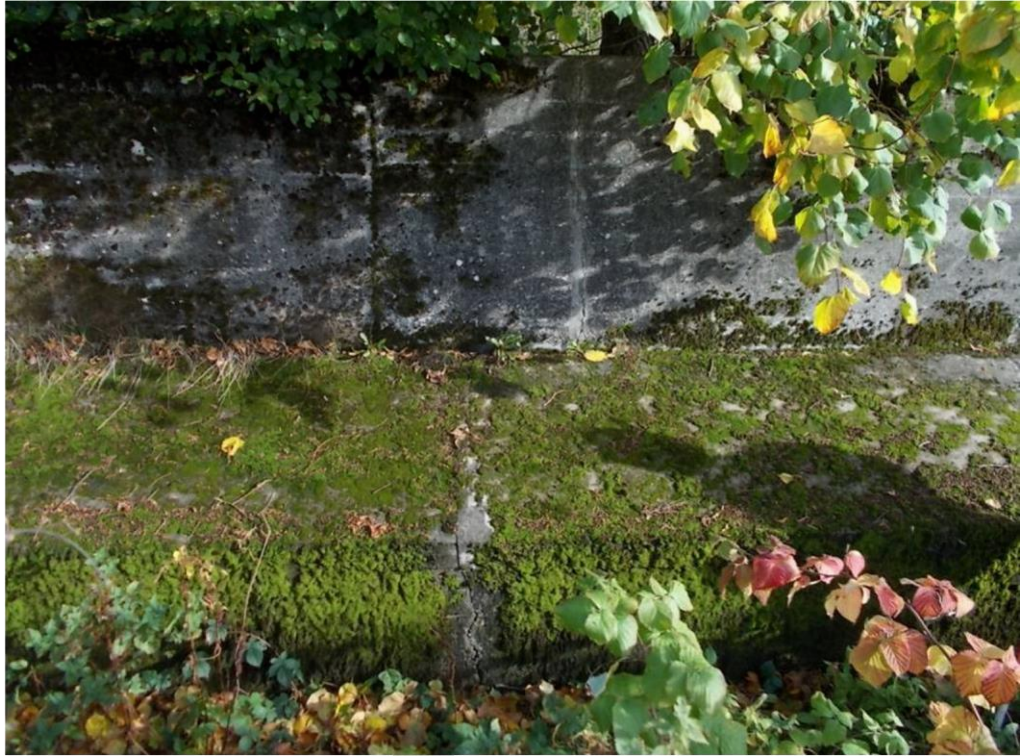
Photograph 18

- A crack in the wall that continues through the mass concrete was seen at chainage 141.8 metres. A tree is located behind the wall where the crack appears (photograph 18). The tree at this point was not touching the wall but the roots might be the cause of the crack. There is no immediate concern but it is recommended that this is monitored during future inspections with a view to removing the tree if required;

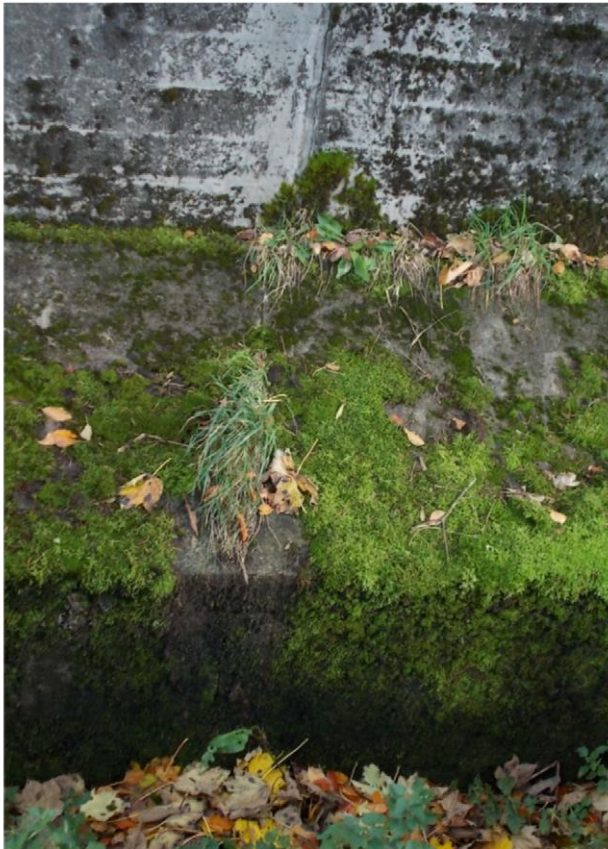
- At chainage 170 all three sections of the wall are cracked and there is evidence of vegetation growth within the cracks (photograph 19).  
Vegetation should be removed and cracks repaired prior to the next inspection;

Photograph 19 wall cracked from top of wall to invert level

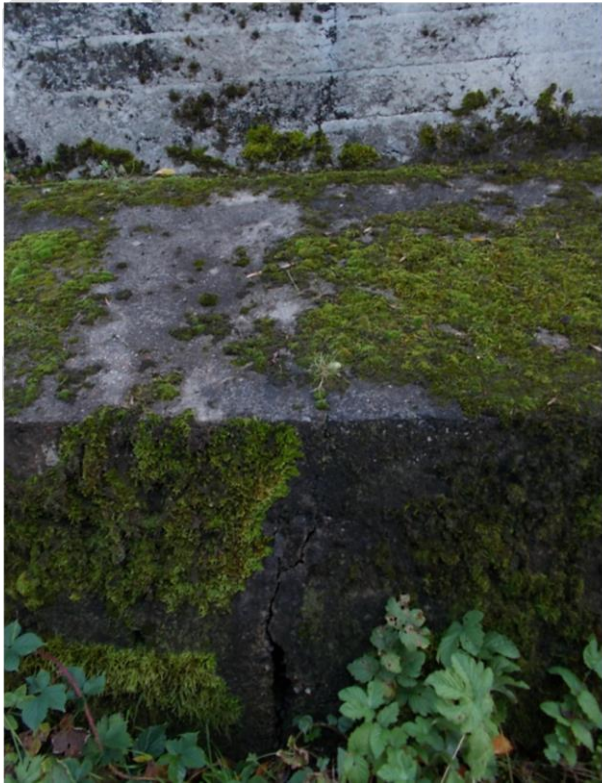
- Photograph 20 shows the crack in the base of concrete wall at chainage 184.7 metres. This is not believed to be significant, however its is recommended that this is repaired prior to the next inspection;

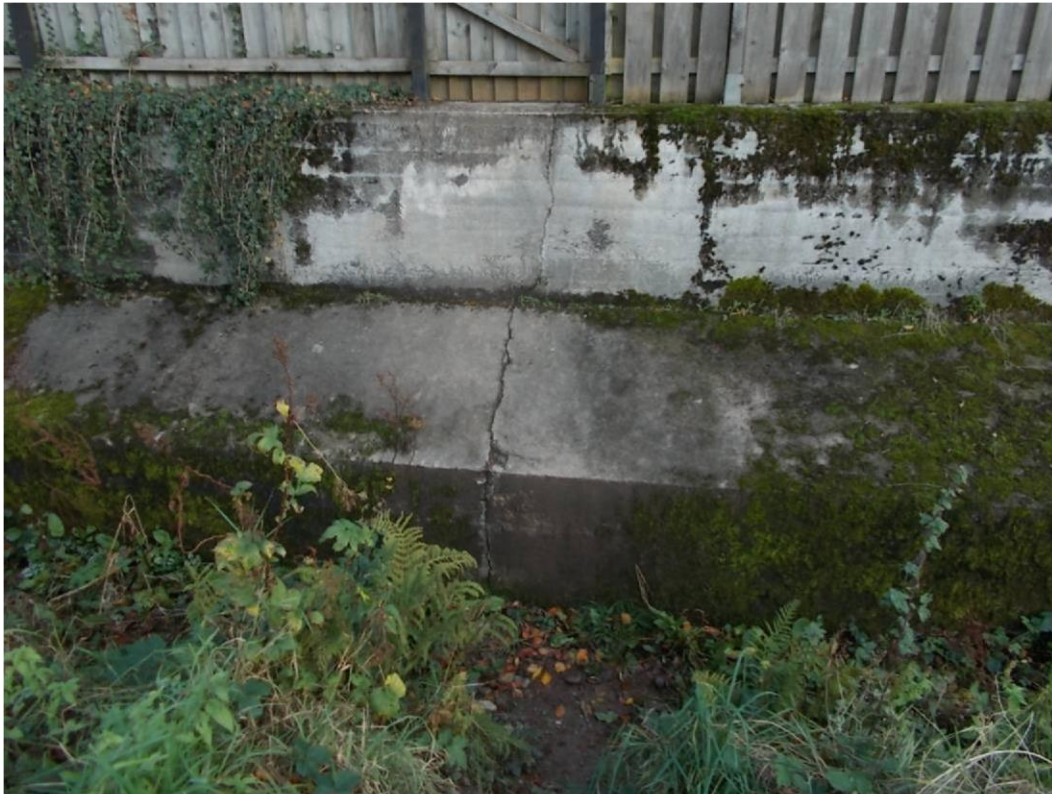
Photograph 21

- Spalling of concrete has occurred at the crack shown in photograph 21;

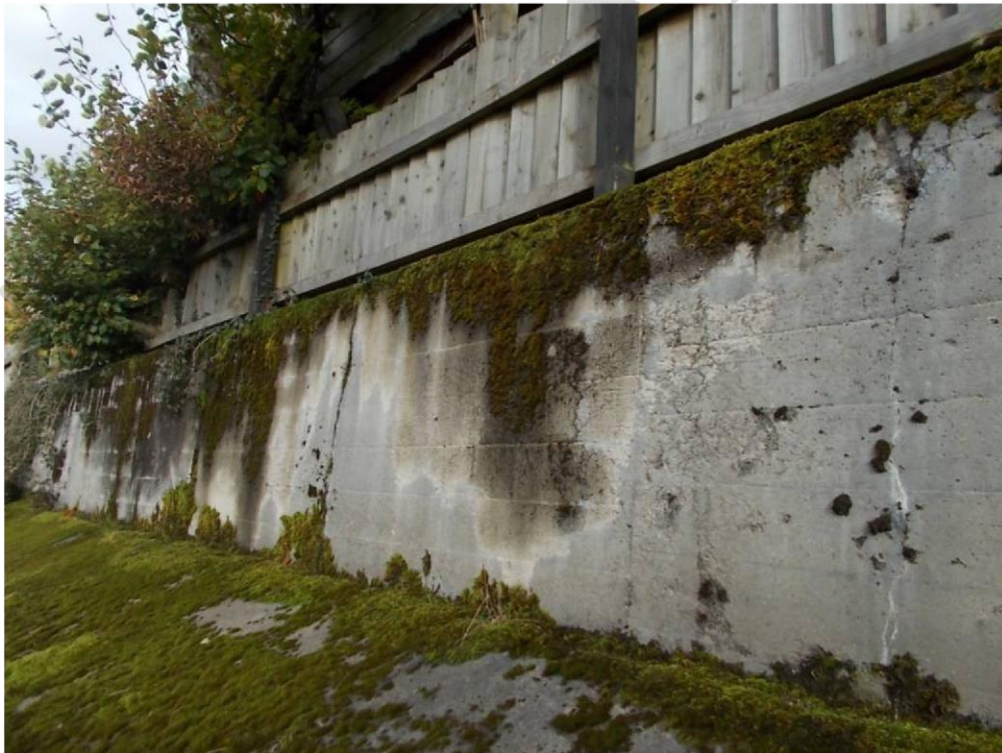
Photograph 22

- Hairline cracks were noted at chainage 204 metres. There were 4 vertical cracks at 4 metre intervals. There is a tree house behind the wall (photograph 22) These are not thought to be significant but should be monitored for movement at the next inspection;

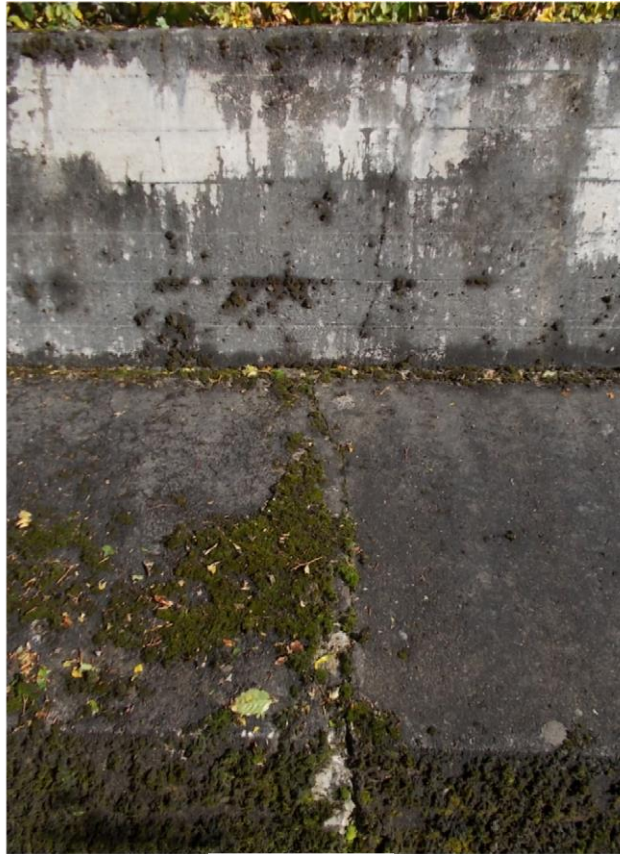
- Photograph 23 shows a crack on the surface at chainage 225 metres which is not of immediate concern. Recommend monitoring for movement at the next inspection;

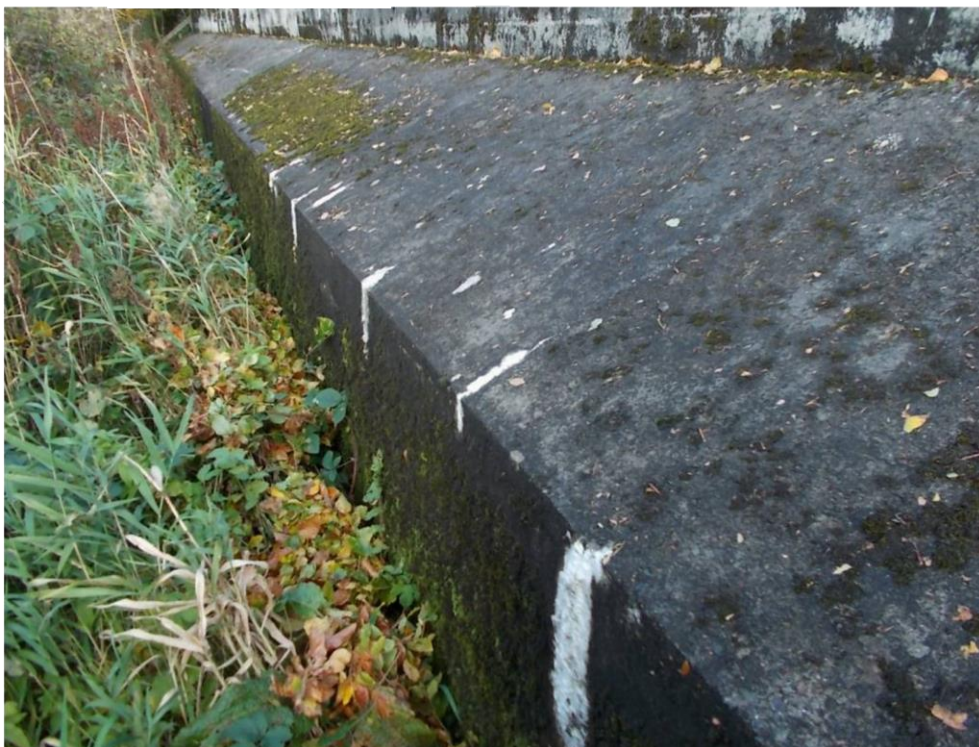
Photograph 24

- At chainage 231 metres, calcite deposits on the concrete base were noted indicating the surface of the concrete to be damp. The freezing and thawing can cause the concrete to crack and crumble reducing the cover to reinforcement (photograph 24);

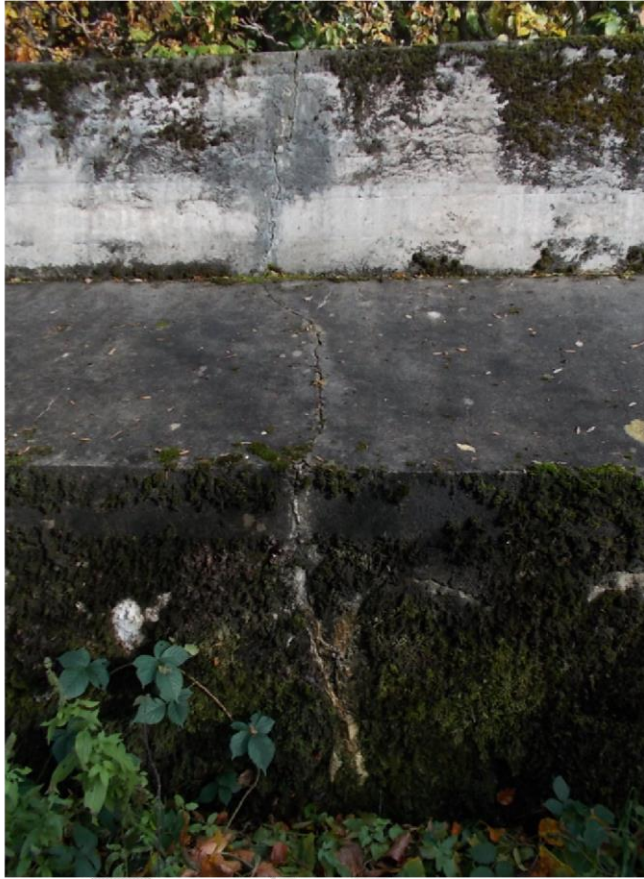
- Calcite deposits with multiple cracks on concrete base at chainage 255 metres (photograph 25). The cracks should be repaired and monitored at the next inspection;

Photograph 25 calcite deposits and multiple cracks on base of concrete.

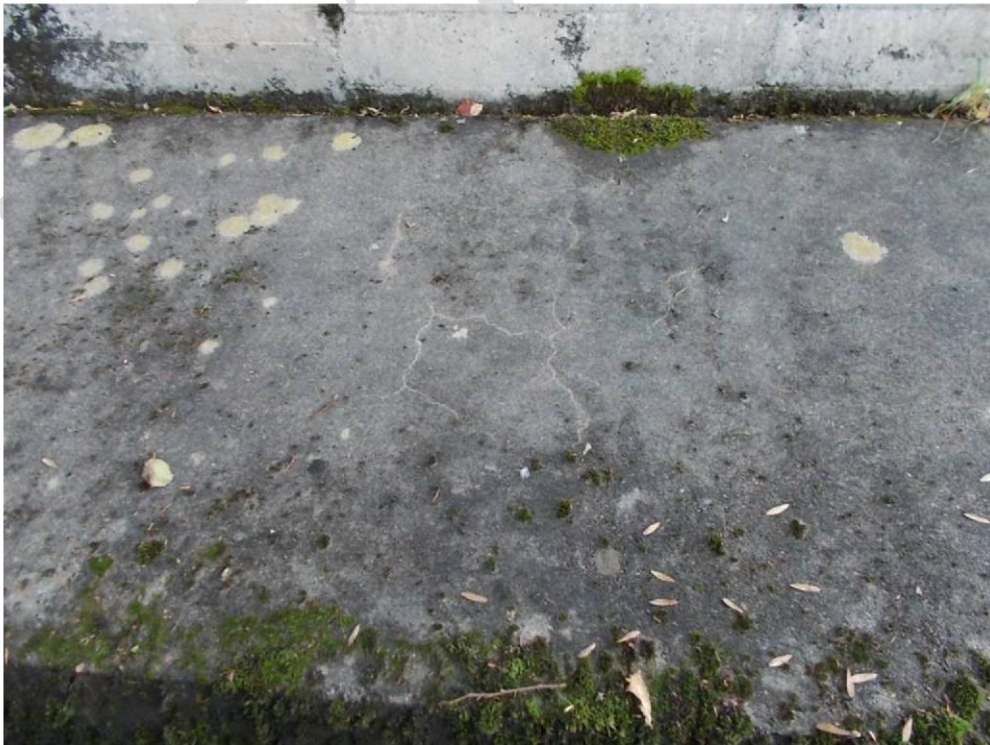
Photograph 26

- Mapping cracks were seen on the sloping section of the wall at chainage 259.5 metres (photograph 26). Map cracking can be a symptom of alkali – silica reaction within the concrete. Not of immediate concern but needs to be inspected during planned inspections;

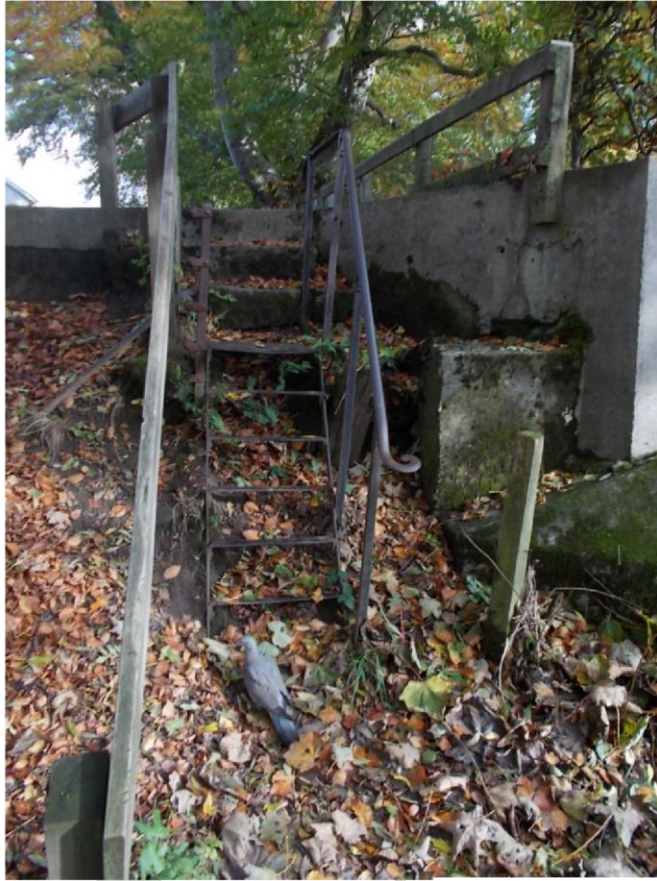
Photograph 27

- The metal ladder at the north end of this section is in a poor condition and should be replaced. (photograph 27);
- There is vegetation growth along the whole length of flood wall. It is recommended that this is removed prior to the next inspection;

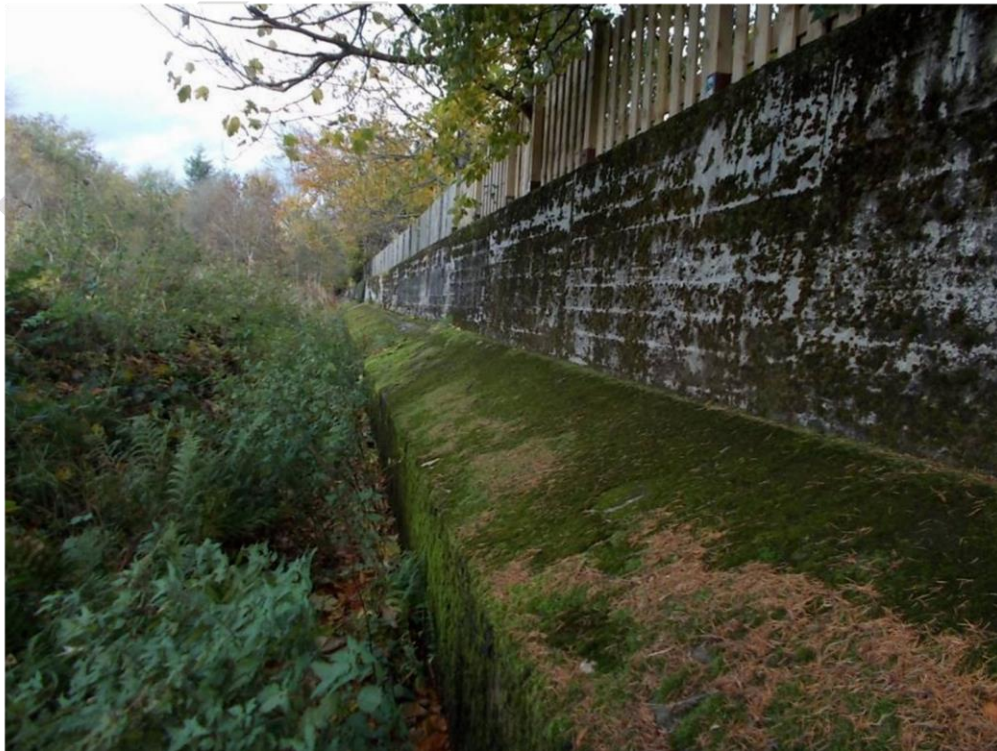
Photograph 28

- It was also noted that at a number of locations, the local residents had attached fence supports to the flood wall; photograph 28 shows an example.

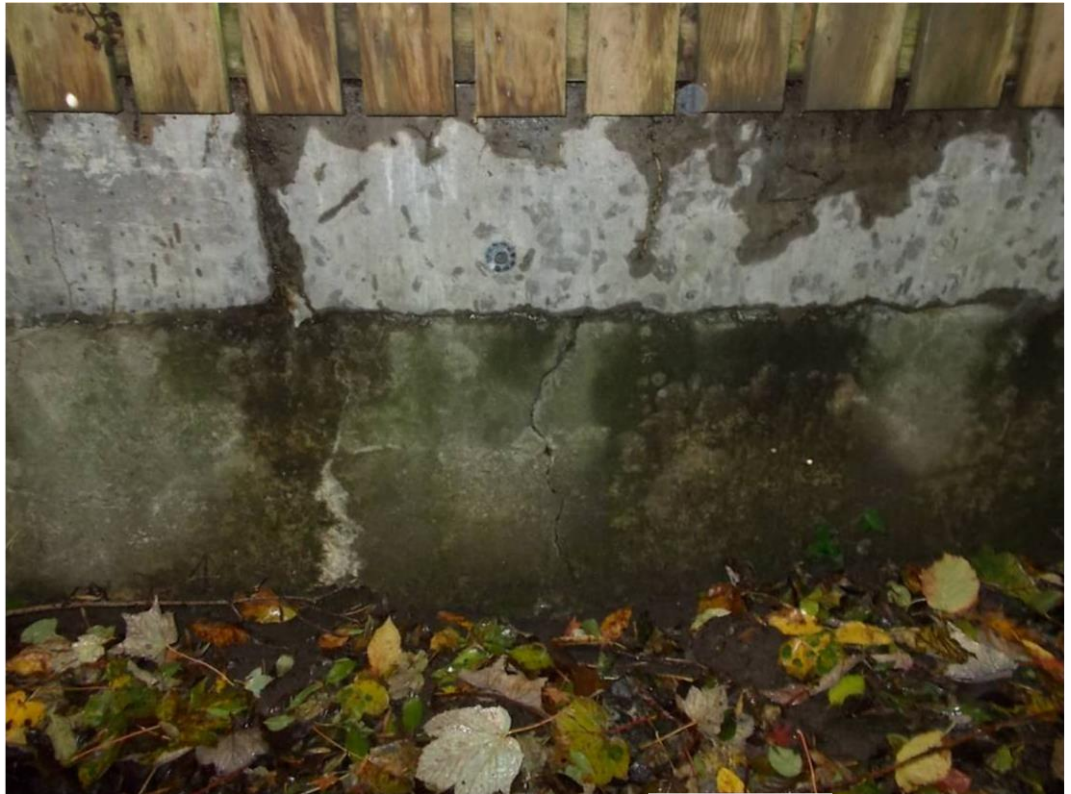
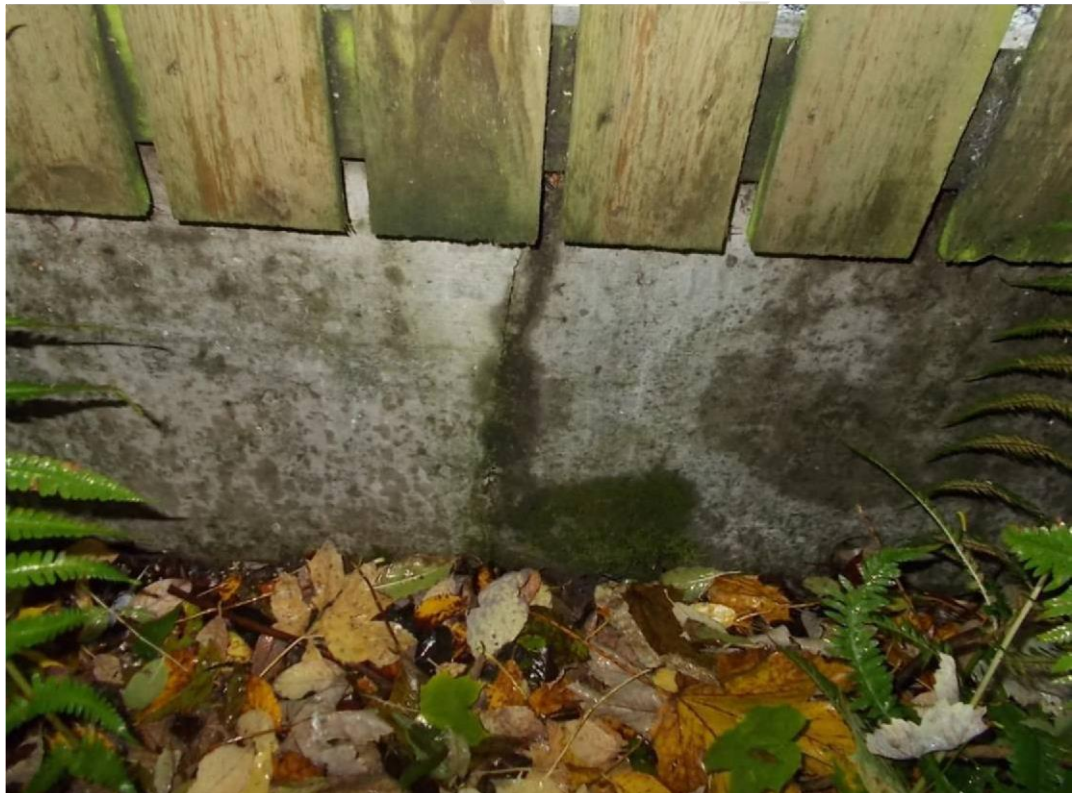
The wall is generally in good condition with no signs of movement or distortion. However, some minor cracking was noted (photographs 29 and 30). In some areas, the recent addition to the wall shows signs of honeycombing and spalling on the vertical faces where new concrete has been cast above the existing concrete. This would indicate poor workmanship during construction but is not of immediate concern. (Photograph 30).
