# Comrie and Dalginross 2013 Flood Study

## **Flood Defence Inspection Report**

03 November 2014 – Issue 2

*Produced for*  
Perth and Kinross Council

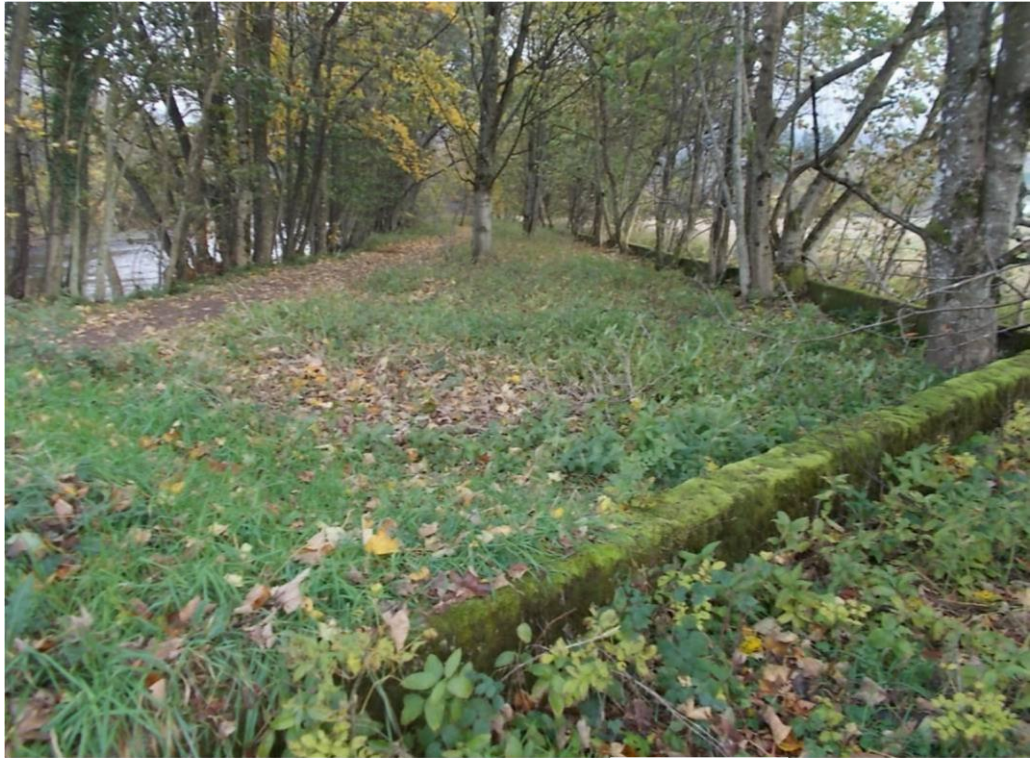
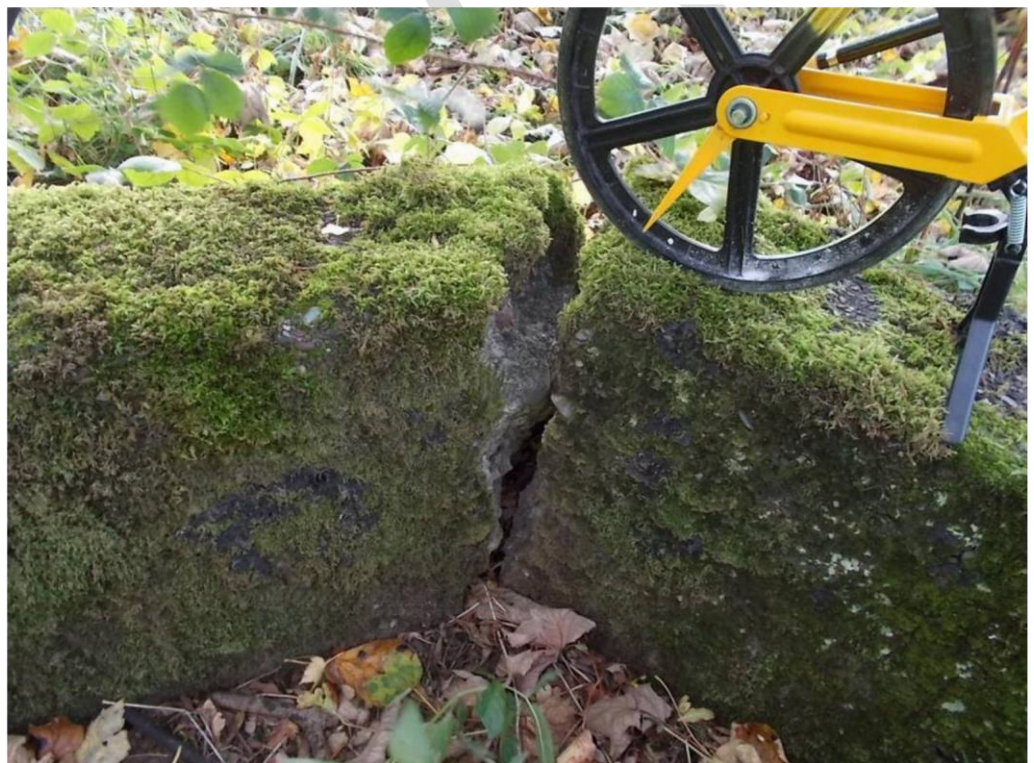
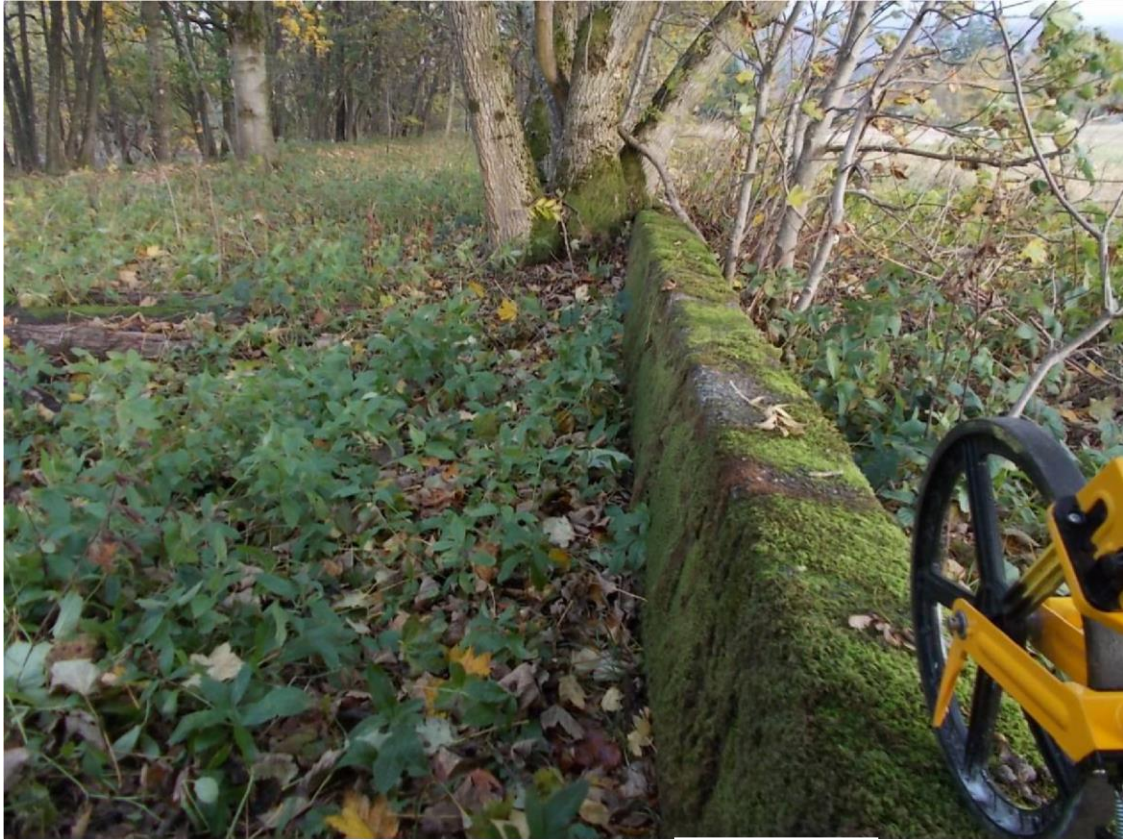
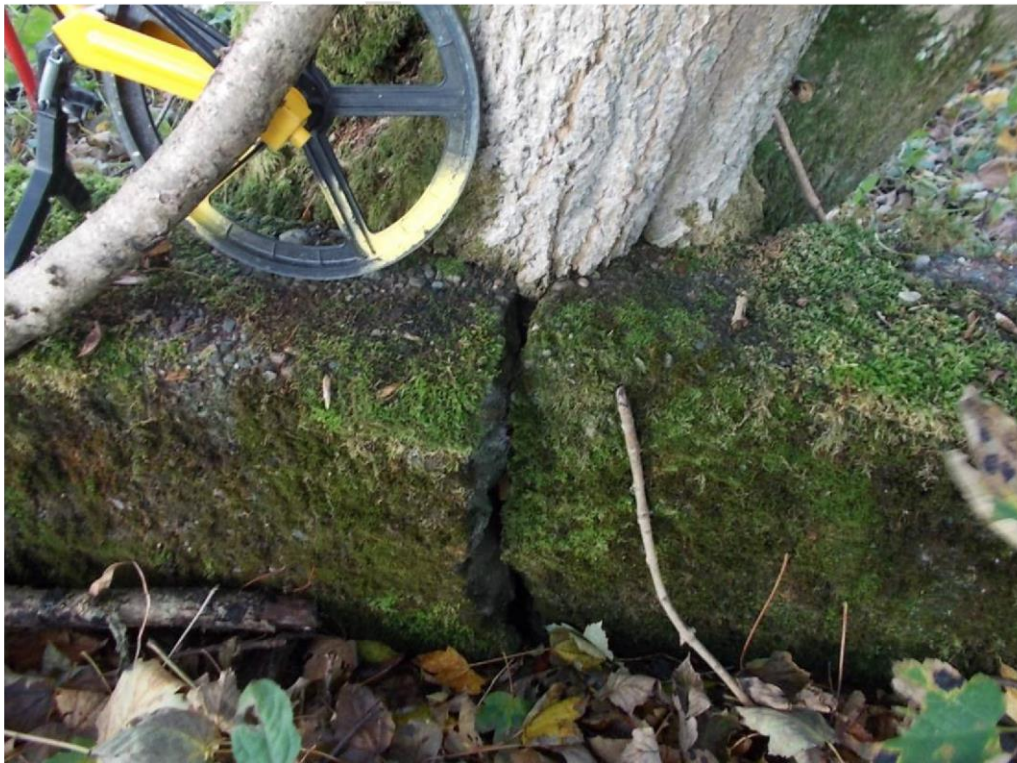
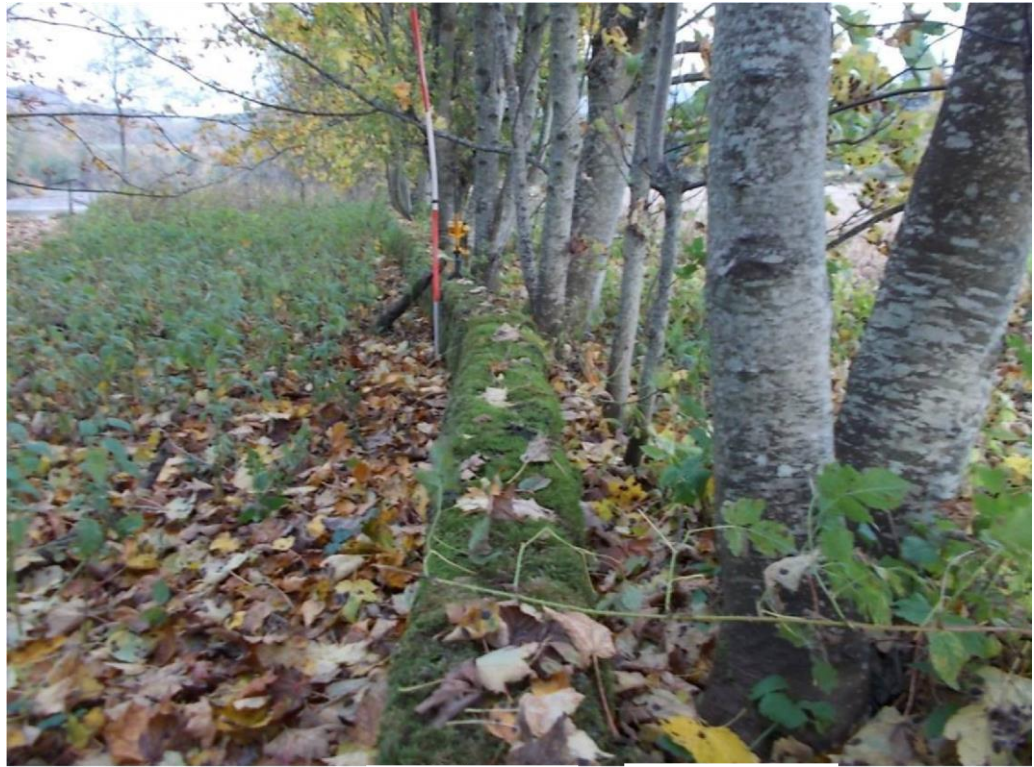
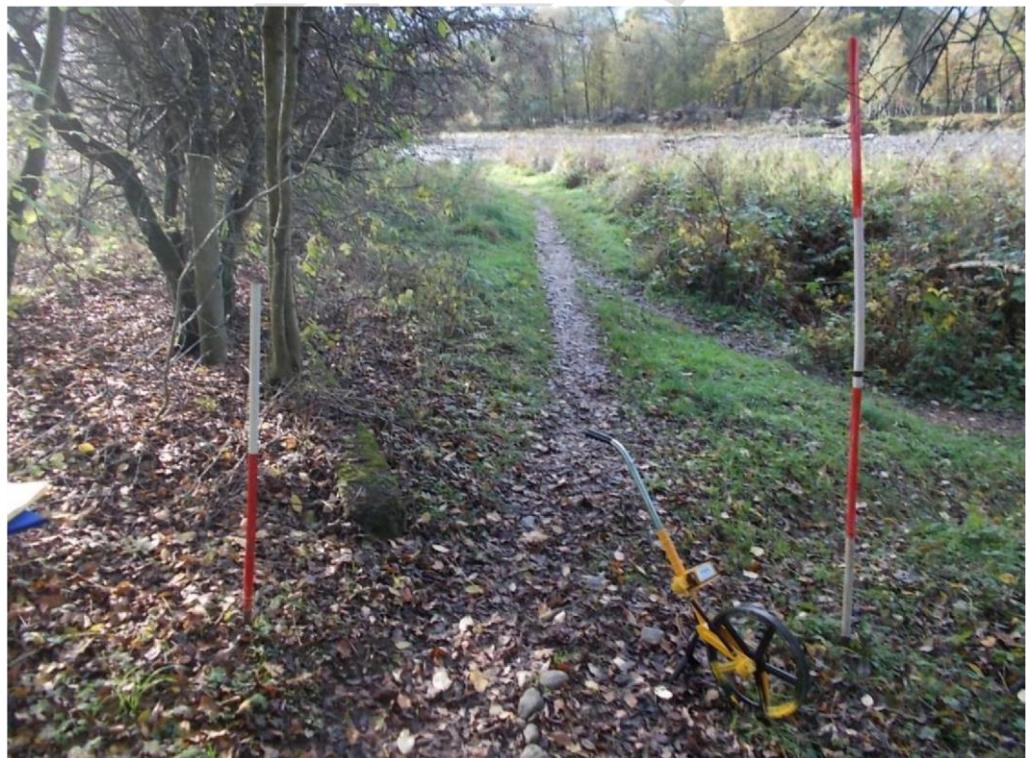
- Photograph 31 shows a general photo of the wall at south end;
- Photograph 32 is at chainage 8.2 metres. The tree next to the wall is suspected to have caused the crack;
- At chainage 8.2 metres looking north, the wall appears to lean outwards (Photograph 33);
- Trees are situated very close to the wall which may be causing the wall to crack. Reinforcement was not visible through the open crack at chainage 14 metres (Photograph 34);
- Photograph 35 also shows trees close to the wall;
- There is heavy vegetation growth around the wall with the majority of the surface covered in moss;
- The section of wall between chainage 237 metres and 264 metres is buried and cannot be seen;
- The wall appears to terminate at chainage 267 metres (Photograph 36).
