Lamprey Survey - River Almond and East Pow Burn September 2008

Project: Lamprey Survey - River Almond and East Pow Burn – September 2008

Title: Final Report, V2

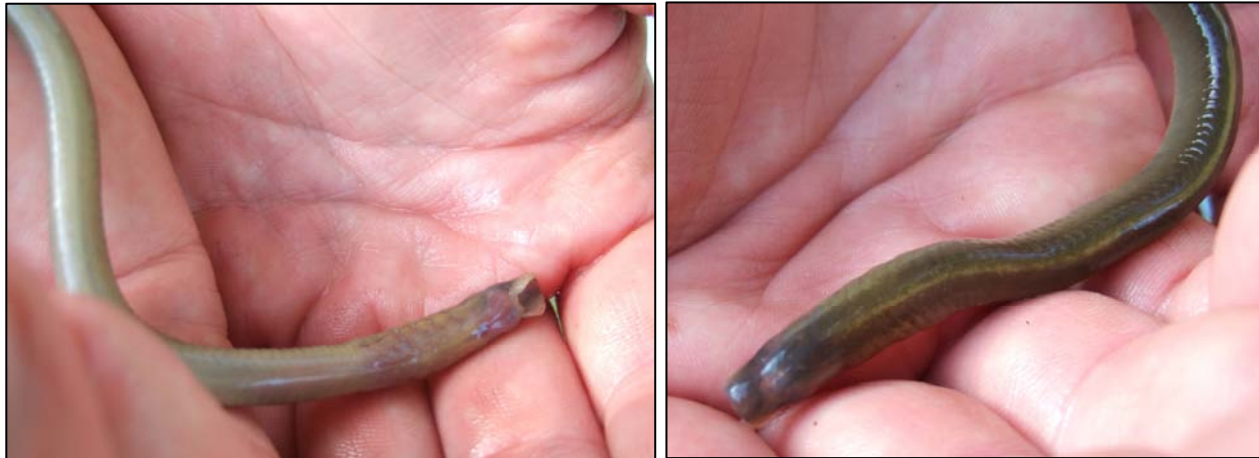
Figure 4: River/brook lamprey larvae. Left ventral, right dorsal view

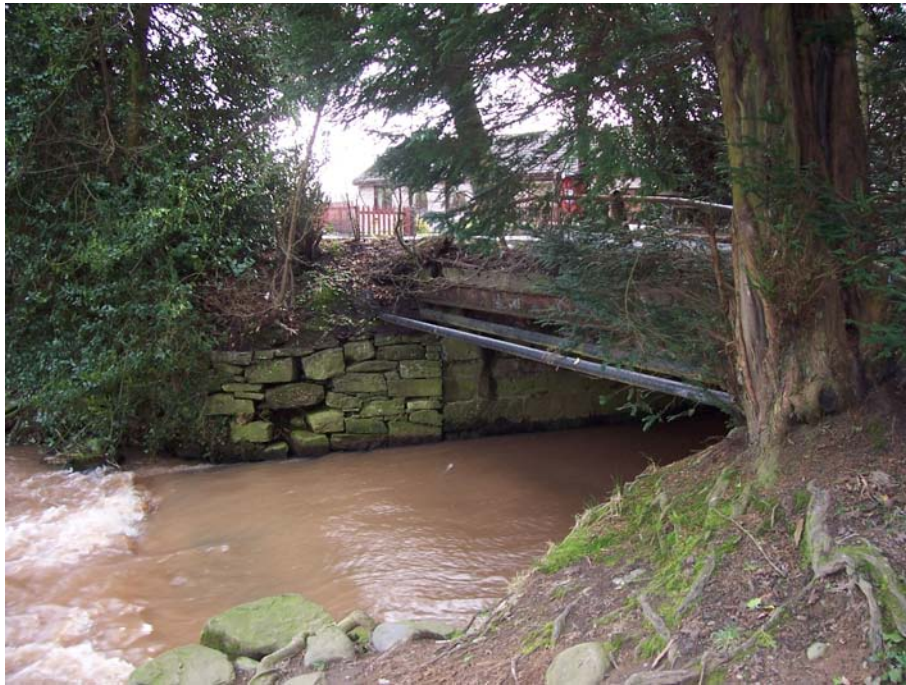
- 3.5.2 Figure 5 (February 2008, compare Figure 2) shows that this tributary to the River Almond is connected during high water levels, allowing adult lampreys to migrate between the two watercourses during these periods.

Figure 5: Outfall of East Pow Burn at high water level

3.4.1 The outfall of the East Pow Burn comprises a concrete river bed together with stone / concrete stabilised banks around the road bridge. Approximately 15 m upstream from the bridge where the bed reinforcement ends, a mixture of cobble stones and sandy sediments were sampled. Lamprey larvae were not found on either of the replicate sampling sites.

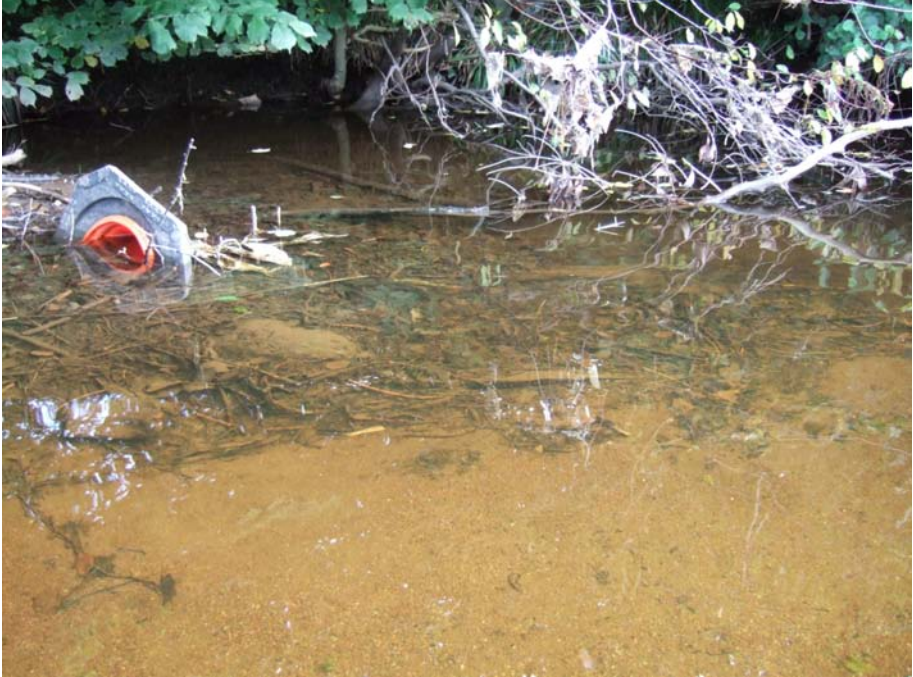
Site	Image
RA1-1

<p>A photograph showing a stormwater inlet pipe (a grey concrete pipe with a red interior) partially submerged in a stream. The water is highly turbid and brown, indicating sediment. The stream is surrounded by dense vegetation and fallen branches.</p>
RA1-2

3.1.1 The site was situated ca. 40 m upstream from the footbridge across the River Almond. Low flow velocities and large deposits of coarse organic material, mainly branches and leaf material, have resulted in an optimal habitat for lamprey larvae. Three river/brook lamprey ammocoetes were found within the m² at RA1-1 and the replicate site RA1-2 (Figure 4). The sampling site was 50% shaded by beech and willow branches (compare Appendix A – Survey Protocols).

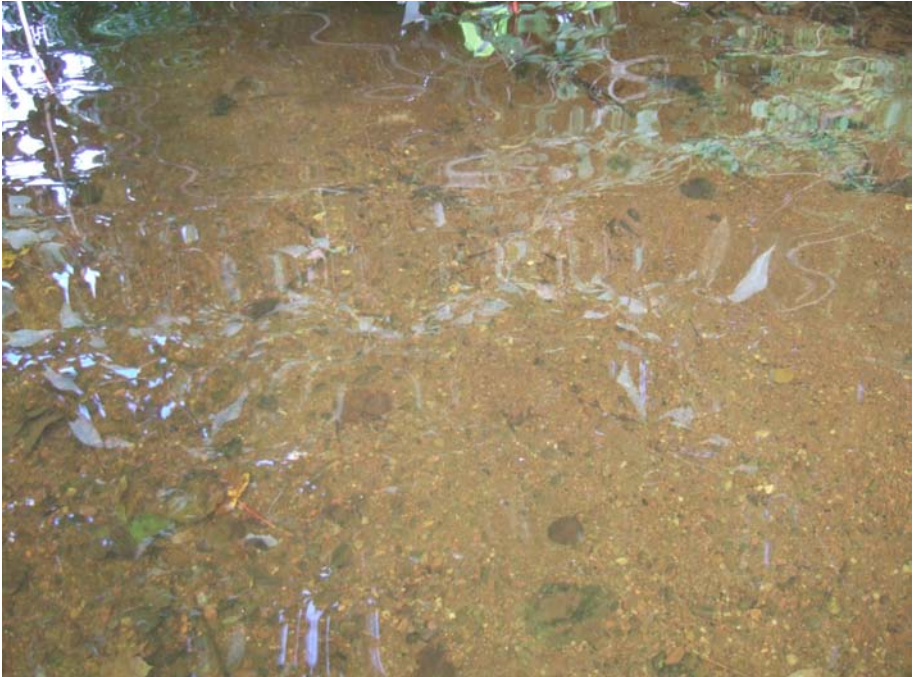
<p>A close-up photograph of the water in the stream, showing significant turbidity and brown discoloration. The water surface is covered with reflections of the surrounding green foliage.</p>

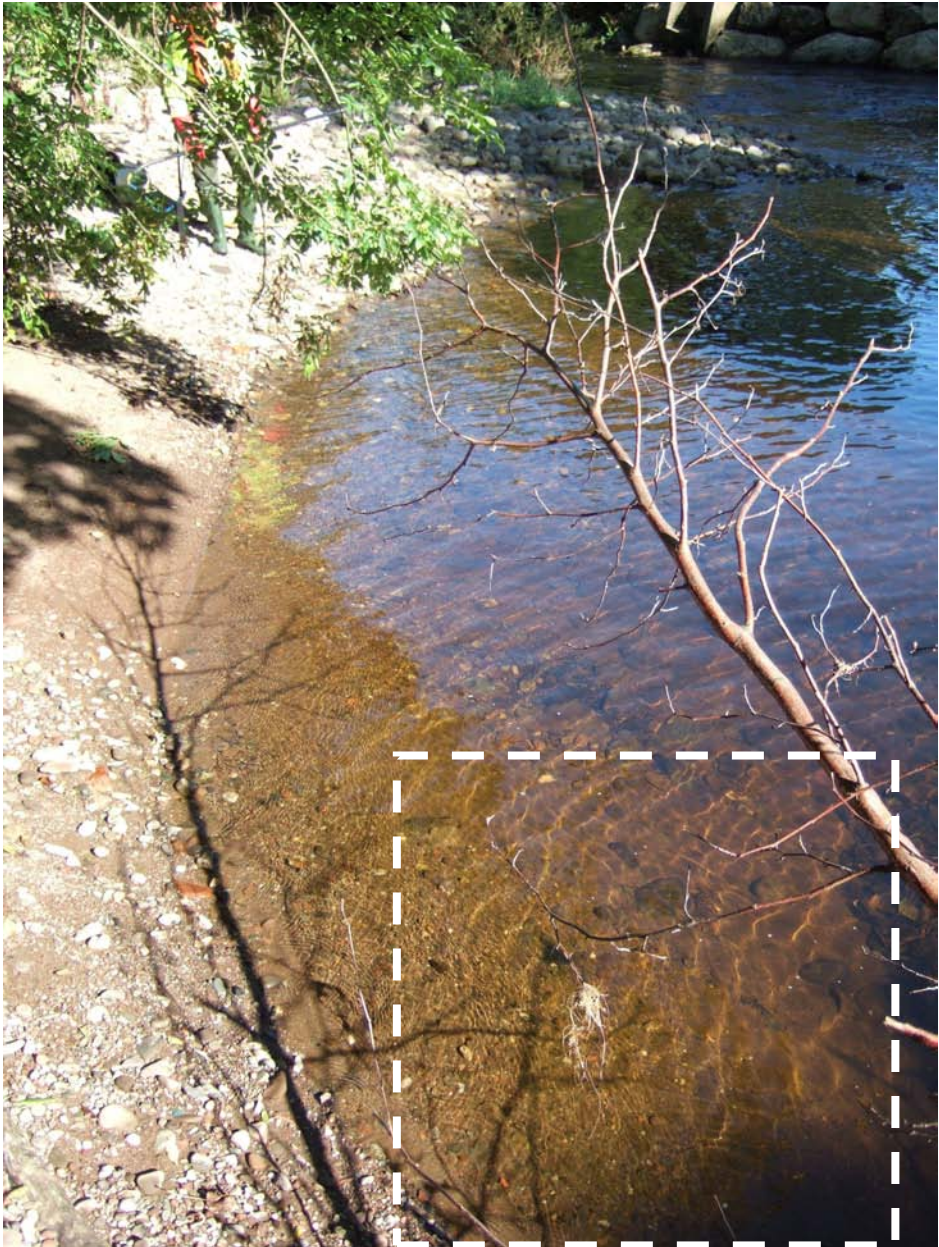
Site	Image
RA3-2

A photograph of a stream with a rocky bank on the left and a large fallen tree branch in the water on the right. The water is clear, showing the stream bed. A dashed white box highlights a section of the stream bed in the lower right quadrant of the image.

3.3.1 The remaining footings of a former bridge across the River Almond at this point have resulted in fine sediment depositions and accumulations of dead wood along the left-hand bank. One river/brook lamprey larvae was found at RA3-2. RA3-1 did not reveal any lamprey larvae.

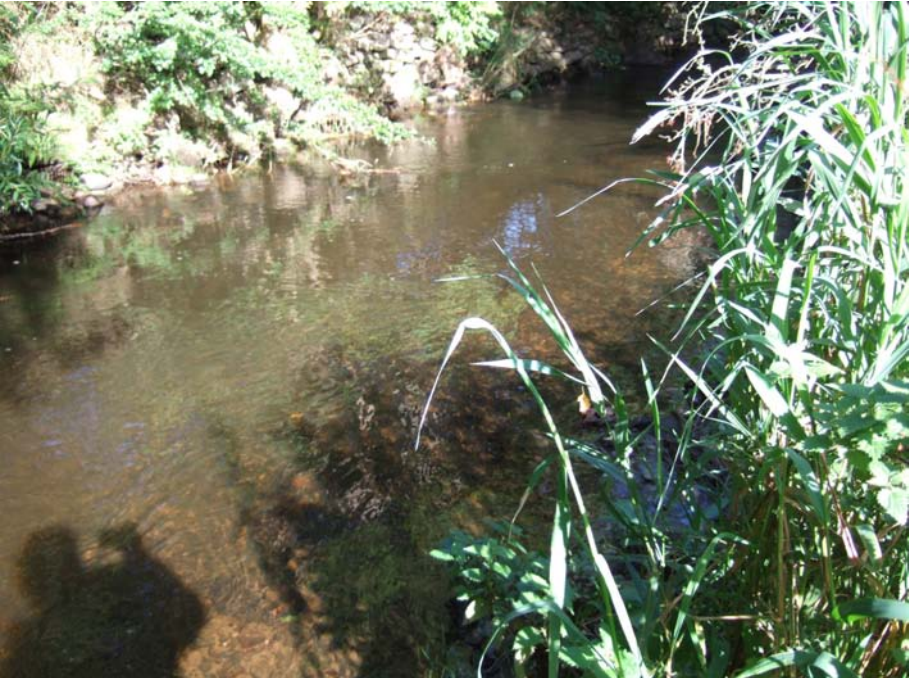
EPB1-2	N.A.
EPB2-1

provide 80% shading. The two adjacent sampling sites revealed river/brook lamprey densities of four (EPB2-1) and ten larvae per m² (EPB2-2). The population density at EPB2-2 reflects a favourable conservation status for river/brook lamprey larvae according to Harvey & Cowx (2003). Although the outfall of the East Pow Burn into the River Almond is probably impassable for lampreys during medium/low water levels.
