**Comrie Flood Protection Scheme  
Environmental Impact Assessment  
Report**

**Chapter 6: Water Environment &  
Fluvial Geomorphology**

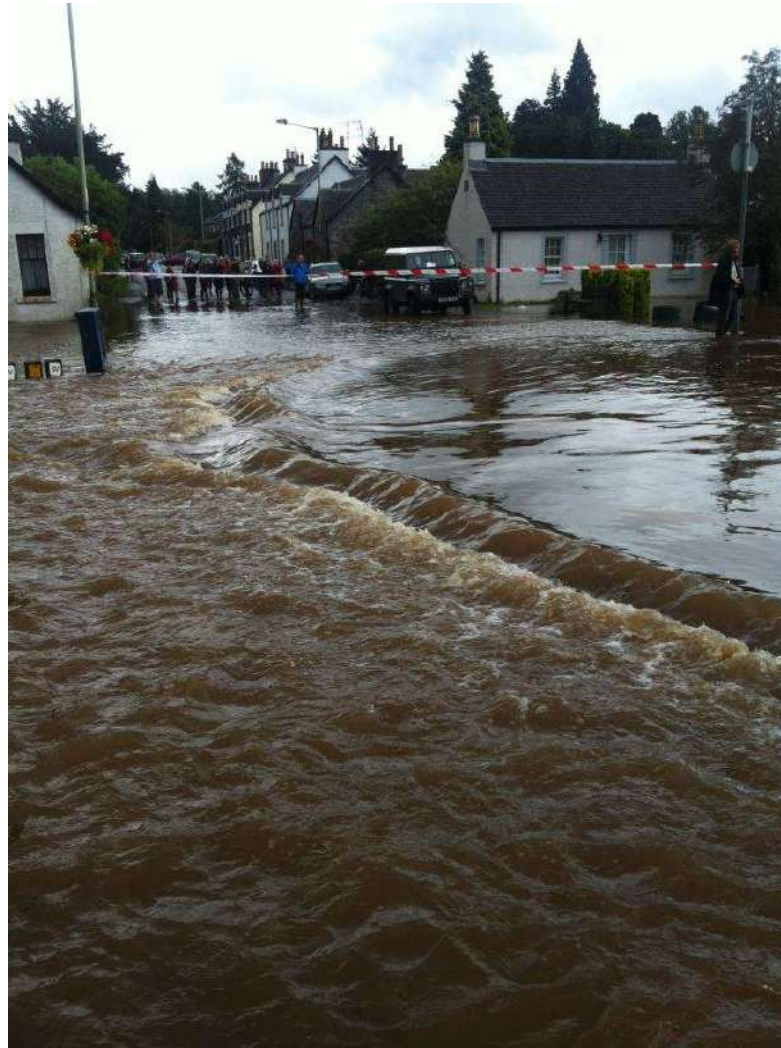
**Photograph 6-1: Flooding at Barrack Road (Dalginross), August 2012**

- 6.5.8 The town has been subject to repeated flooding in the past. The most recent flood events occurred in January 1993, February 1997, December 2006, August 2012 and November 2012. The latter of the 2012 events was significant and impacted approximately 150 properties within Dalginross. **Photograph 6-1** shows the severity of the flooding during the August 2012 event at Barrack Road in Dalginross.

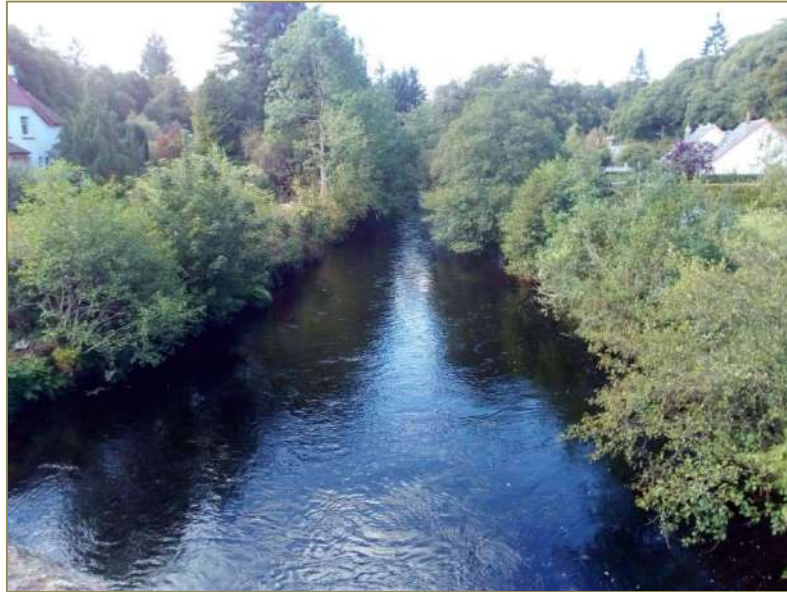
- 6.5.15 This reach of the River Earn is monitored by SEPA. The most recently determined 2017 WFD morphology status of the reach was classified as 'Good'. Despite the 'good' status, there are several morphological pressures on the channel, including a stone weir in the upstream section of the reach. There are also several sections of piled stones, embankments and flood walls along the banks, particularly in the downstream section of the reach. These confine the watercourse within its current alignment and are causing incision, as evidenced by intermittent bedrock outcrops in the base of the channel.

**Photograph 6-2: Upstream reach of the River Earn (Reach 1)**

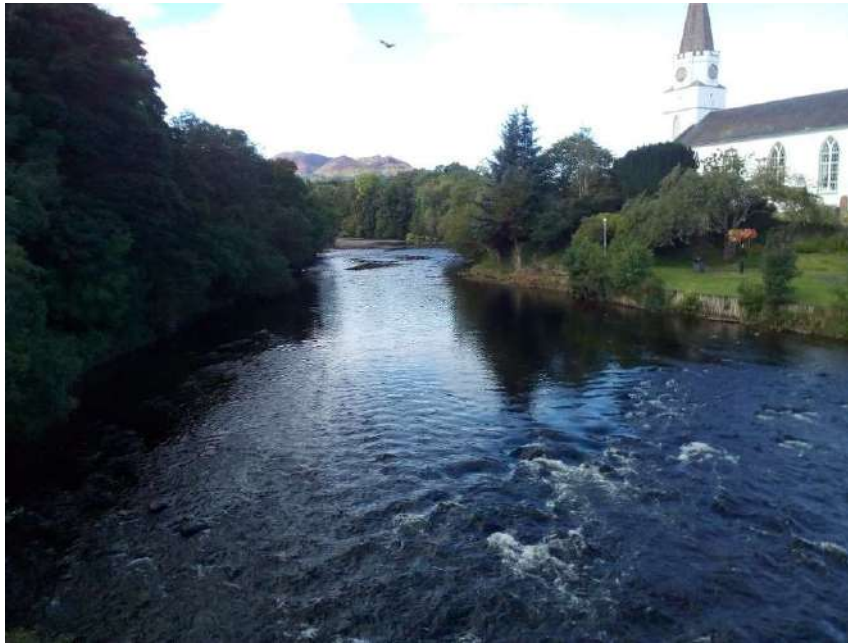
- 6.5.19 The River Earn displays some geomorphic features but has some modifications which are confining the channel and altering the natural processes. Overall, the River Earn has been assigned a 'High' sensitivity to modification from a geomorphology perspective.

Photograph 6-3: Downstream reach of the River Earn (Reach 2)

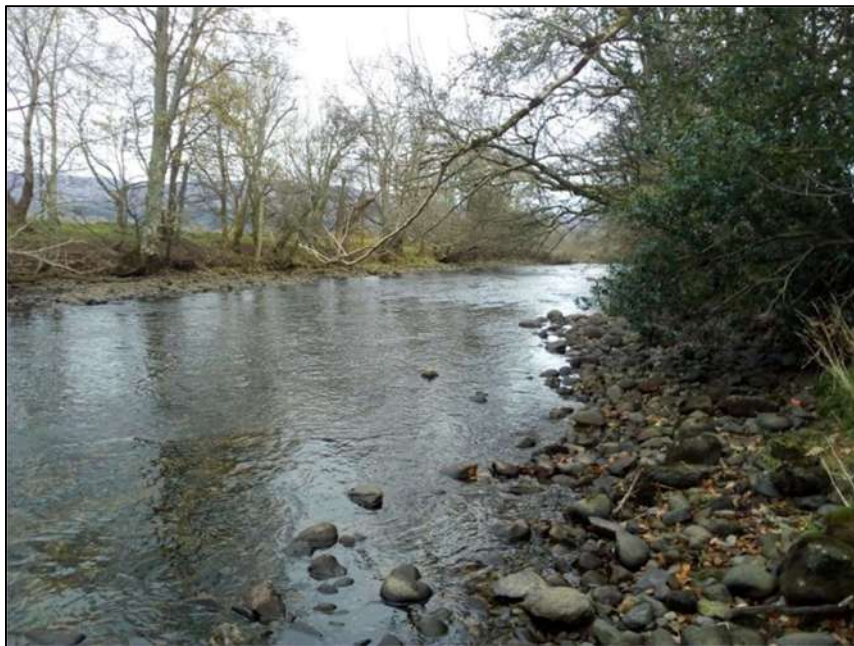
- 6.5.25 The upper reach exhibits localised areas of both erosion and deposition, except for an area of significant erosion on the left bank. In the downstream section of the reach towards Ruchilside, where there is a lack of tree cover on the left bank, there has been some bank protection installed in this area, but it does not cover the extent of the erosion. For the most part, continuous tree cover of the banks has provided stability to the channel and prevented it from returning to its naturally wandering state.

**Photograph 6-4: Upstream reach of the Water of Ruchill (Reach 3)**

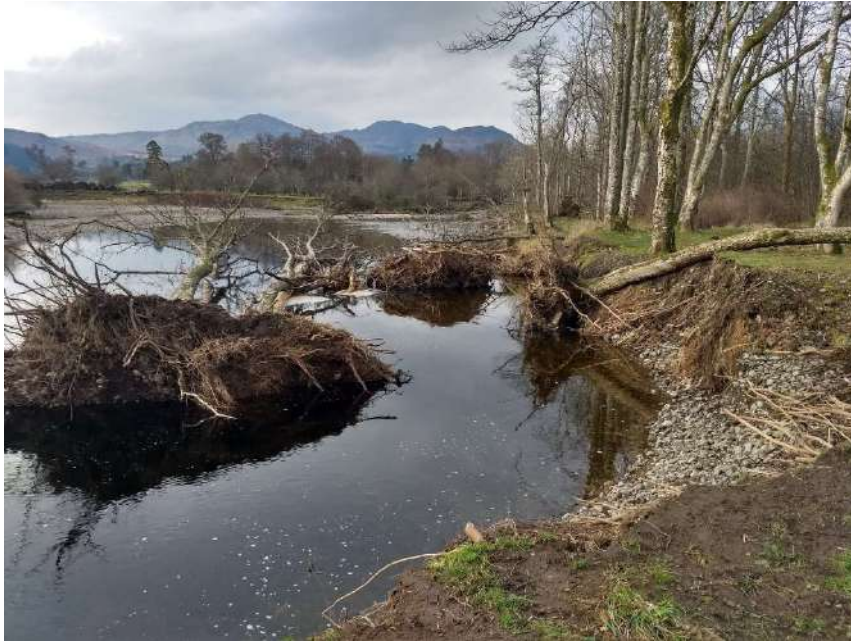
Photograph 6-5: Downstream reach of the Water of Ruchill (Fluvial audit undertaken in January 2019) (Reach 4)

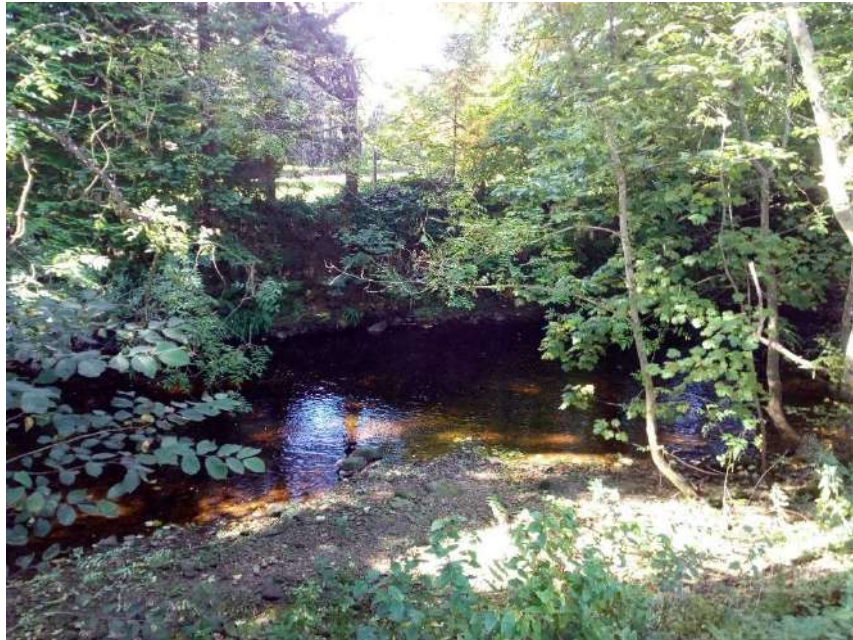
- 6.5.35 The River Lednock channel appears to have undergone historic narrowing and straightening towards the downstream extent of the reach at the confluence with the River Earn. Other morphological pressures observed on the lower part of the channel were two bridges with abutments (footbridge and road bridge). In addition to this, a concrete weir from a former mill was situated on a bedrock outcrop at the upstream extent of the reach, and multiple cases of bank protection (piled stone and intact stone wall) were observed throughout the reach.

Photograph 6-6: River Lednock in vicinity of the cycle path crossing (approximate NGR NN 776 223)

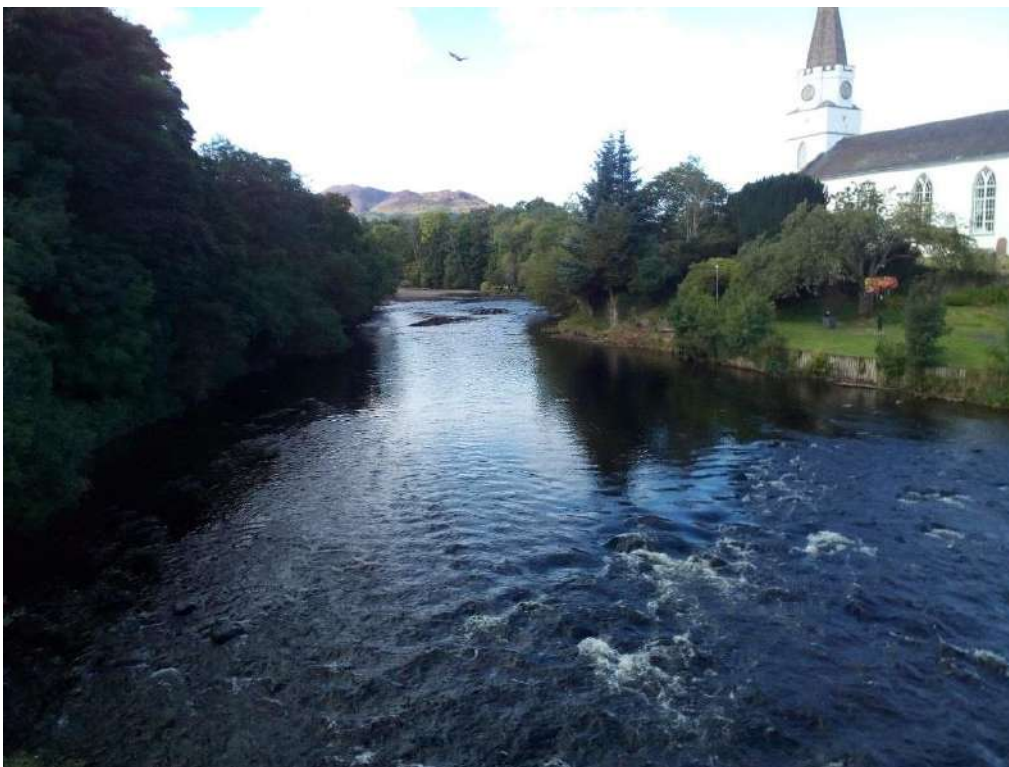
Historic Ordnance Survey (OS) maps of the River Earn show large alluvial bar features in a wider channel in the upper part of the reach, near the confluence with the Water of Ruchill. However, currently there is very limited sediment storage in this part of the reach. This may be a result of recent and historic works on the Water of Ruchill which have resulted in significant deposition within the tributary and reduced capacity to transport material out of the tributary. Bar formations are more common in the downstream section of the reach where the channel is slightly more sinuous.

*Figure 2-3: Photo taken during the site visit of the downstream reach of the River Earn (Reach 2)*

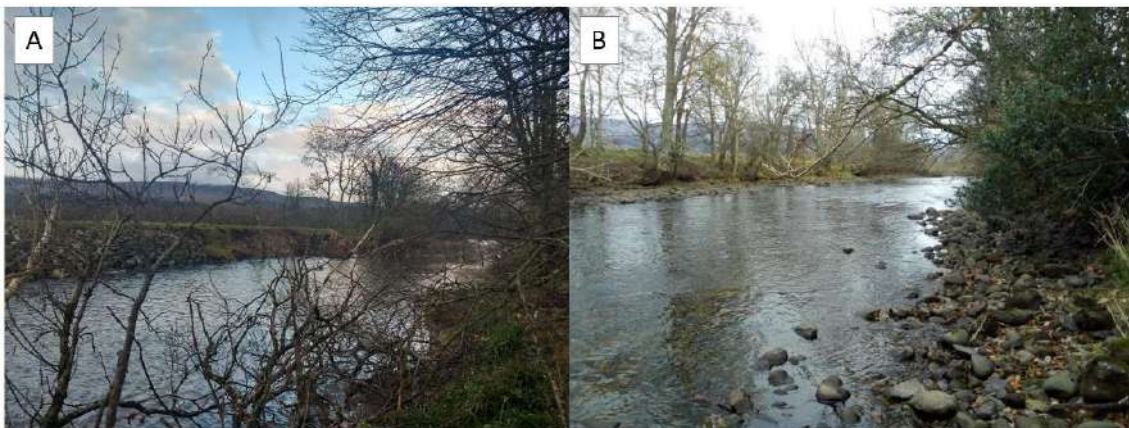
The upper reach comprises localised areas of both erosion and deposition, which are fairly minor, except for an area of significant erosion on the left bank, in the downstream section of the reach towards Ruchilside, where there is a lack of tree cover on the left bank. There has been some bank protection installed in this area, but it does not cover the extent of the erosion (Figure 2-4A). For the most part, continuous tree cover of the banks has provided stability to the channel and prevented it from returning to its naturally wandering state.

*Figure 2-4: Photos of the upstream reach of the Water of Ruchill (A) Shows rip-rap bank protection on the left bank which has been out flanked at the downstream end. (B) Shows a typical stretch of the Reach 3*

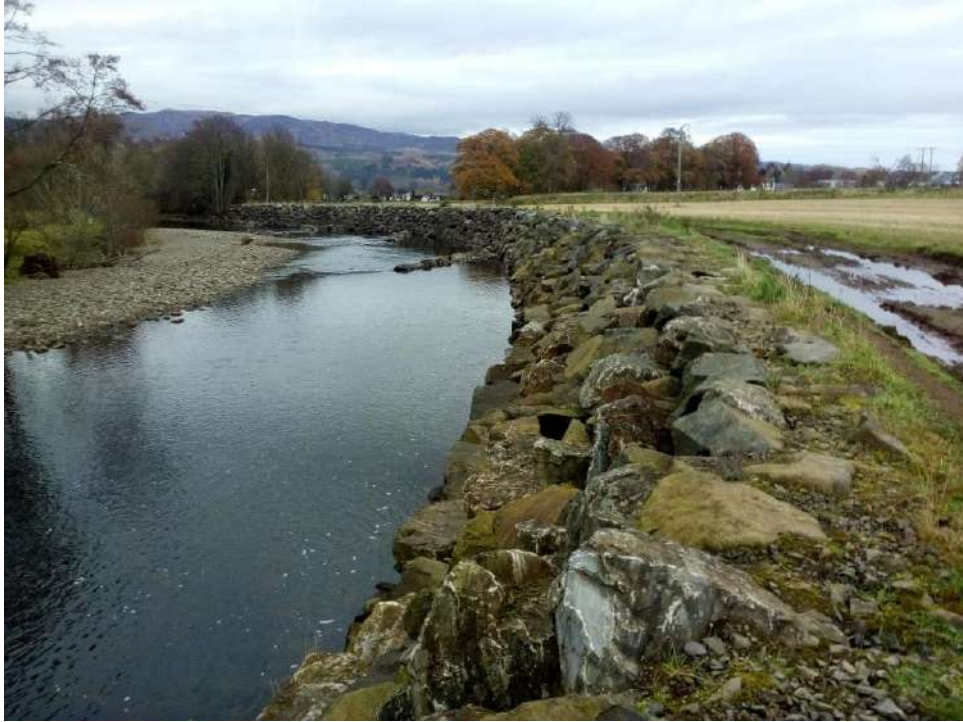
The Water of Ruchill is a very dynamic watercourse which displays a range of fluvial processes and exhibits a range of geomorphological features. Although it has been historically straightened, it is attempting to return to its naturally wandering state, as evidenced by the significant bank erosion.

*Figure 2-5: Photo taken during the site visit of the downstream reach of the Water of Ruchill (Reach 4)*

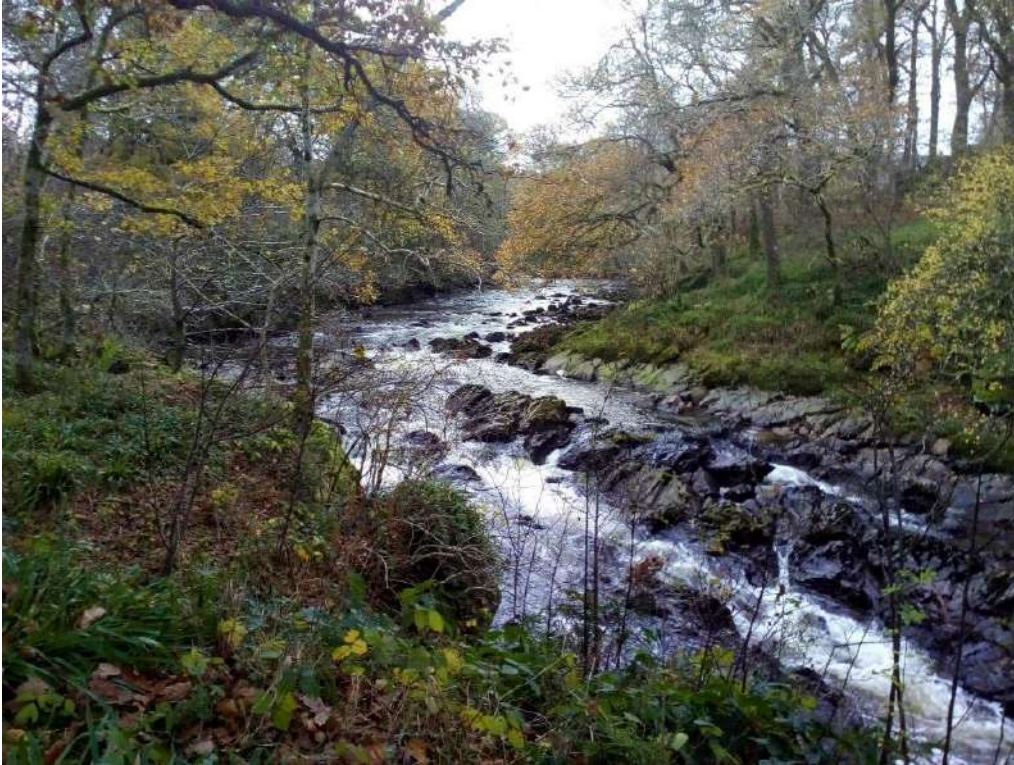
The reach is dominated by sediment transport processes. Along the lower part of the channel, the banks are protected by continuous mature vegetation, which acts to stabilise the banks. As a result, only minor bank erosion was observed along the reach.

*Figure 2-6: Photo taken during the site visit of the River Lednock*

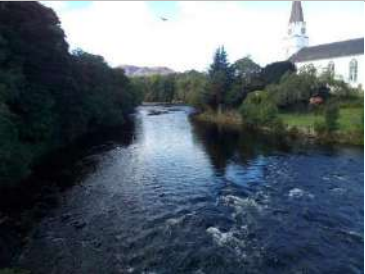
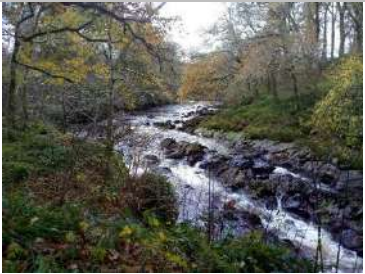
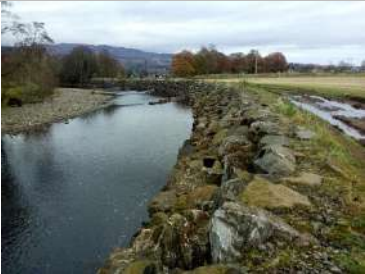
<b>PHOTO</b>

<b>ANTHROPOGENIC PRESSURES</b>	<ul style="list-style-type: none"> <li>• Two stone weirs</li> <li>• Piled stone and stone walls along banks</li> <li>• Stone arch bridge (Bridge of Ross)</li> <li>• 7m high set back embankment</li> <li>• Embankments along field boundaries and Comrie Holiday Park</li> <li>• Realigned sections</li> <li>• Bank protection</li> <li>• Invasive Species – Japanese Knotweed and Rhododendron</li> </ul>	<ul style="list-style-type: none"> <li>• Concrete weir (not intact)</li> <li>• Two bridges with abutments</li> <li>• Bank protection – piled and intact stone wall</li> <li>• Realignment – narrowing and straightening of channel</li> </ul>	<ul style="list-style-type: none"> <li>• Realignment - Straightening of channel</li> <li>• Significant and extensive hard bank protection</li> <li>• Significant embankments and dredged material along banks</li> <li>• Gravel extraction</li> <li>• Over-widening</li> <li>• Invasive Species – Japanese Knotweed</li> </ul>

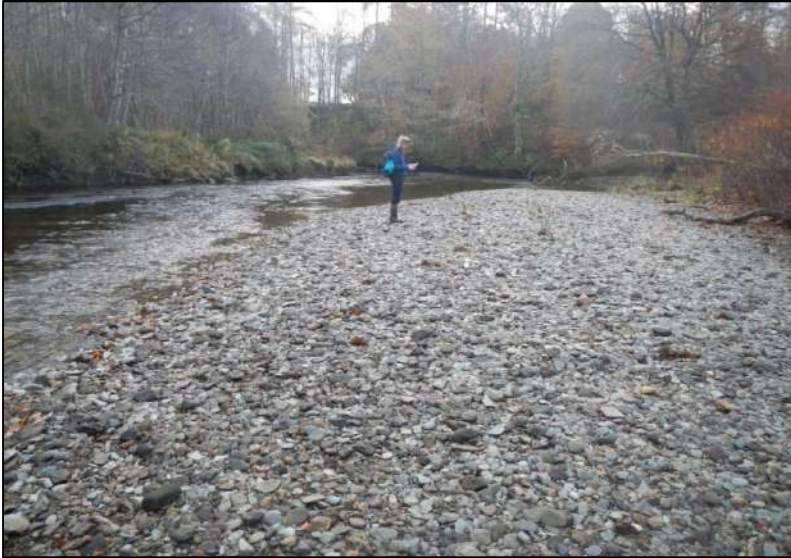
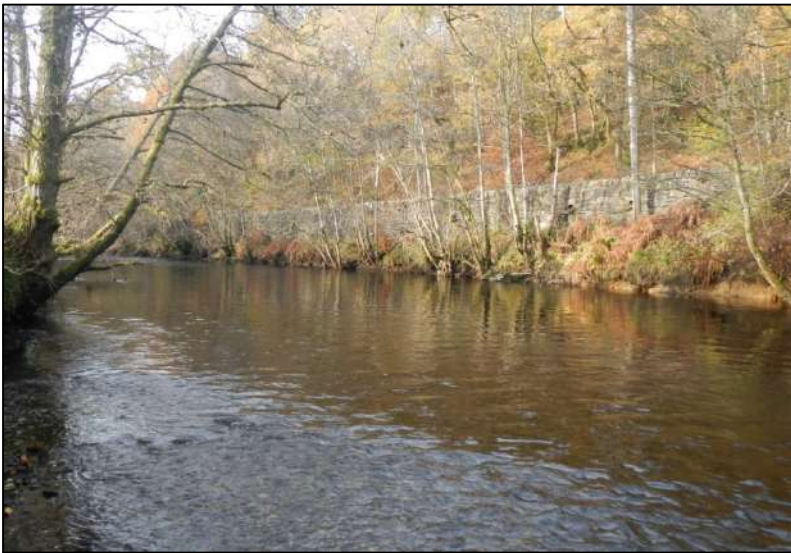
**Figure 2.5 Survey photos from mainstem River Earn (upstream).** Top left: significant gravel/ cobble deposition, bottom left: stone wall bank protection aligning road on left bank, top right: low embankment on left bank bordering pastoral land, bottom right: section of bedrock outcrop on approach to Water of Ruchill confluence, with some coarse cobble deposition, and large rip rap bank protection on right bank (view upstream)

Additional comments	Photos for this reach are provided in <b>Figure 2.5</b> .

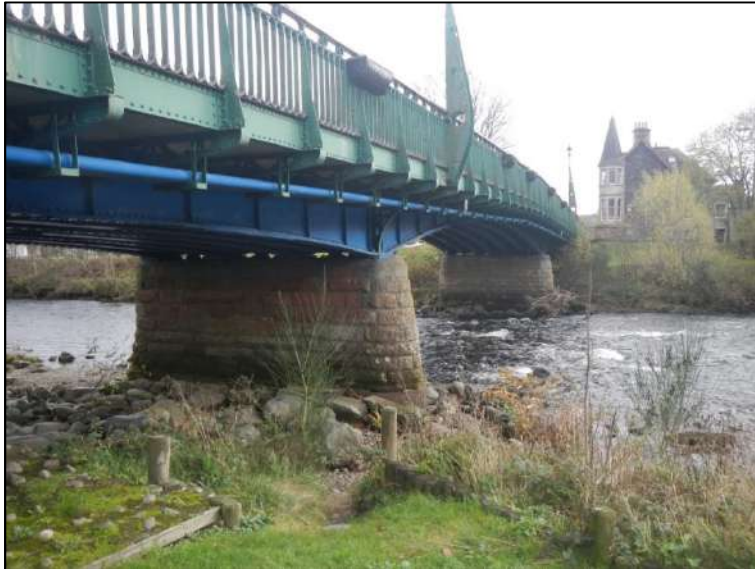
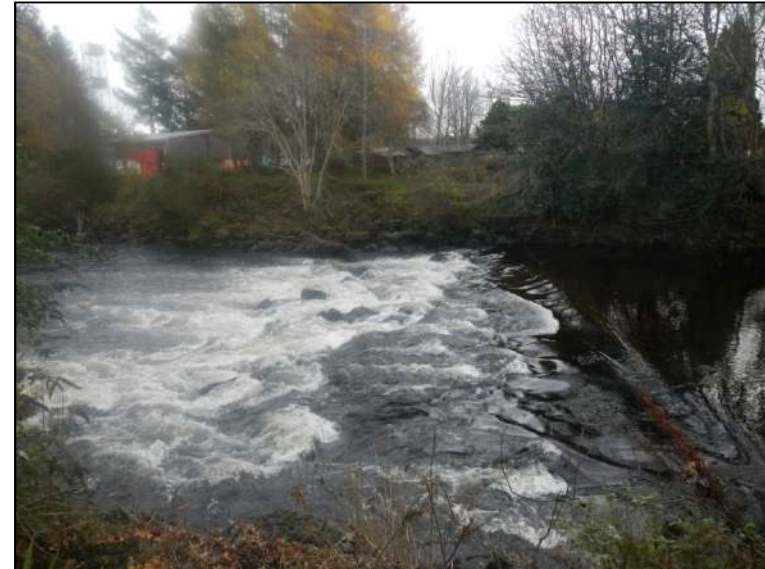
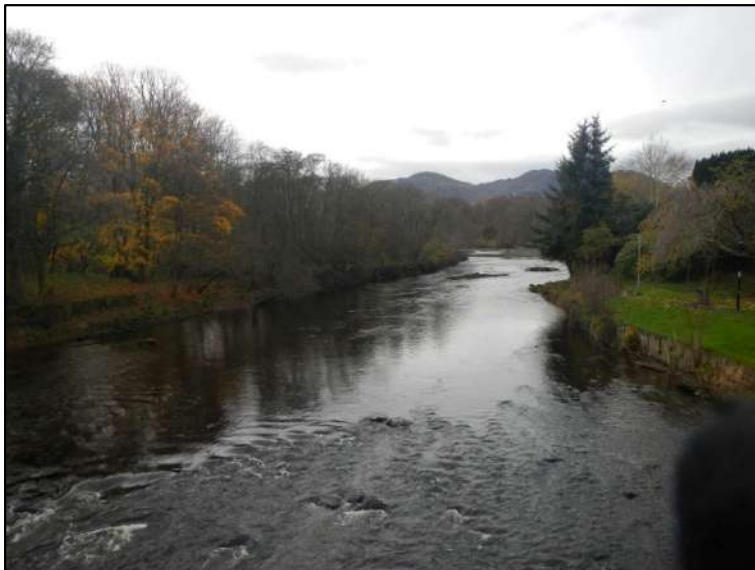
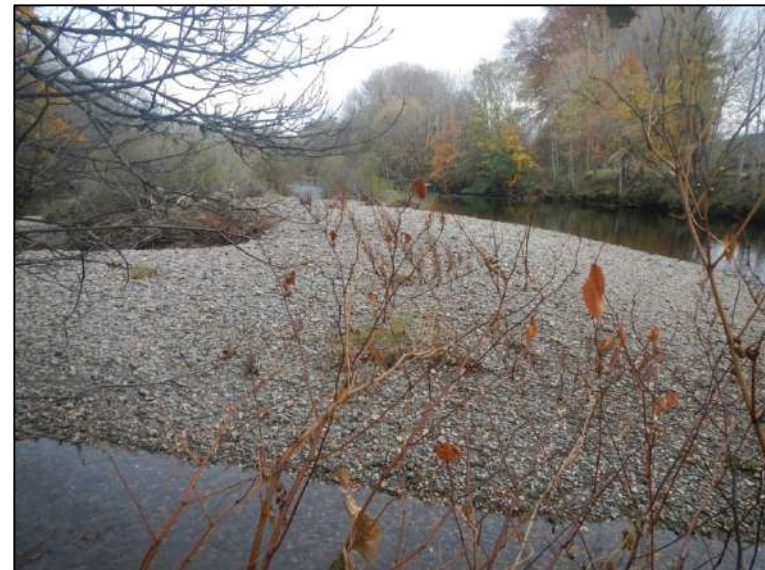
**Figure 2.6 Survey photos from mainstem River Earn (downstream).** Top left: Two pier Bridge of Dalginross, bottom left: view upstream from bridge, towards Water of Ruchill confluence, top right: large rock weir spanning width of channel, bottom right: large, localised unstabilised deposition at downstream end of reach).

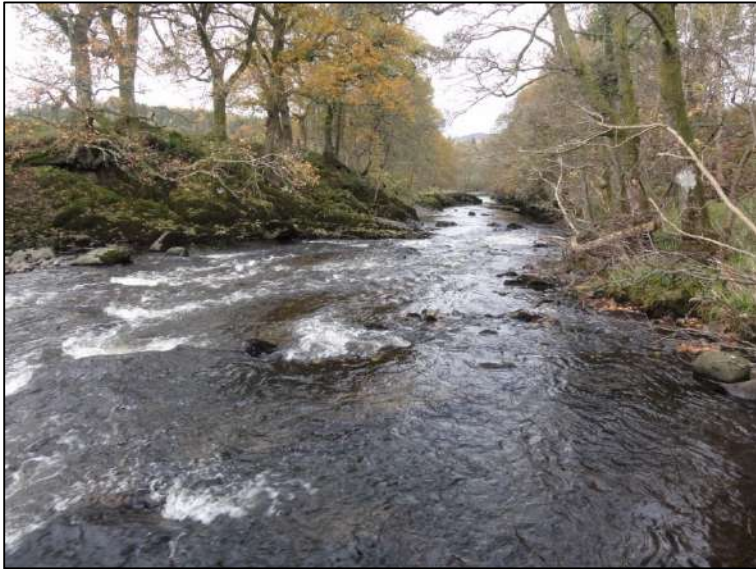
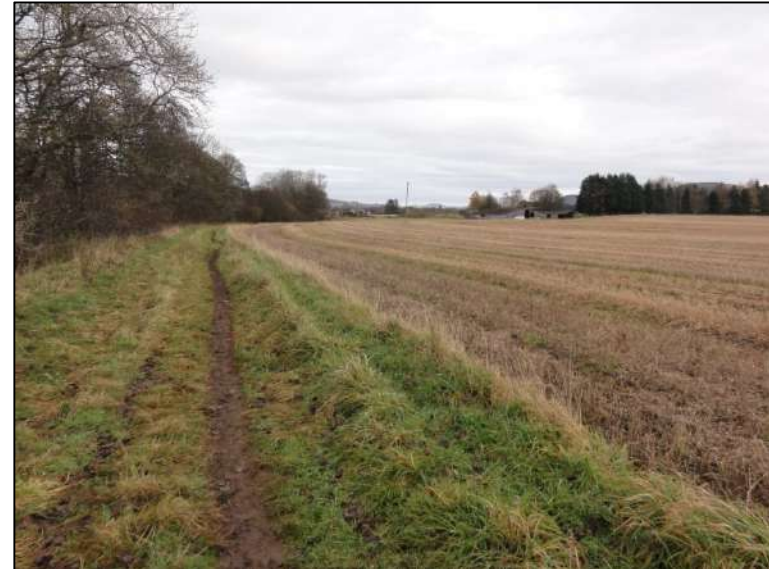
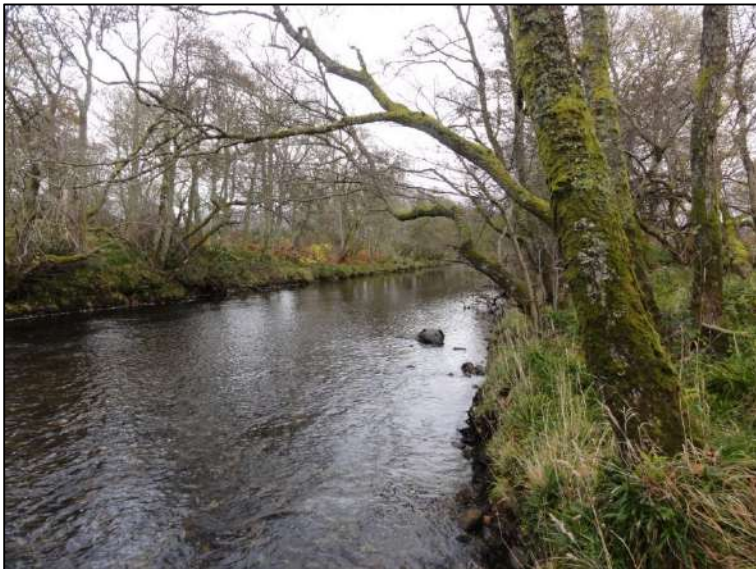
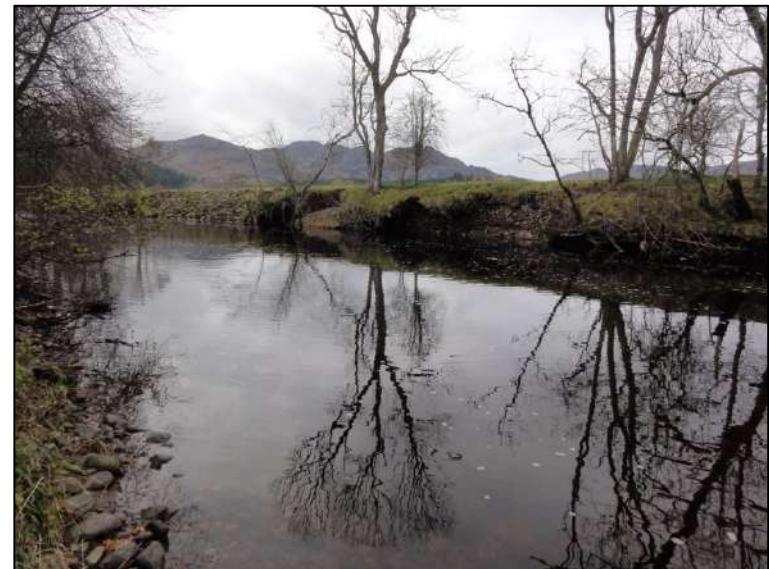
**Figure 2.7 Survey photos from Water of Ruchill (Cultybraggan to Ruchilside).** Top left: bedrock dominated reach, bottom left: tree-lined, stable banks, top right: low gradient arable land in right bank floodplain, bottom right: severe bank erosion on left bank at downstream end of the reach (view upstream).

Additional comments	Photos for this reach are provided in <b>Figure 2.7</b> .

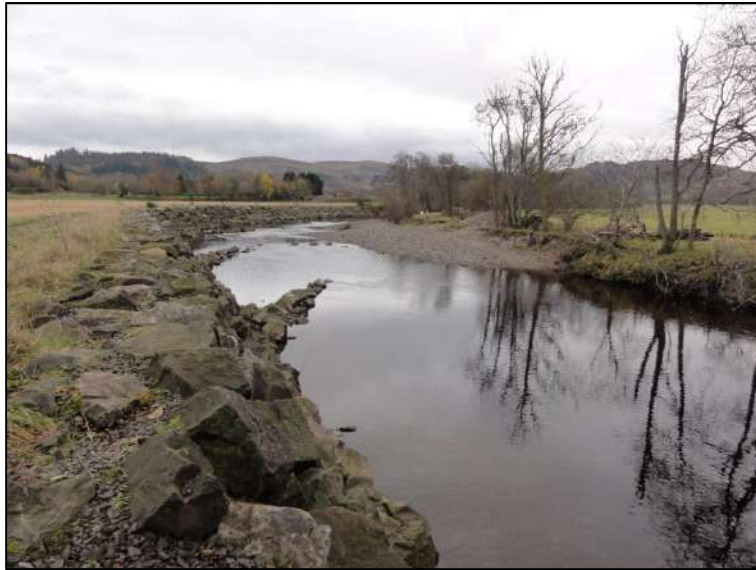
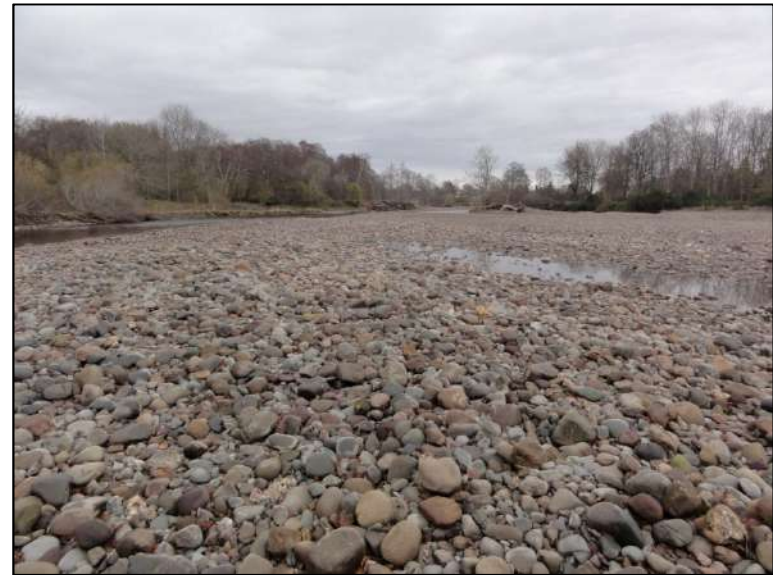
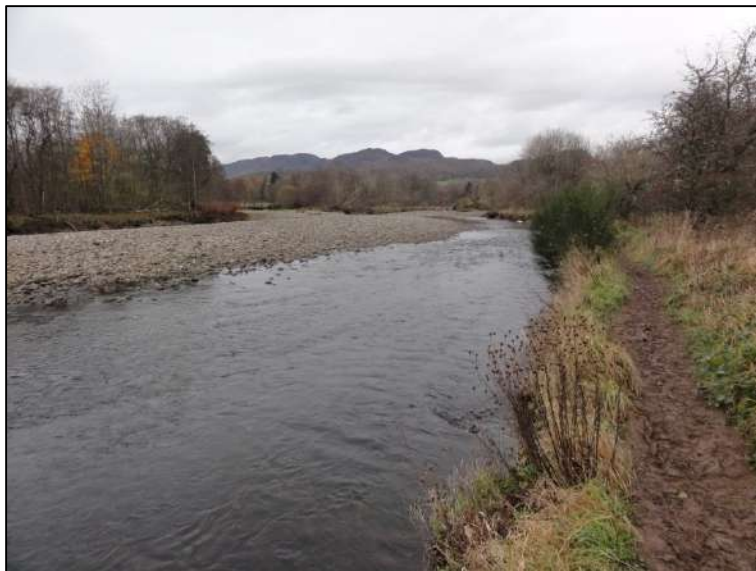
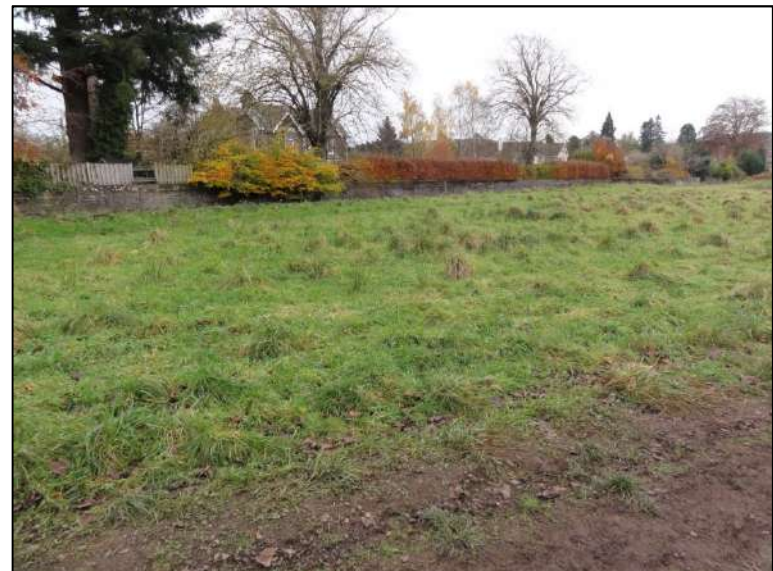
**Figure 2.8 Survey photos from Water of Ruchill (Ruchilside to River Earn confluence).** Top left: extensive rip rap bank protection and in-channel j-vanes, bottom left: large lateral bar feature on left bank, top right: significant volumes of accreted cobble/ gravel alluvial material, bottom right: existing flood wall on right bank.

Reach	4
	<ul style="list-style-type: none"> <li>• Bank cover is predominantly woodland vegetation, with localised areas of less dense tree cover.</li> <li>• Large wood recruitment in-channel evident throughout dynamic section of reach.</li> <li>• The reach displays evidence of active sediment recruitment, transfer and storage processes that contribute to channel evolution and lateral migration.</li> </ul>
Additional comments	Photos for this reach are provided in <b>Figure 2.8</b> and <b>Figure 2.9</b> .

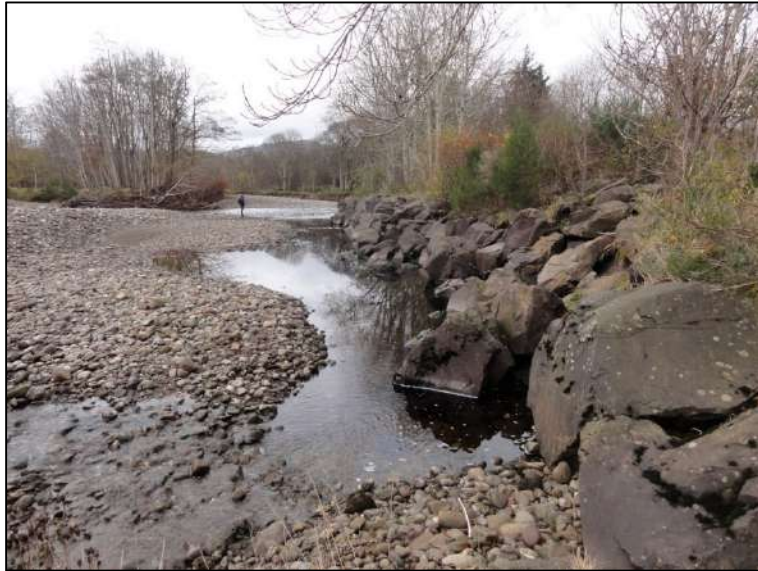
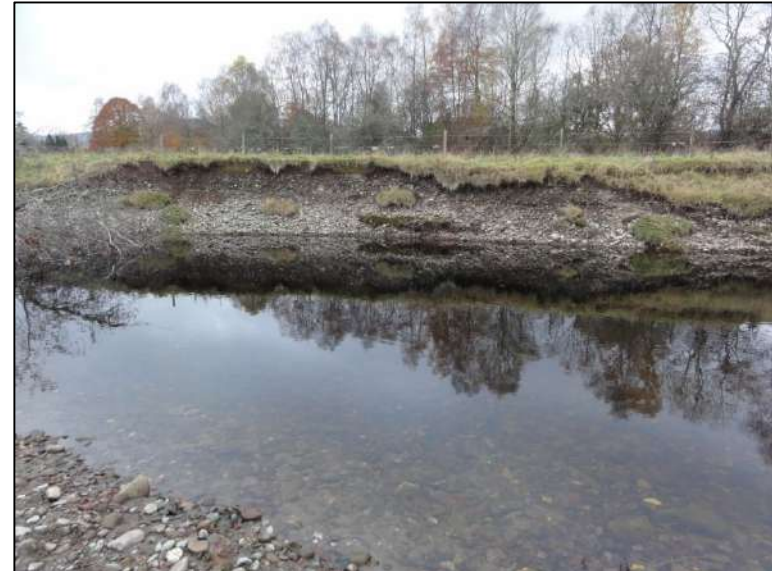
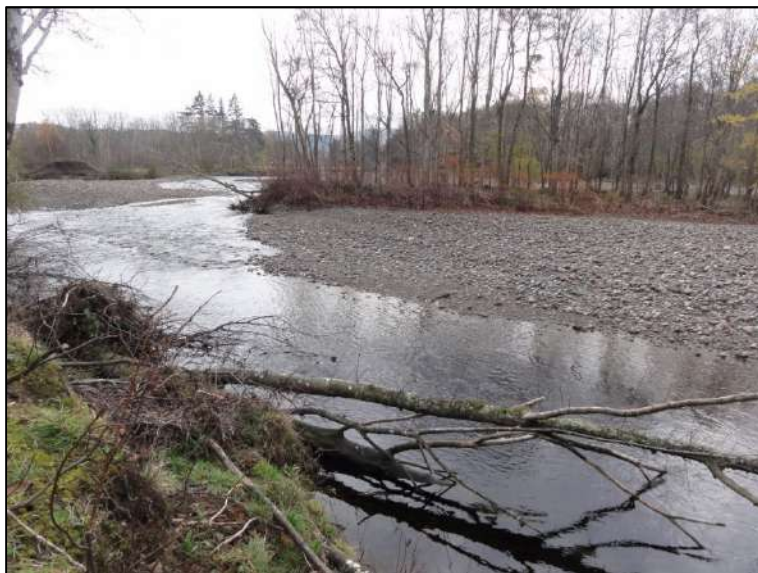
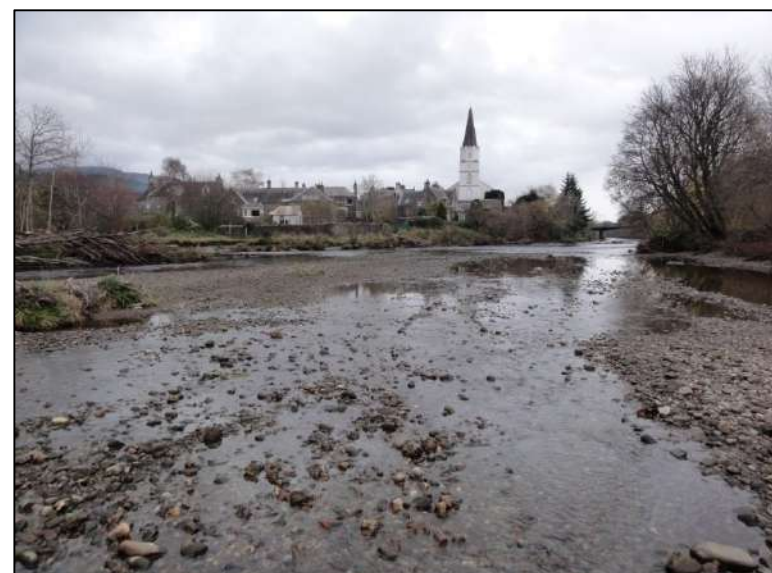
**Figure 2.9 Survey photos from Water of Ruchill (Ruchilside to River Earn confluence) continued.** Top left: extensive rip rap bank protection in right bank, bottom left: Major breach of vegetated, stabilised bank, with new channel formed to the right of the breach and large wood recruitment (view upstream), top right: significant bank erosion on left bank, bottom right: wide and overly shallow/ aggraded channel on approach to confluence.

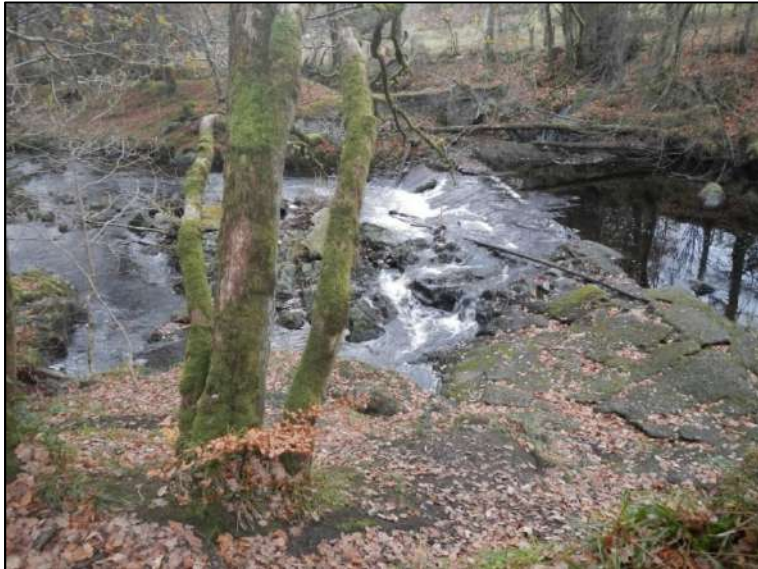
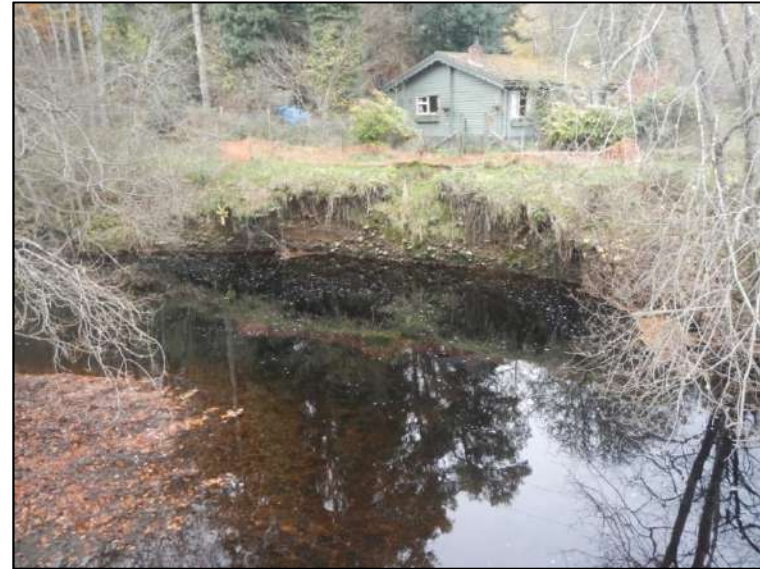
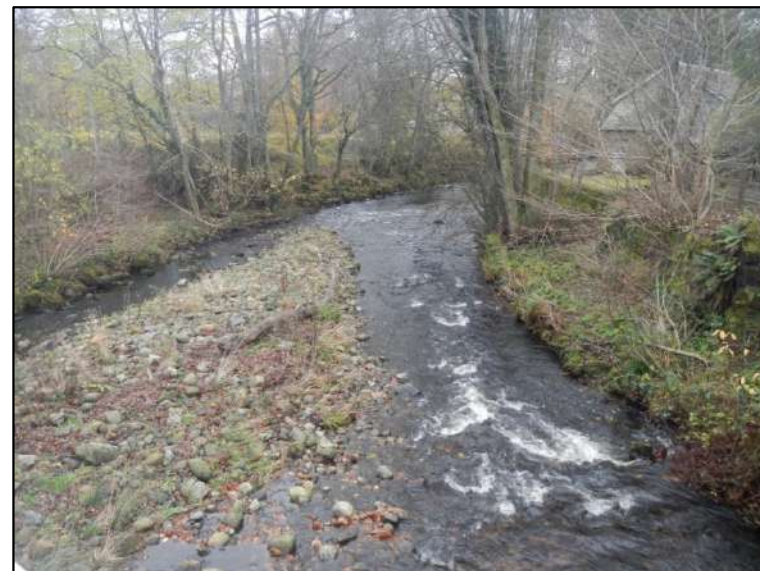
**Figure 2.10** Survey photos from Lednock Burn. Top left: weir structure at upstream extent of reach, bottom left: coarse deposition and view of wooded riparian zone, top right: significant bank erosion on left bank upstream of footbridge, bottom right: view downstream from footbridge showing medial bar feature comprised cobble.

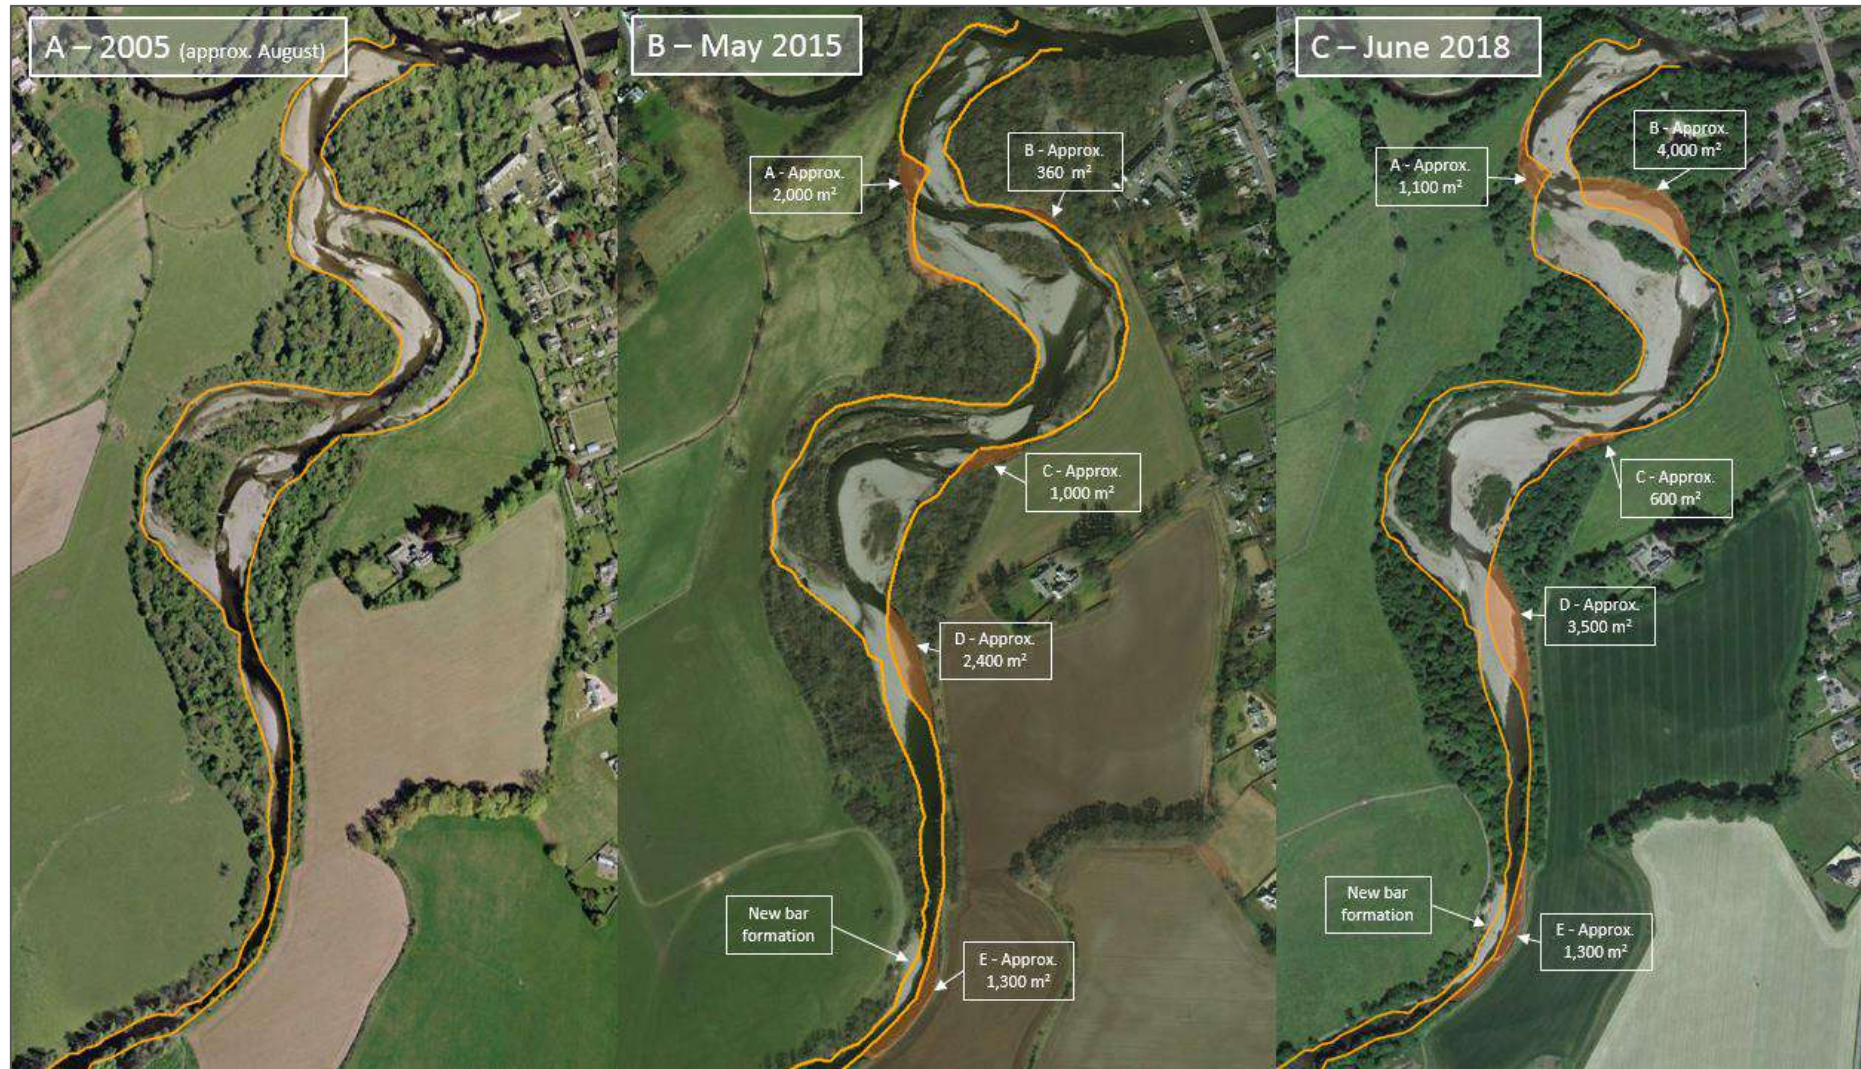
Figure 3-1: Satellite images from Google Earth showing channel change between 2005 and 2018. The 2005 bank lines are shown in orange on all images.

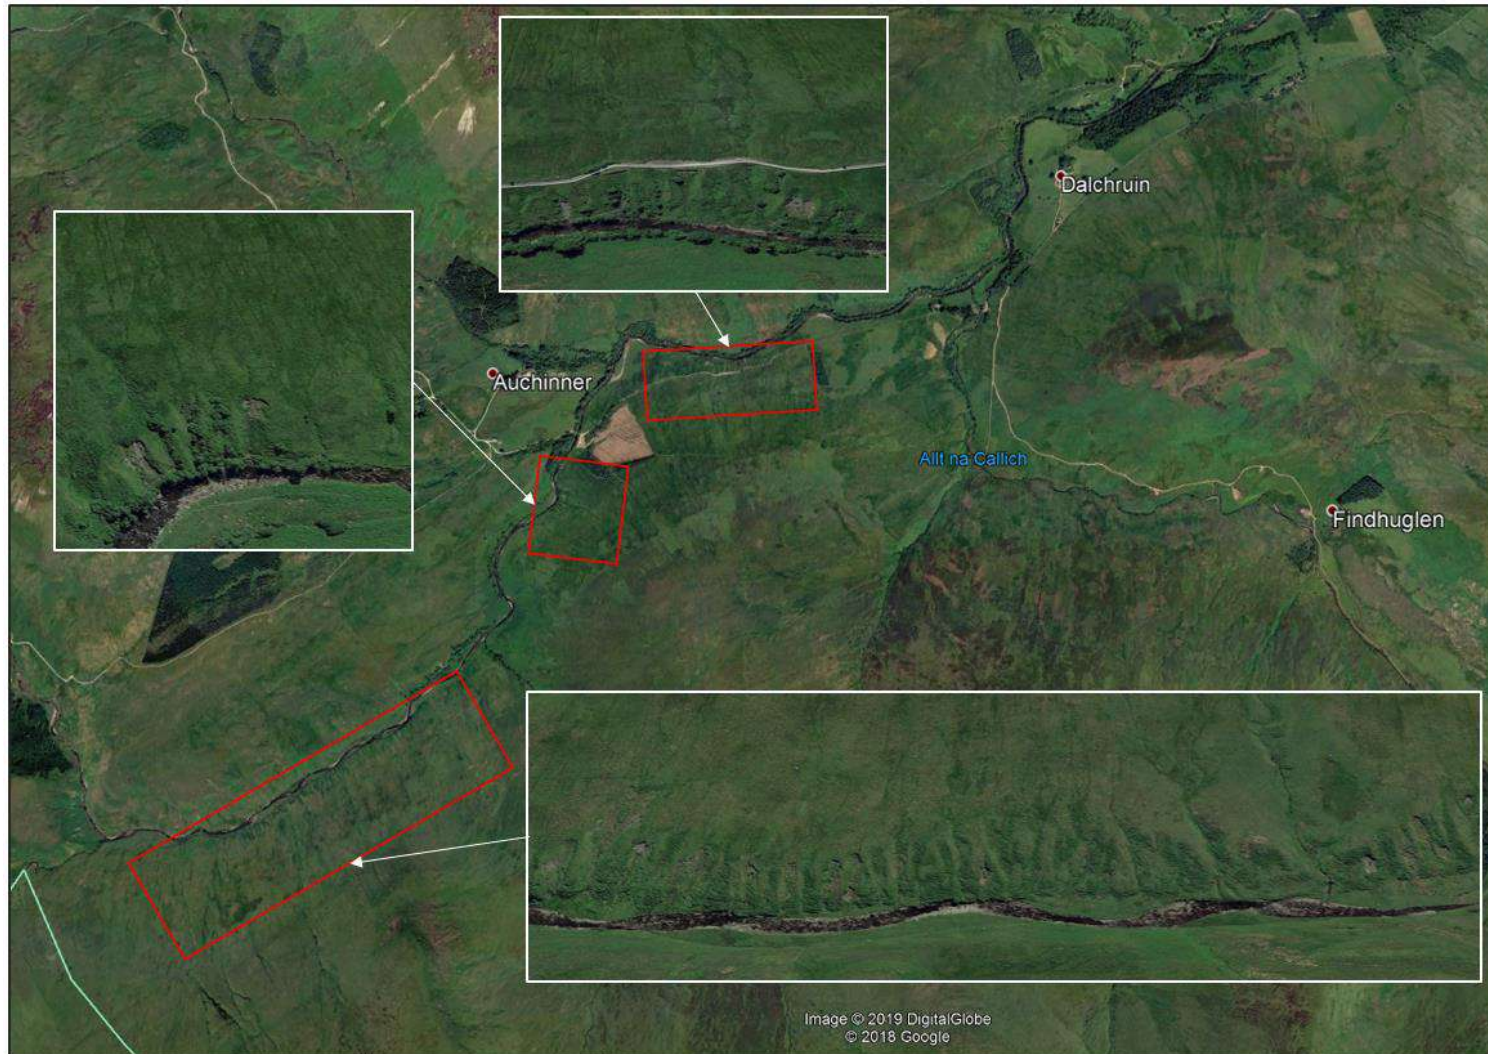
Figure 3-4: Google Earth image showing areas of gully erosion which appear to have resulted from changes to drainage patterns from upslope peat drainage.

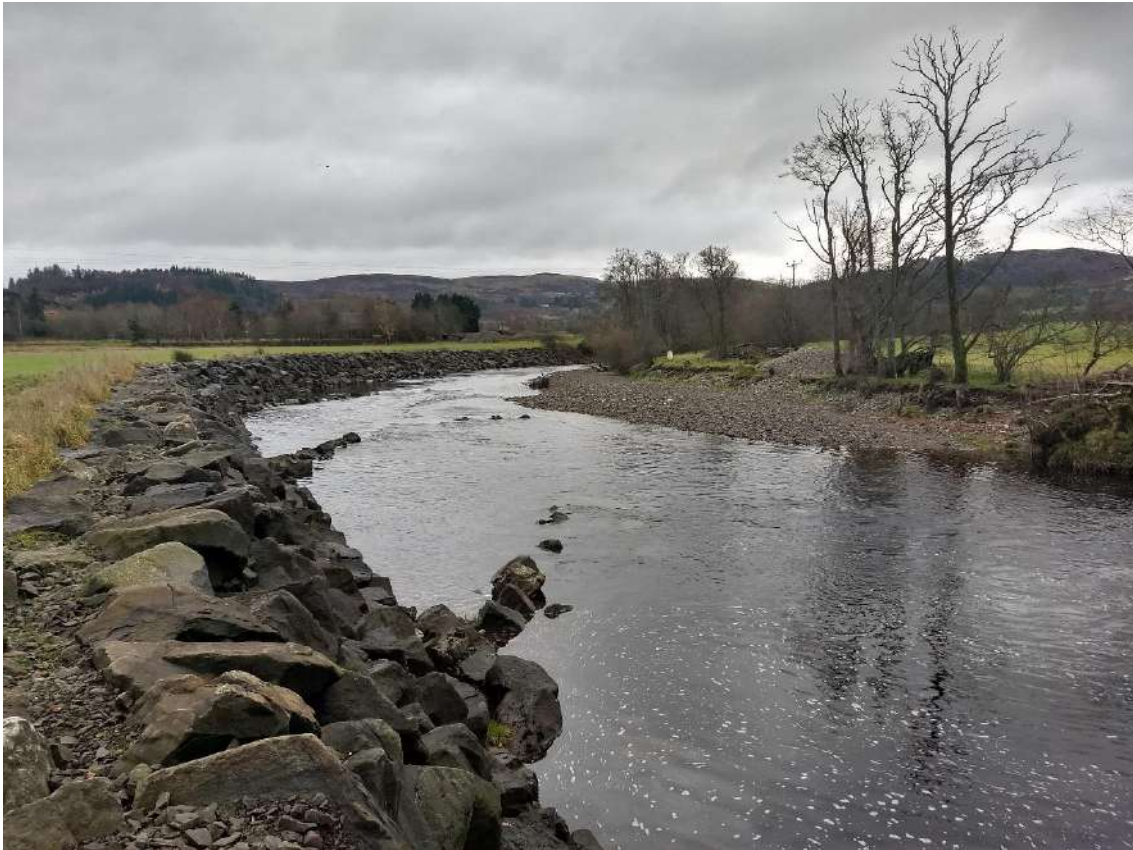
*Figure 3-5: Photo showing bank protection and J-vanes at Ruchilside*
