**Comrie Flood Protection Scheme  
Environmental Impact Assessment  
Report**

**Chapter 6: Water Environment &  
Fluvial Geomorphology**

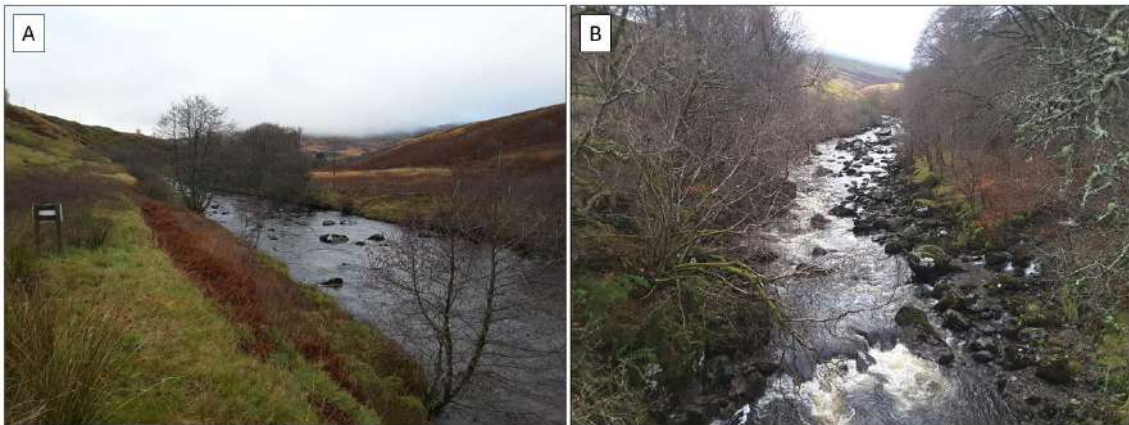
Figure 3-7: Photos of Reach 1. (A) Shows a typical wide section of the valley with plane bed stream typology. (B) Shows a confined section of the reach with step-pool typology.

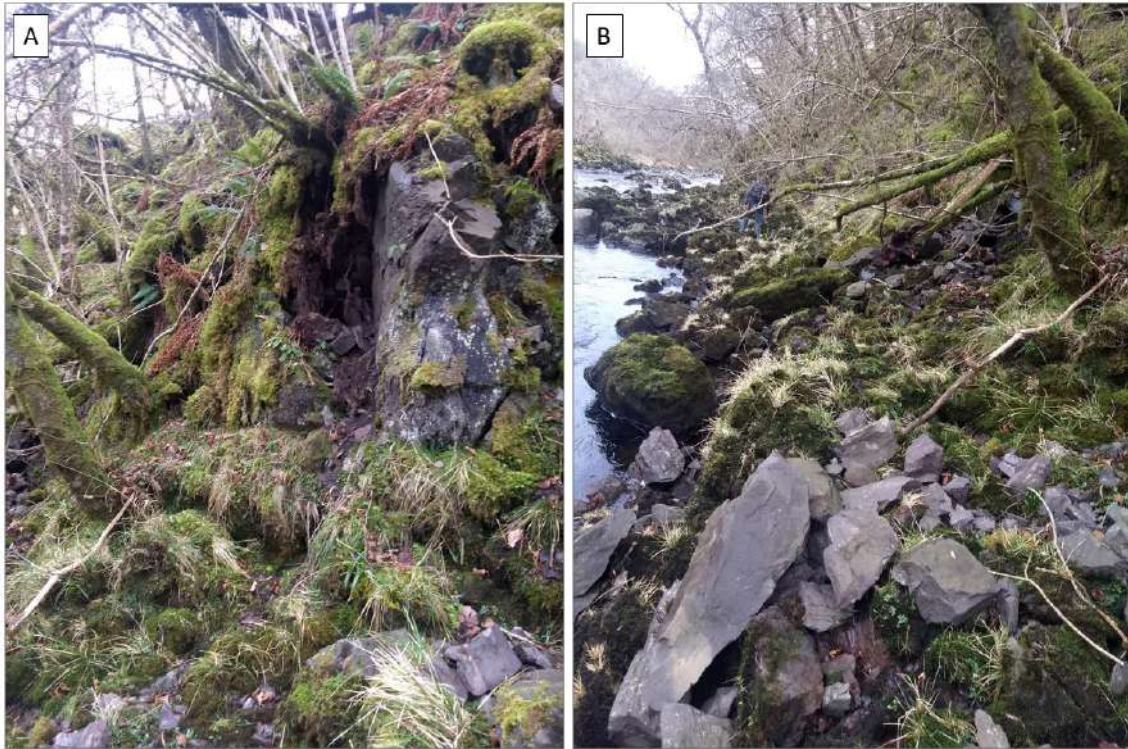
Figure 3-9: Photos of rockfall on escarpments adjacent to the channel. (A) Well-jointed fragmentary bedrock exposed in on the river scarp. (B) Angular rockfall debris adjacent to the channel.

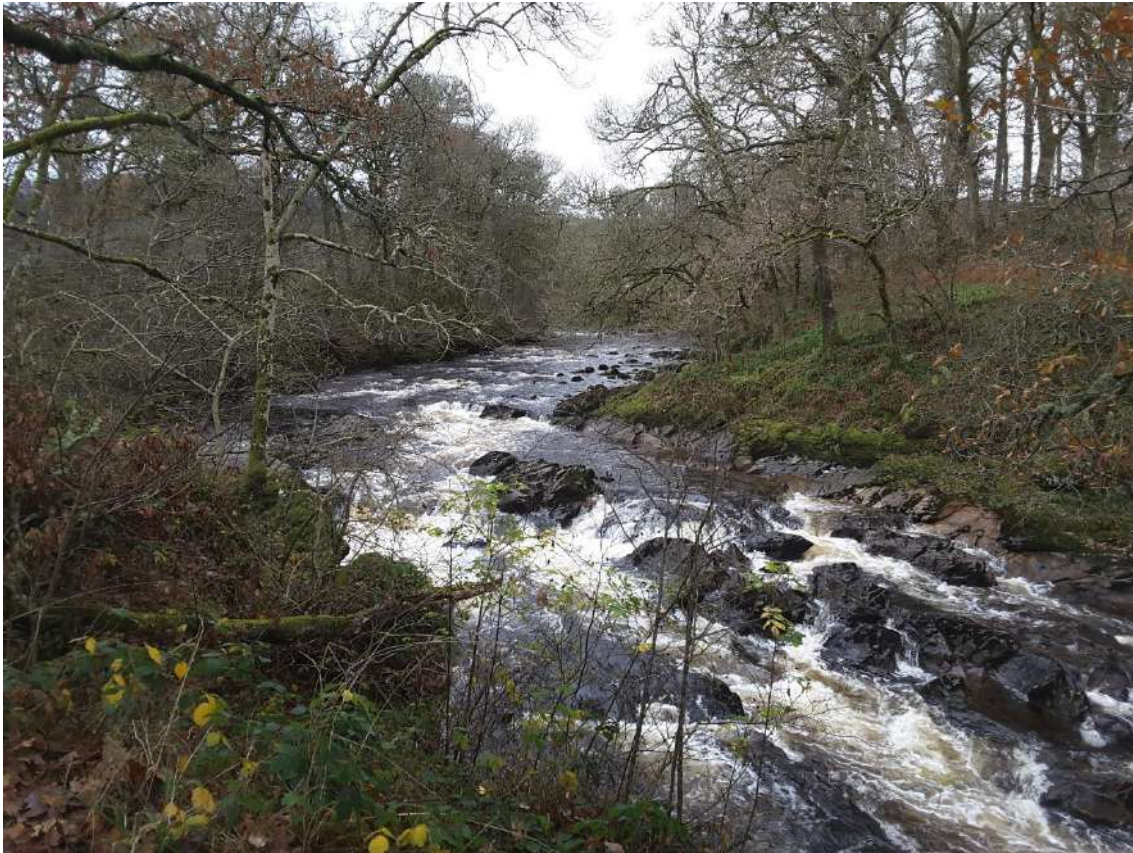
*Figure 3-11: Photo showing the Water of Ruchill as it passes Cultybraggan Camp. The channel has a bedrock typology and has formed a series of cascades.*

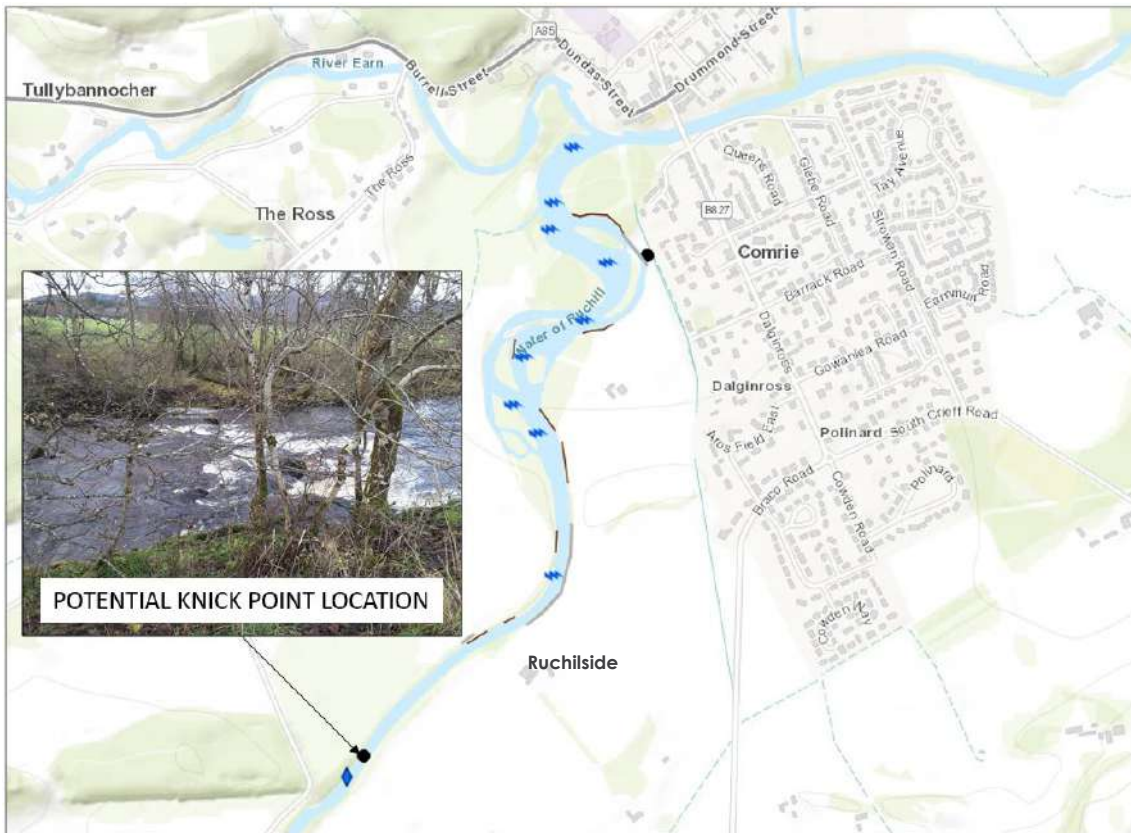
Figure 3-12: Map showing the potential location of the knick point where it appears to have stabilised against bedrock. A drop in bed elevation was observed.

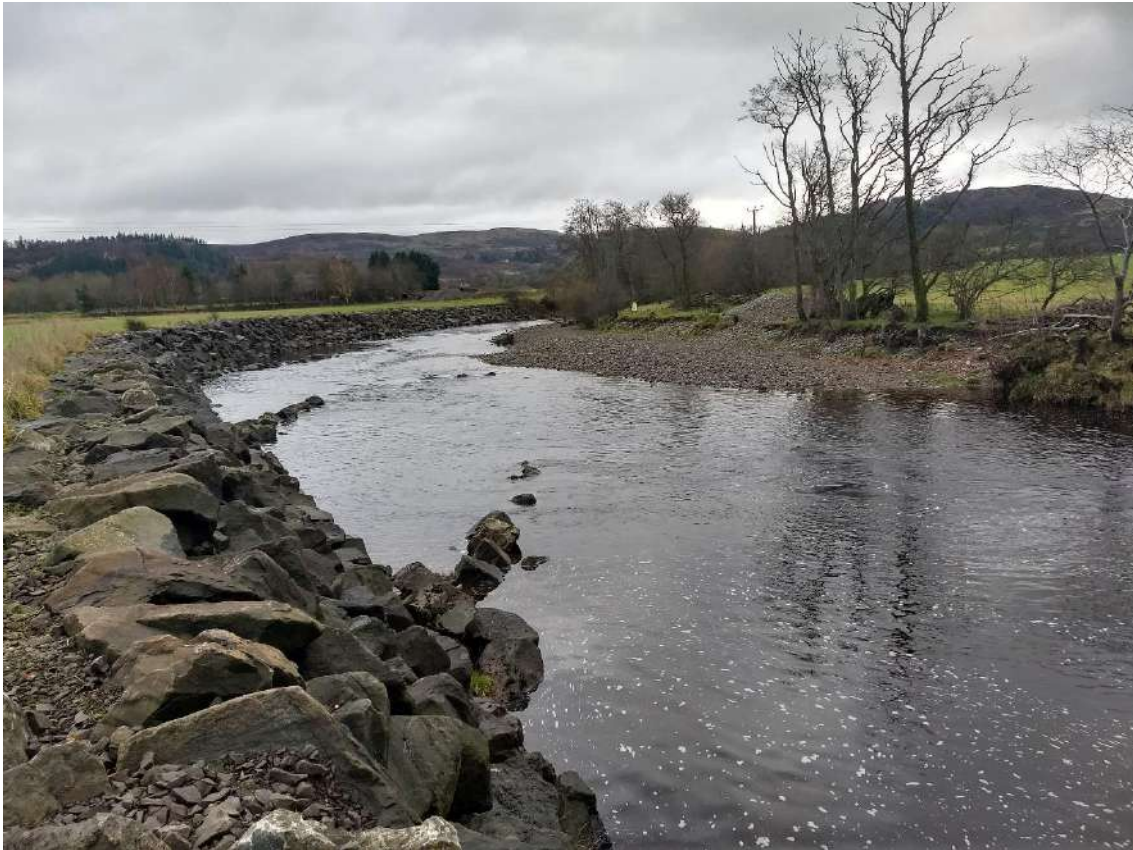
*Figure 3-13: Photo of rip-rap bank protection and J-vanes at Ruchillside. A gravel bar has formed on the inside meander bend. Evidence of gravel extraction is visible on this bar.*

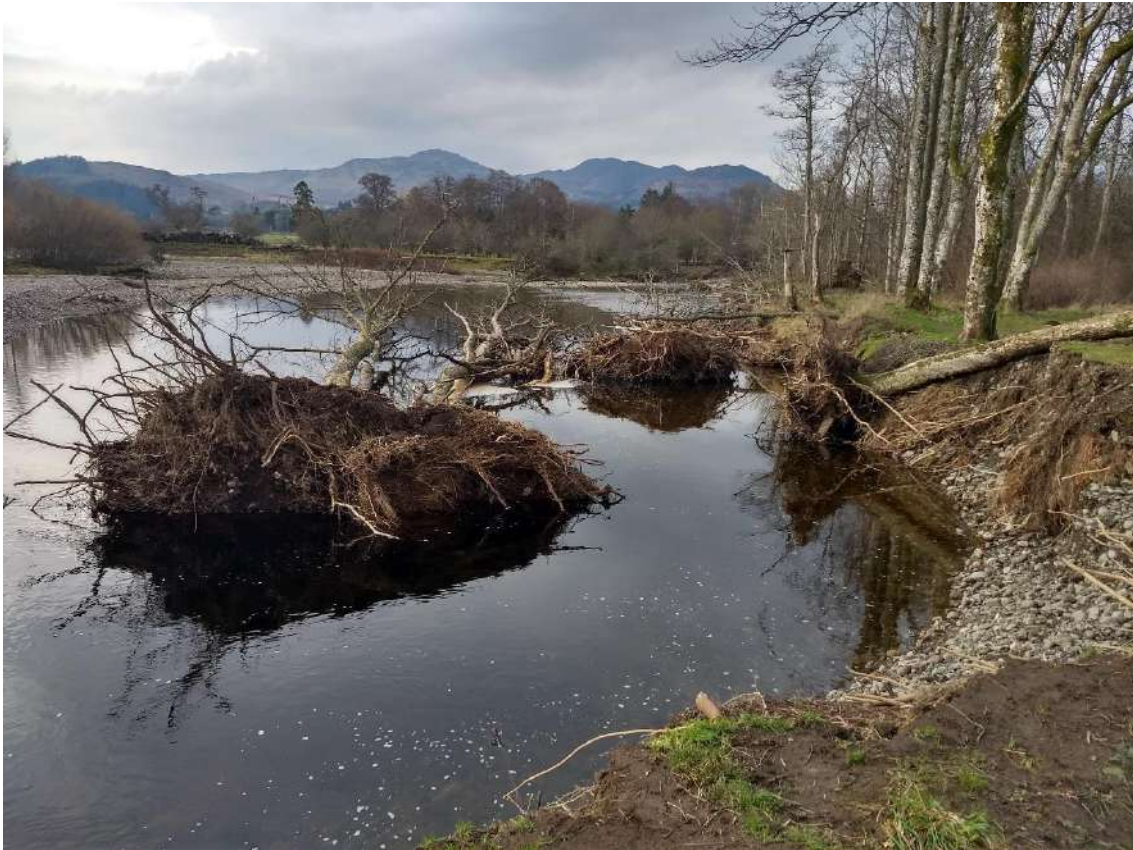
*Figure 3-14: Photo of severe bank erosion downstream of the failing rip-rap bank protection at the outer meander bend at the Field of Refuge.*
