**Comrie Flood Protection Scheme
Environmental Impact Assessment
Report**

**Chapter 8: Ecology and Nature
Conservation**

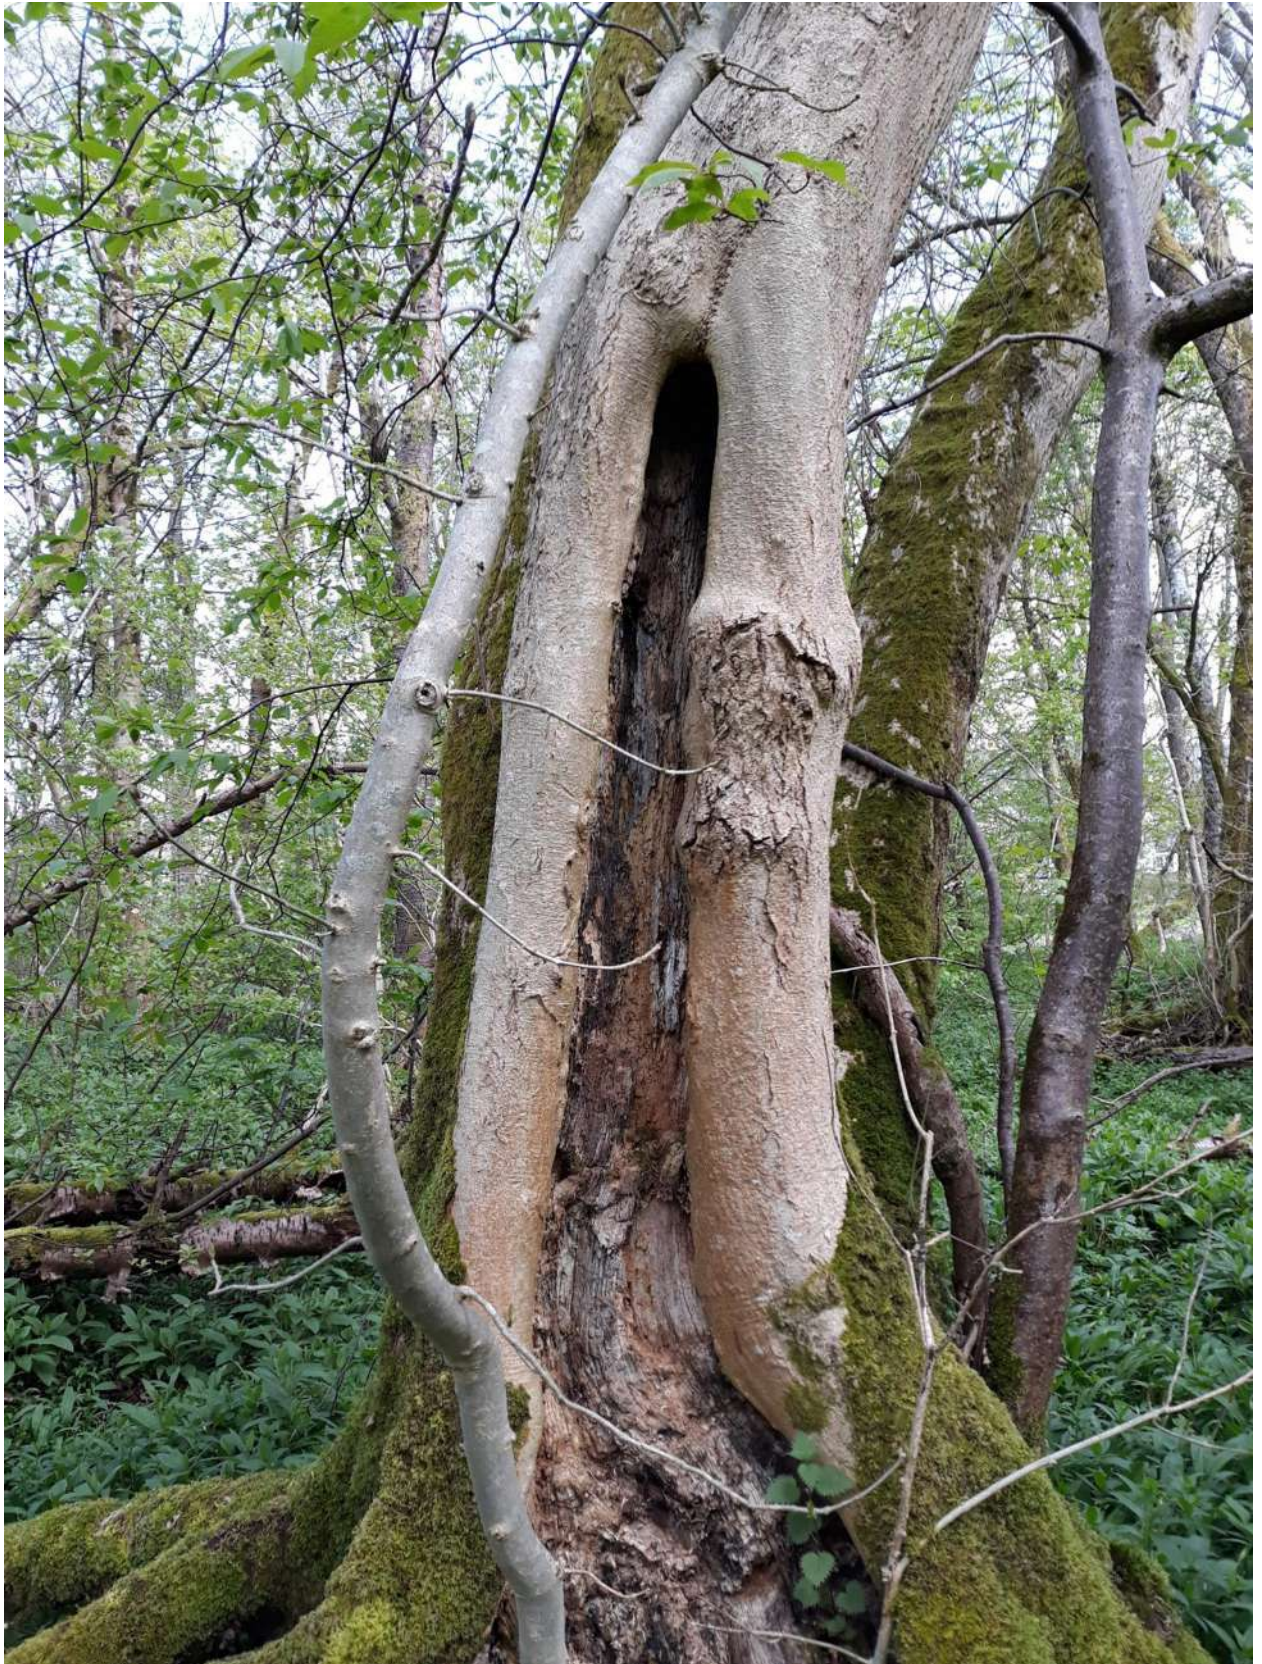
Figure 1. T19 – tree with rotting base leading to large cavity offering low to moderate bat roosting potential.

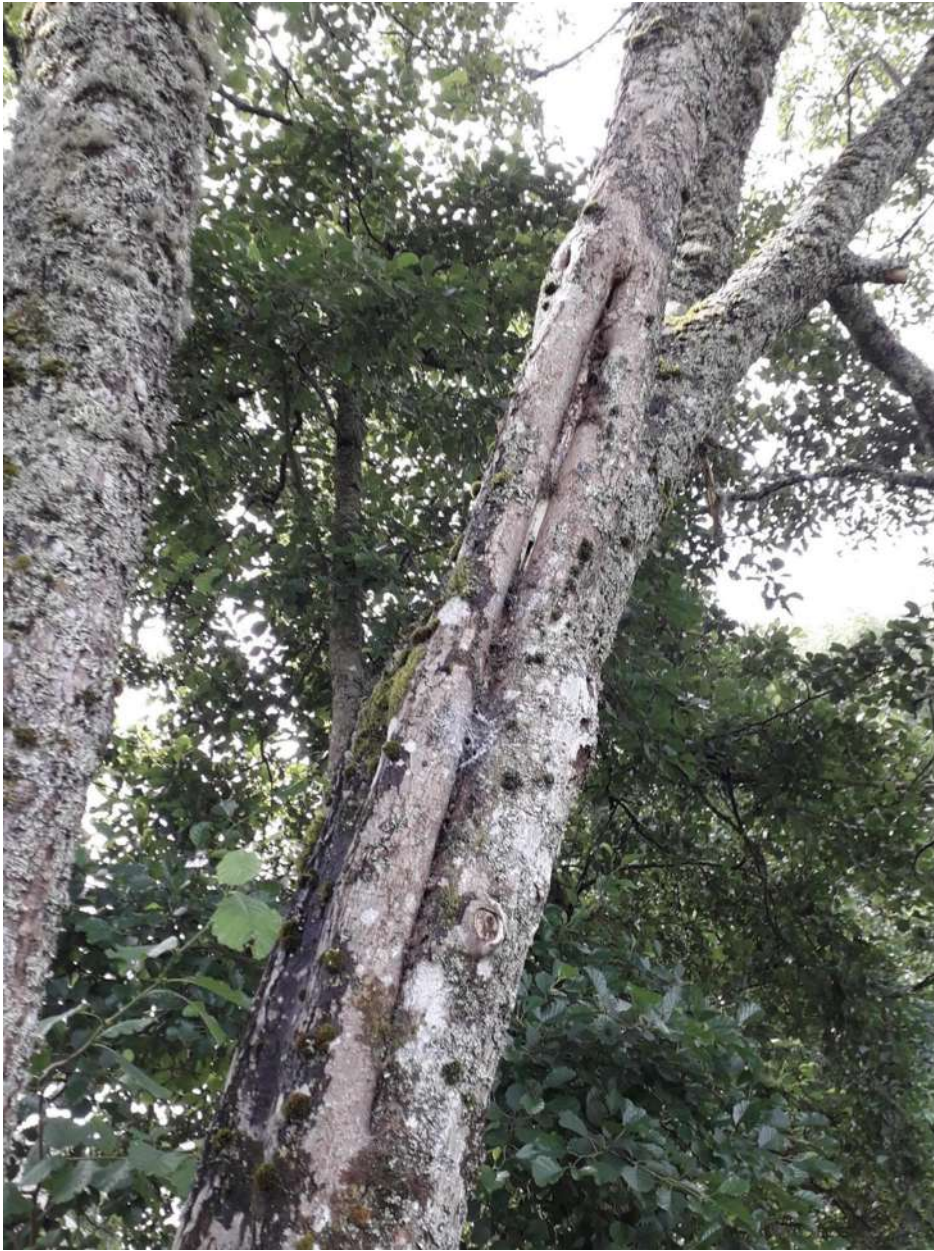
Figure 3. T29 - Willow tree with high bat roosting potential, located to the northeast of the Field of Refuge car park.

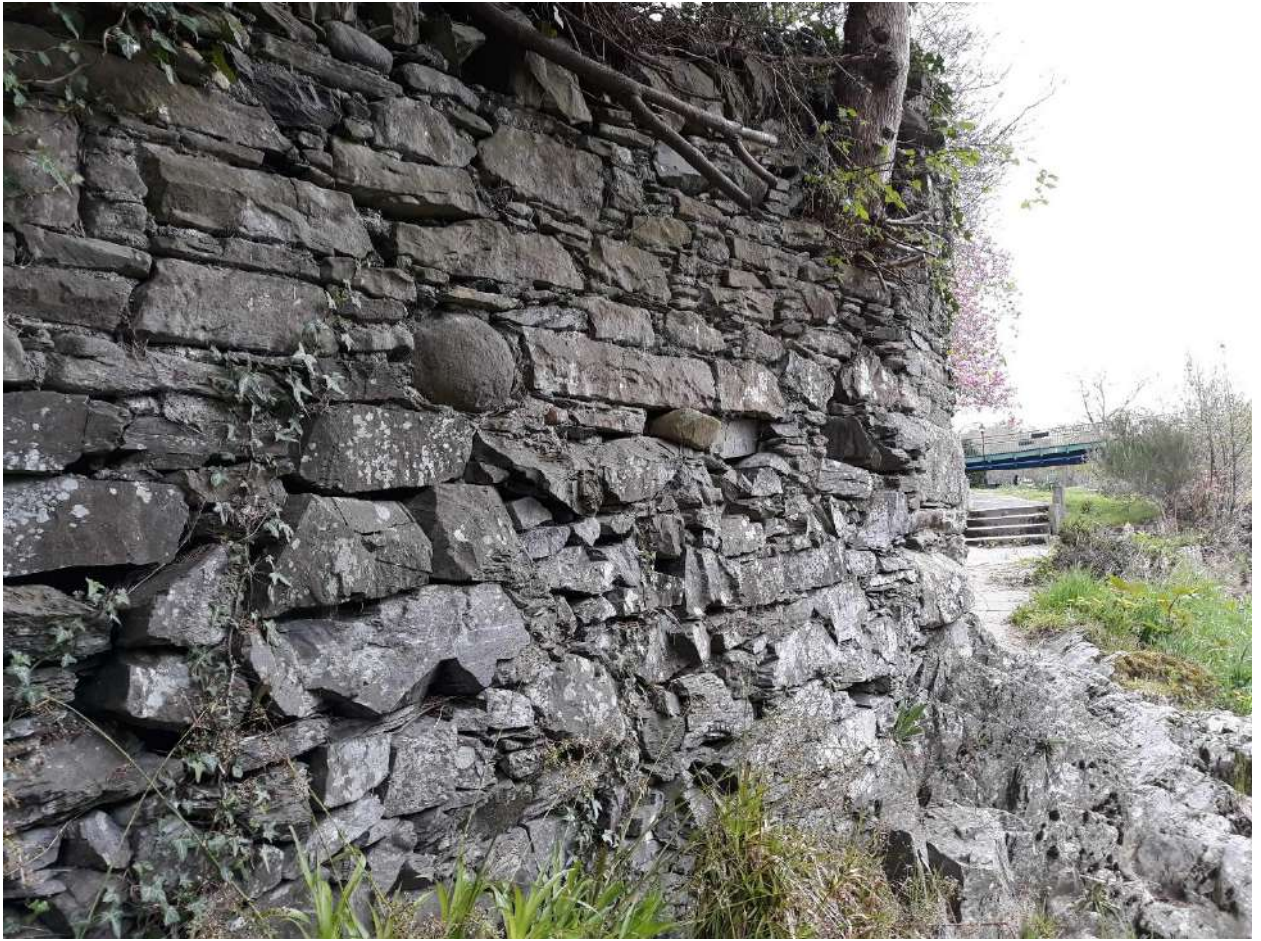
Figure 4. S3 – Dry stone wall with gaps between brickwork presenting bat roosting opportunities.

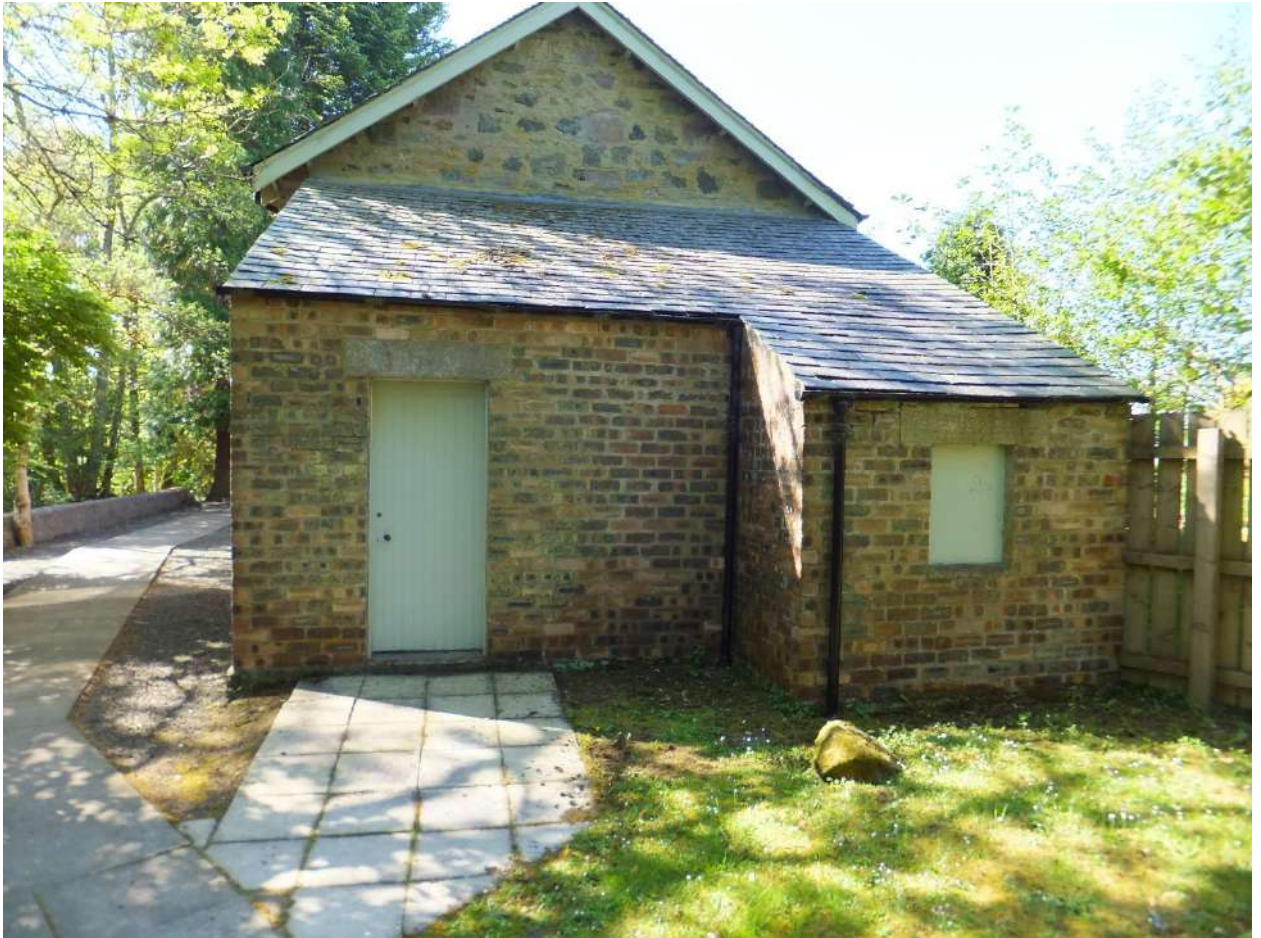
Figure 5. S5 – St Margaret's Catholic Church showing the northern gable. Daubenton's maternity colony was observed at the apex of this gable end.

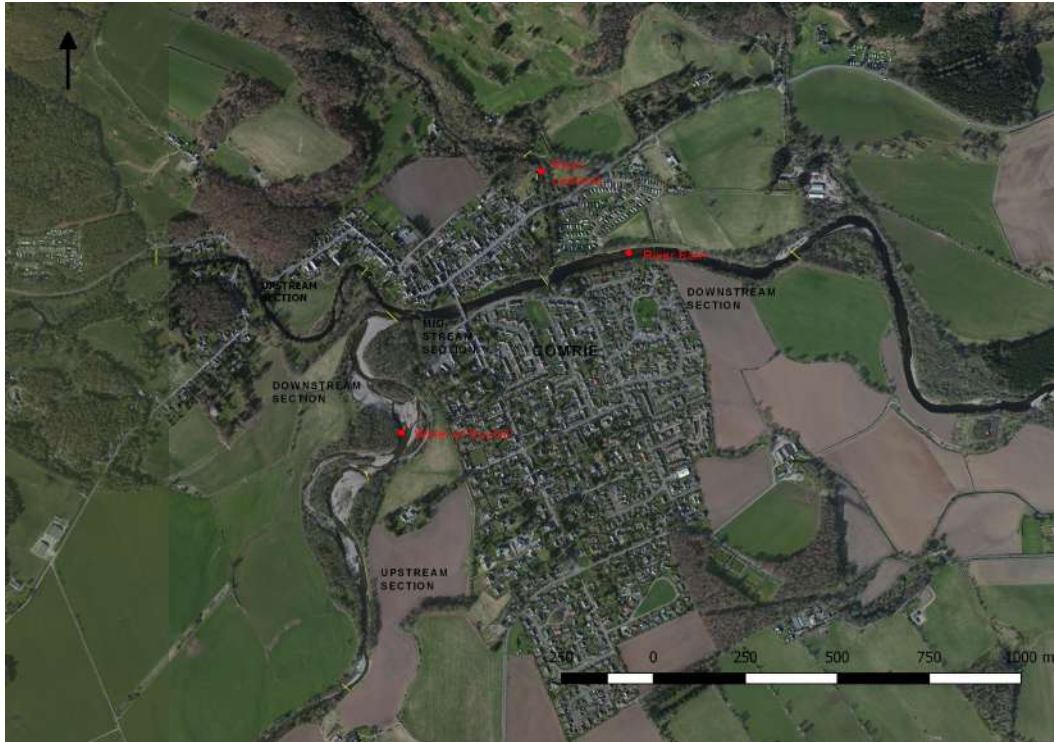
Figure 2: The extent of the three rivers subject to signal crayfish surveys. The extent of each section is indicated in yellow.

3.2.2 The three rivers differ in size and character caused by their different catchment areas and surrounding topography. However, all three seem to respond rapidly to heavy rainfall before returning to previous levels quite quickly. During the survey all rivers were recorded by SEPA as being normal, albeit at the lower end of this classification. A description of each river is provided, with photographs shown in Appendix A.

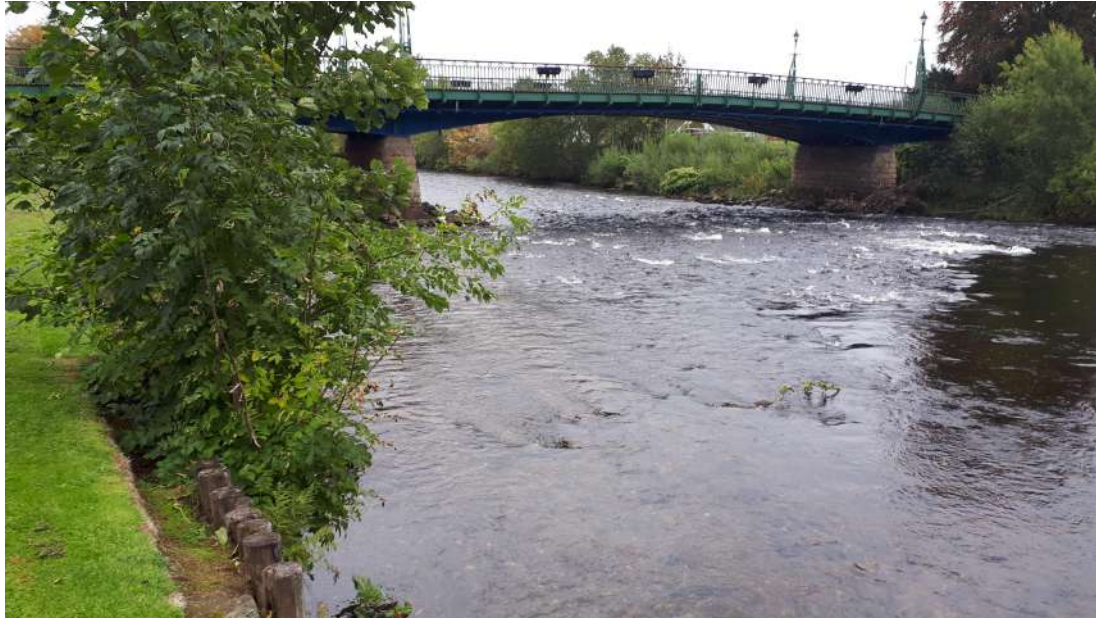
Photograph 1: The River Earn flowing through Comrie. Measures to stabilise the bank are visible in the left foreground.

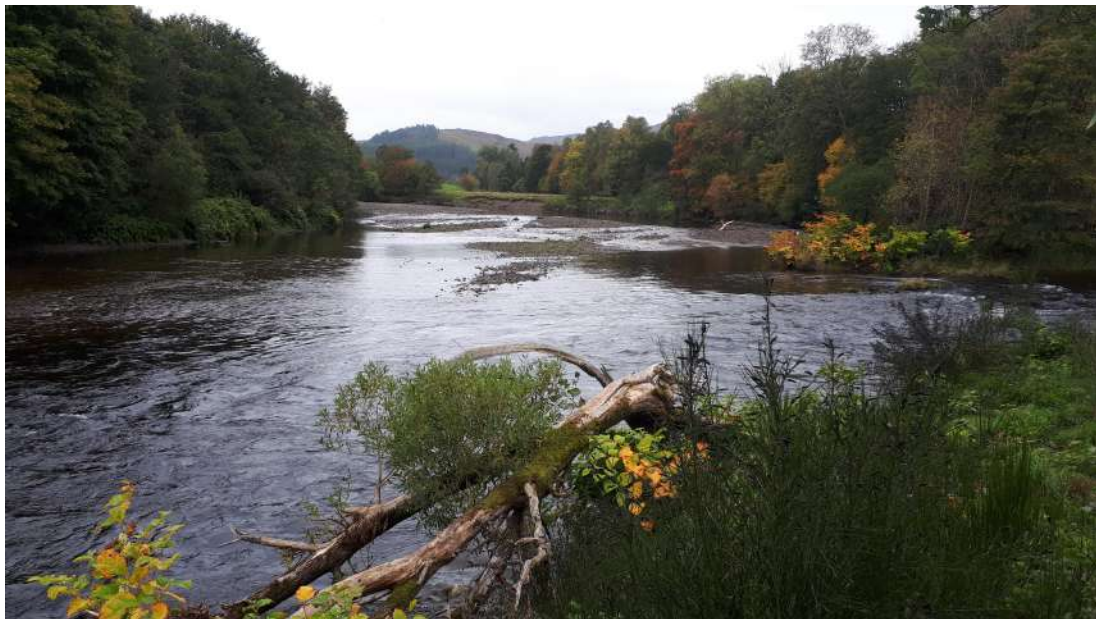
Photograph 2: The confluence of the Water of Ruchill (background) and the River Earn (foreground) showing large areas of exposed bed and eroded banks.

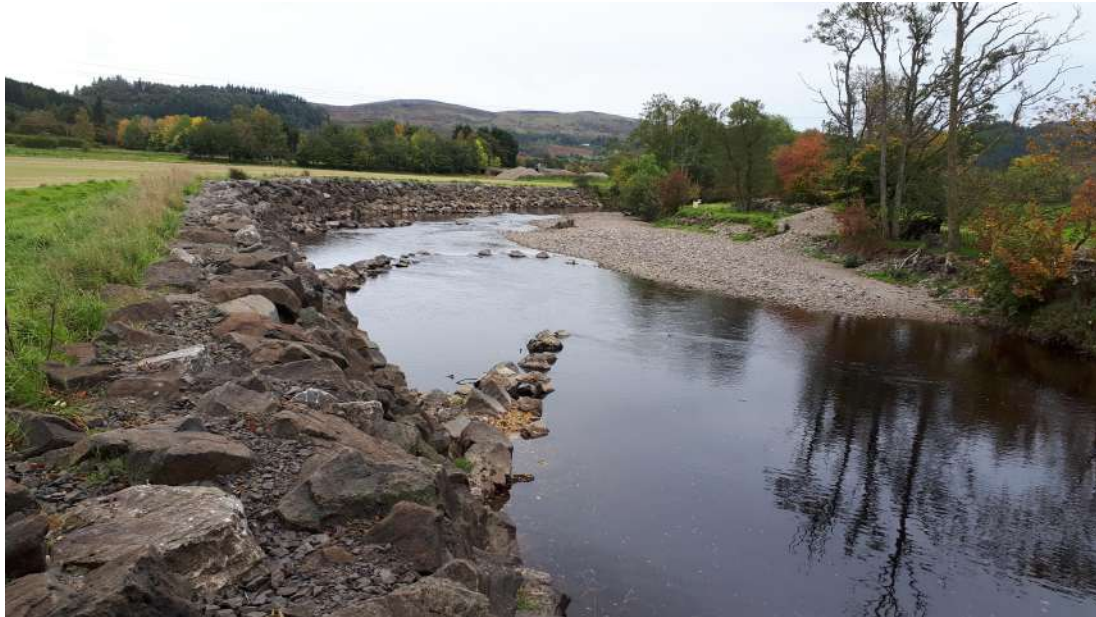
Photograph 3: Groynes and bank-side reinforcement on the Water of Ruchill. Slow water downstream of the groynes, coupled to the crevices between the rocks, was considered to be suitable for crayfish.

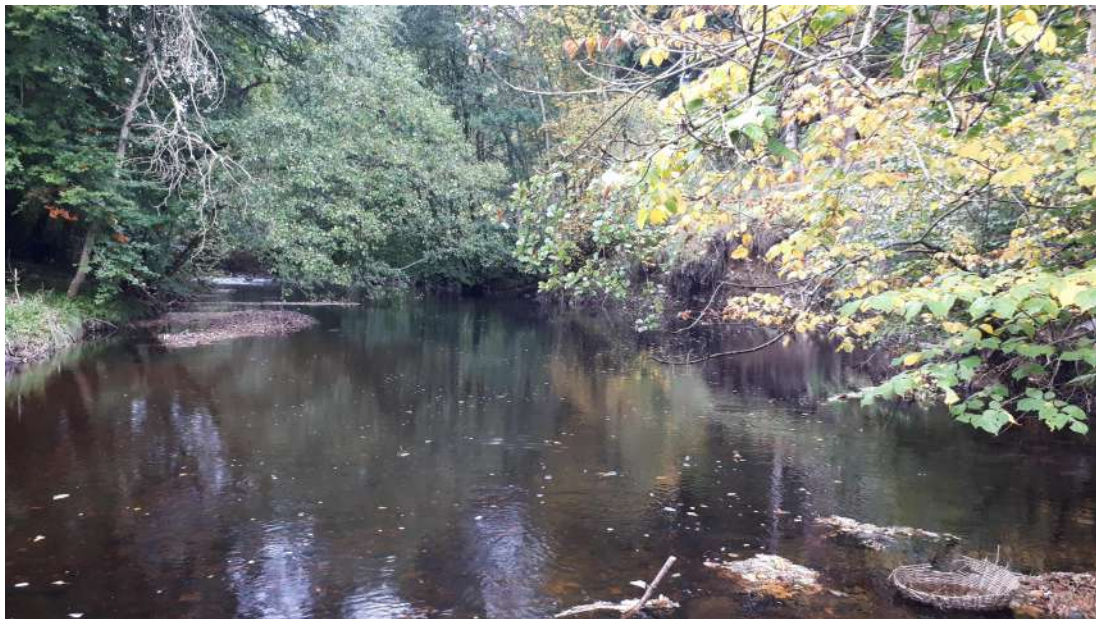
Photograph 4: The River Lednock showing the dense riparian corridor and generally straight channel. Slow moving water offered suitable flow regimes although large boulders often reinforced the channel making the bank unsuitable for burrowing.

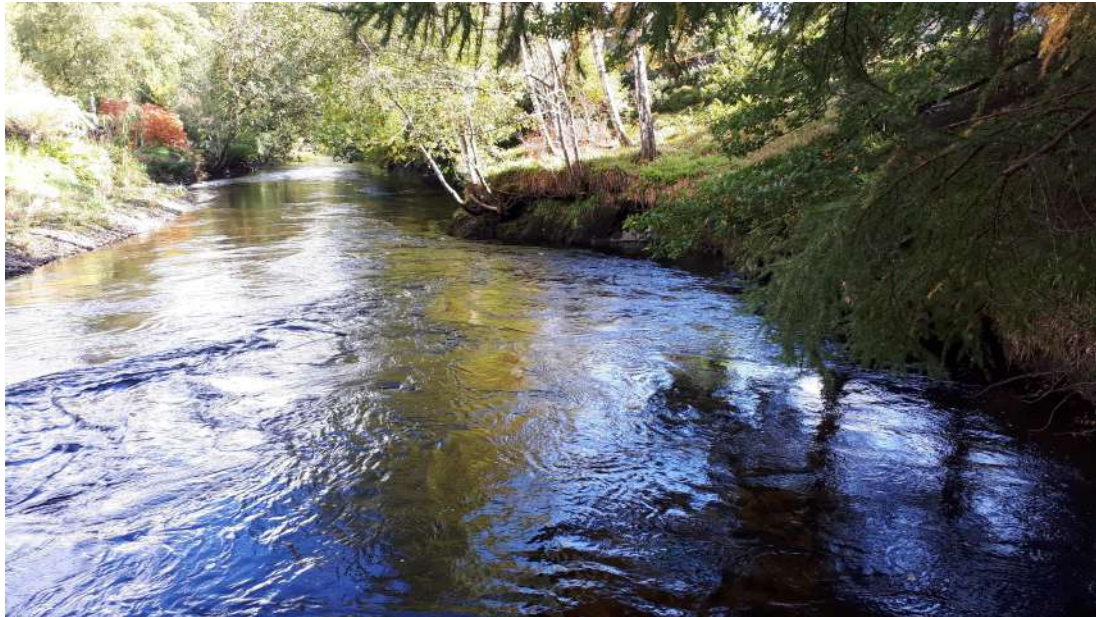
Photograph 5: A deep pool beside the right hand bank of the River Earn with slow flowing water and an earth bank which is suitable for signal crayfish.

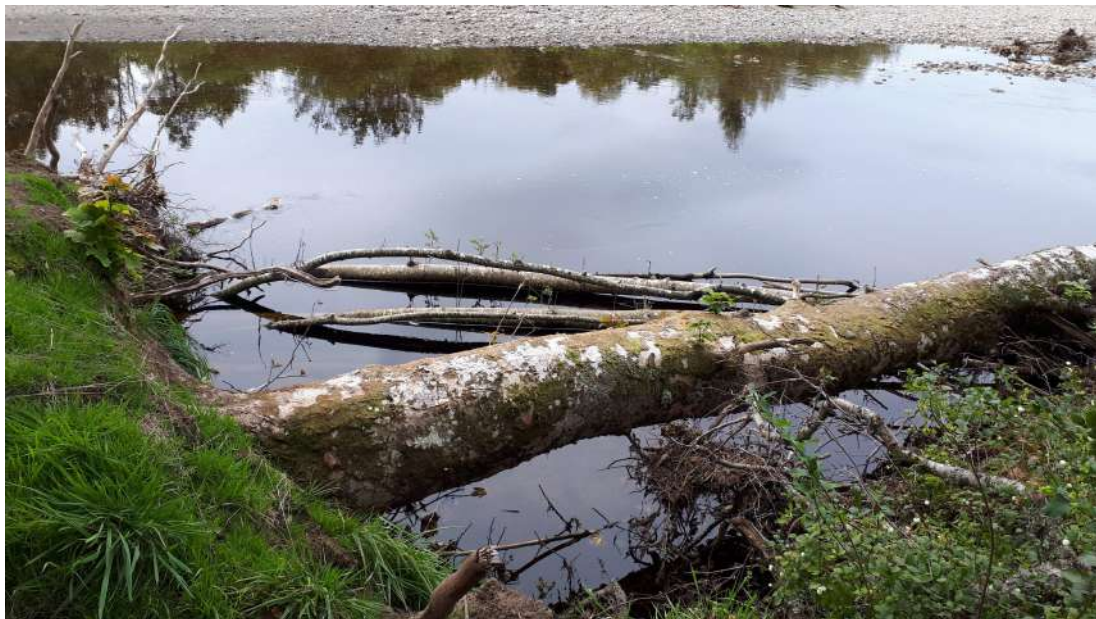
Photograph 6: Submerged tree roots and boughs, coupled to slow moving water, may provide shelter for crayfish. The extent of the patch is centred on the woody debris.

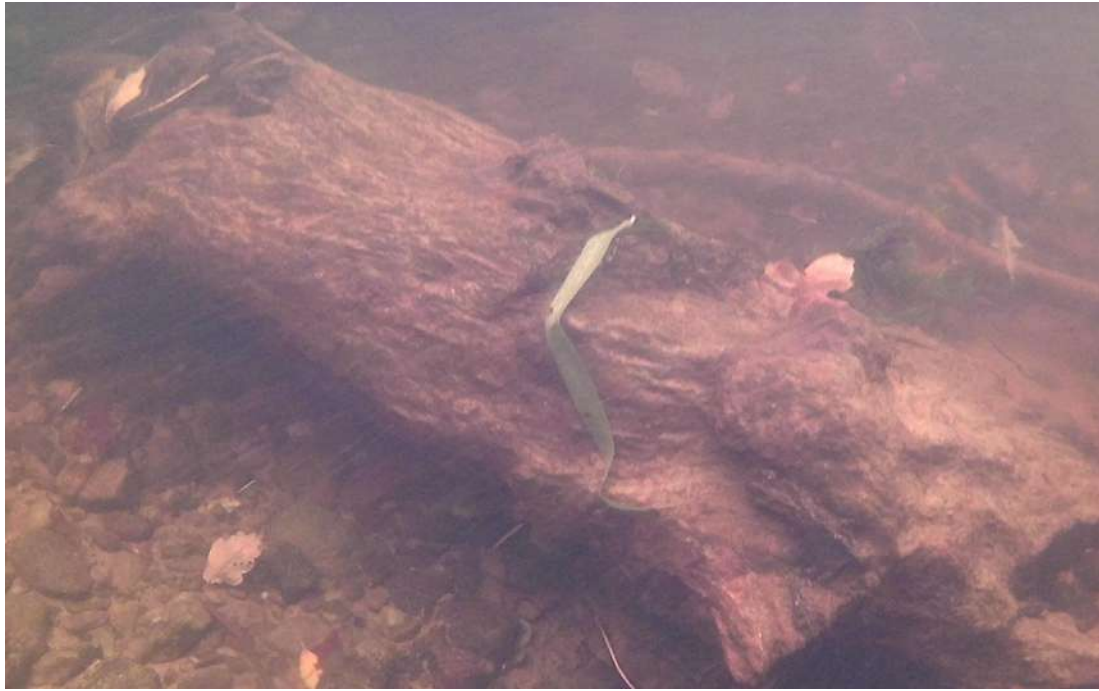
Photograph 7: A submerged log which offers ideal habitat for crayfish to shelter under.

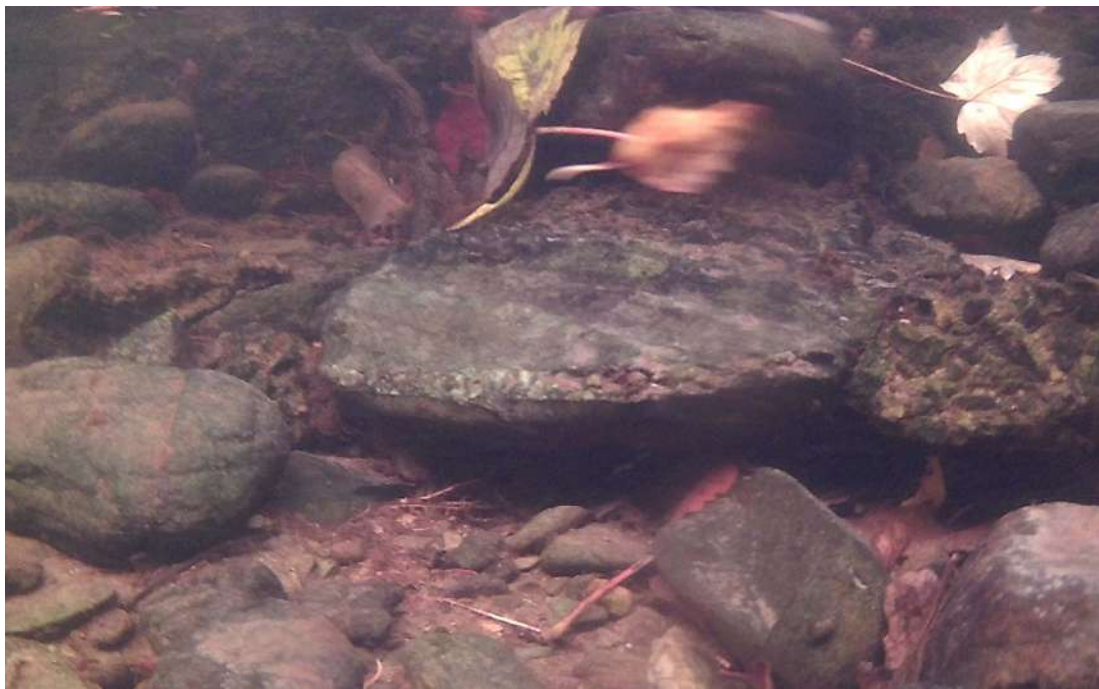
Photograph 8: Boulders were the commonest type of refuge although many of them were not consolidated into the bed and may have moved during flood events.

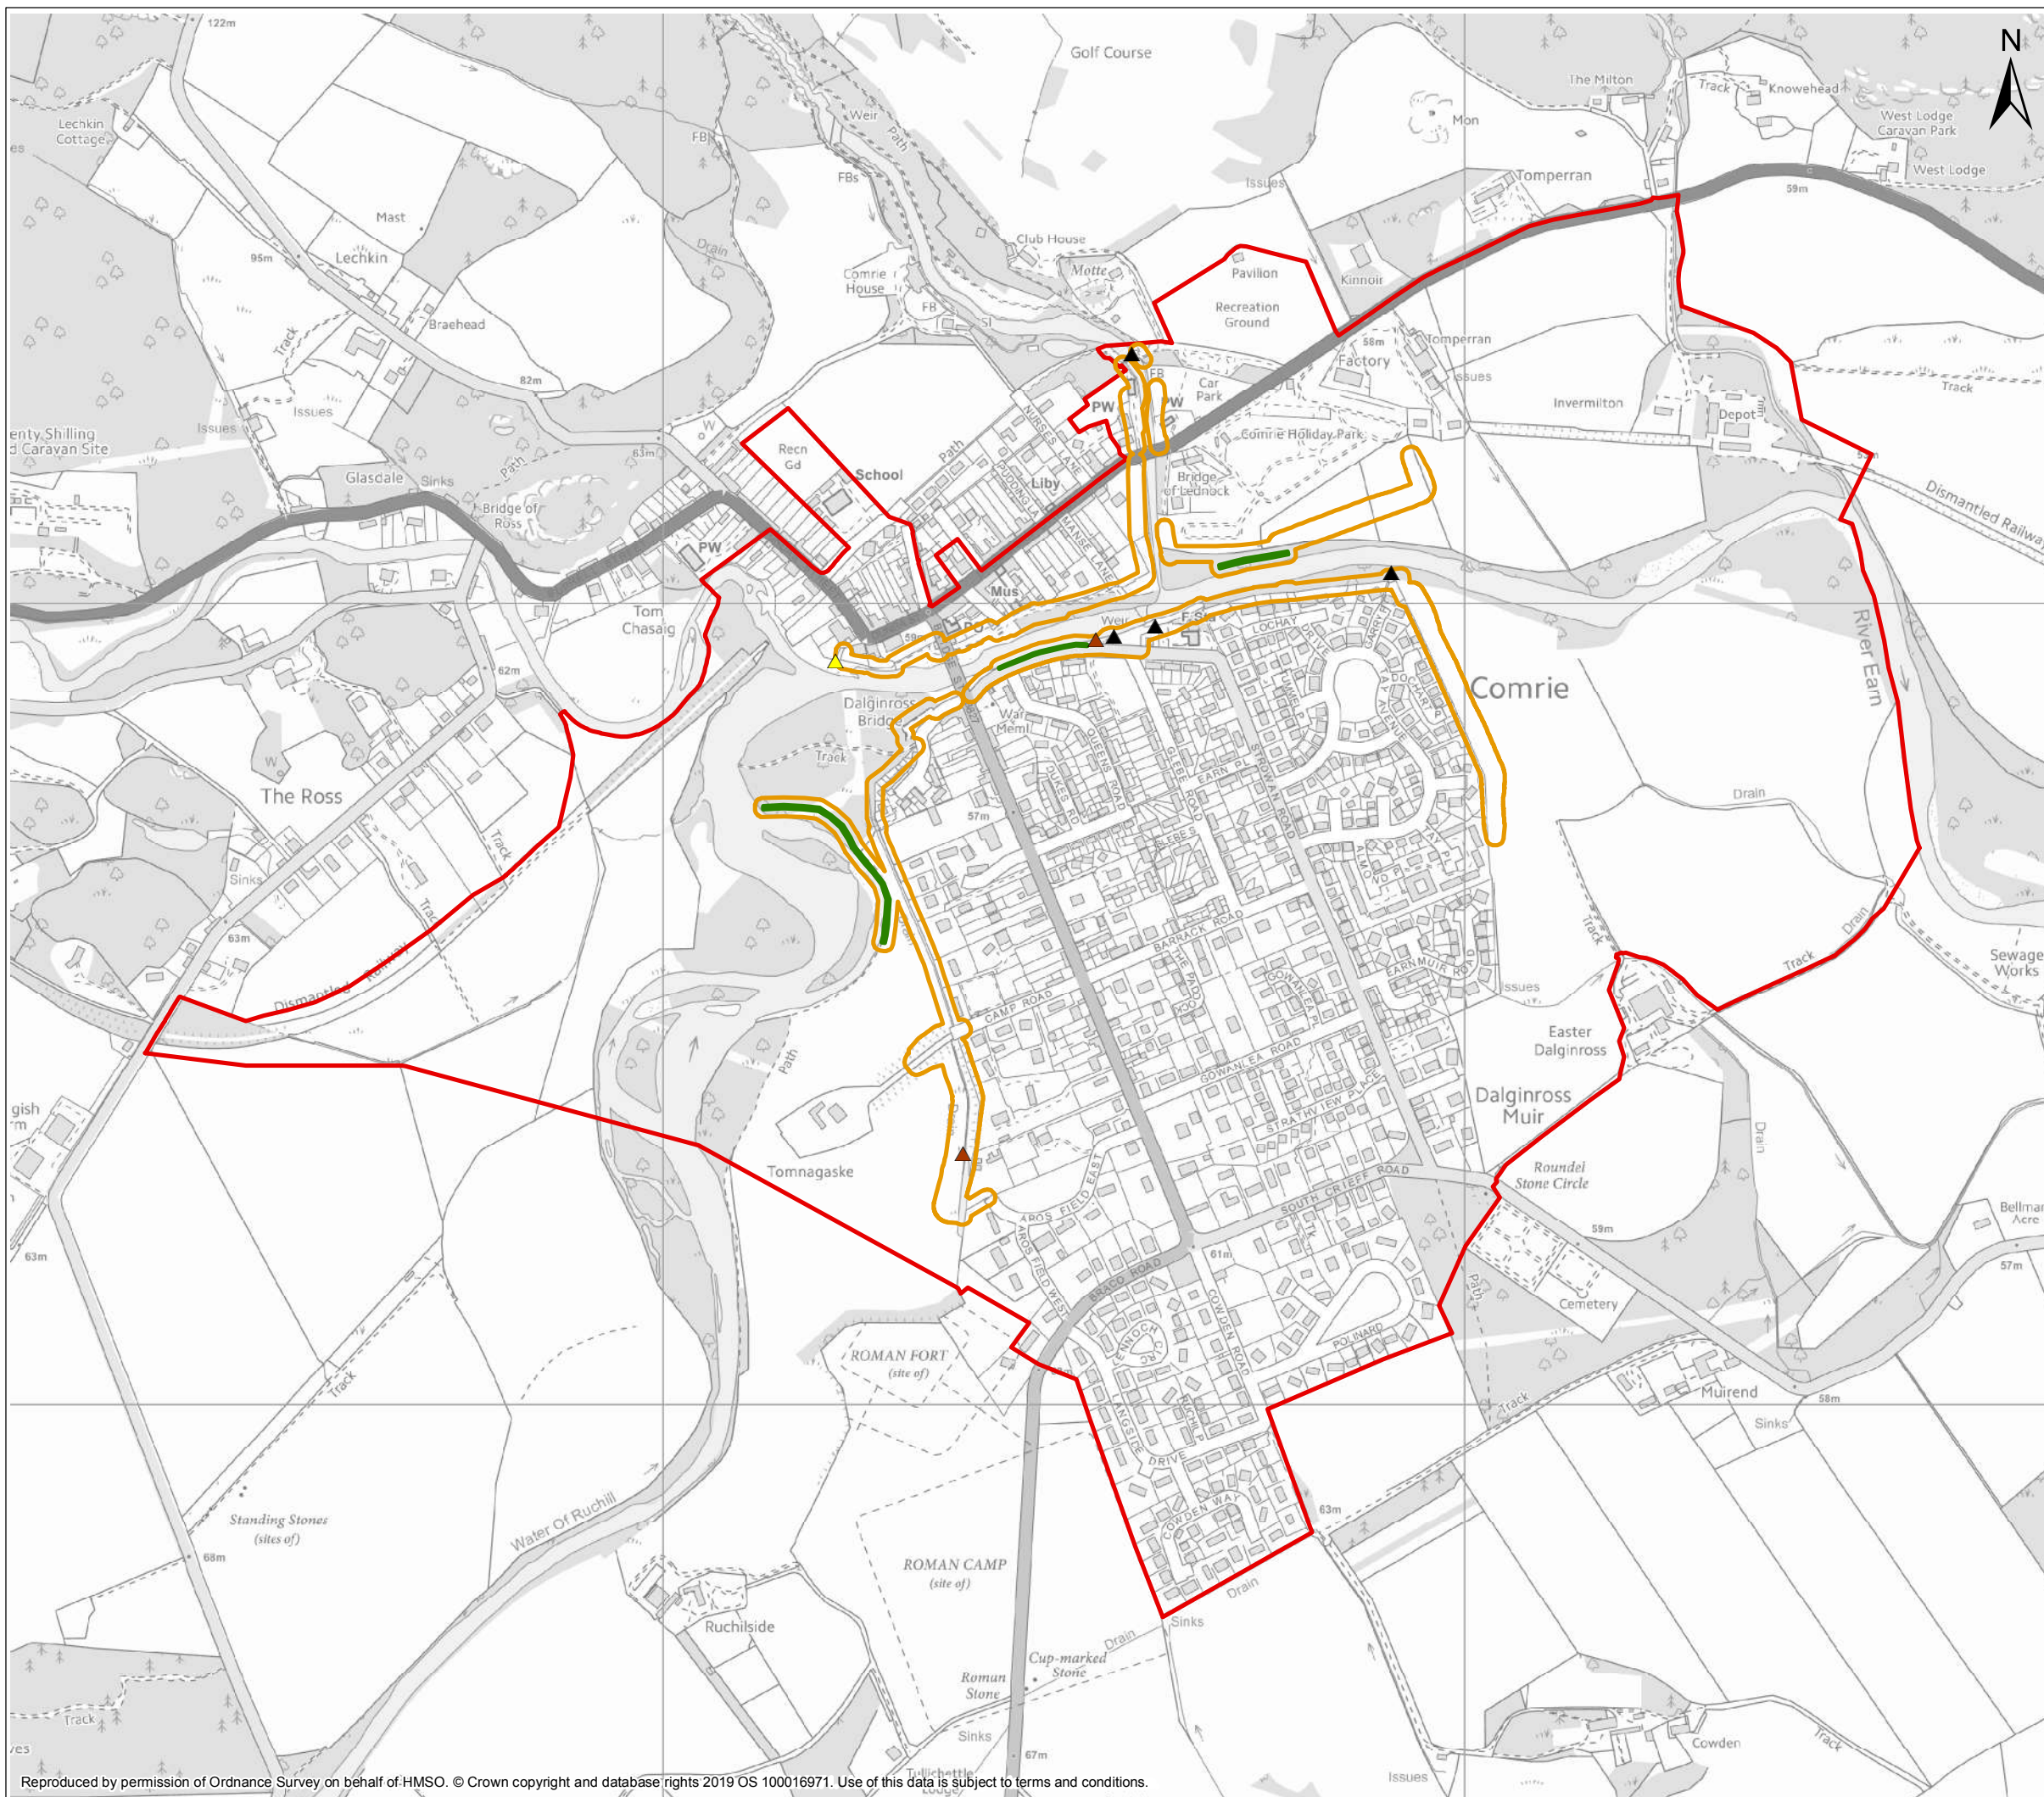
Appendix B – Figure 2: Invasive plants with Scheme design map

- Legend**
- Study Area
 - Scheme Design - 10m Buffer
 - Erosion / Scour Protection
- Invasive Non-Native Species**
- ▲ INNS, Himalayan balsam
 - ▲ INNS, Japanese knotweed
 - ▲ INNS, Variegated yellow archangel

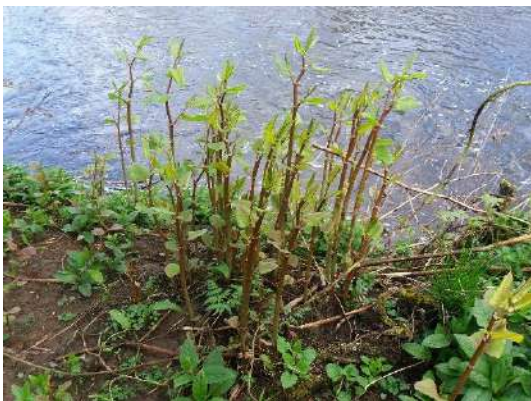
Figure 3. Japanese knotweed growing early in the season on the banks of the Earn.

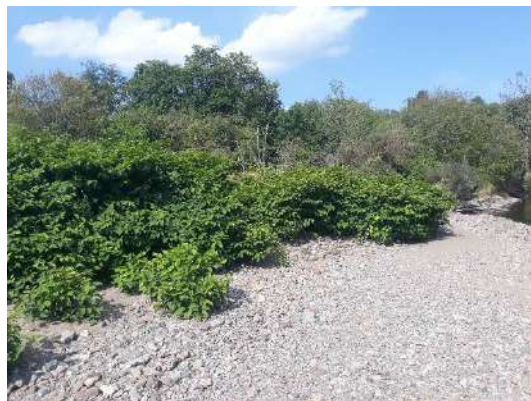
Figure 4. Large stand of Japanese knotweed growing on the Ruchill.
